Oak Archaeology Wales

MASTER INTEGRATED DBA

Targeted Exploratory Excavations and Structural Investigation

Ruperra–Machen Landscape, South-East Wales

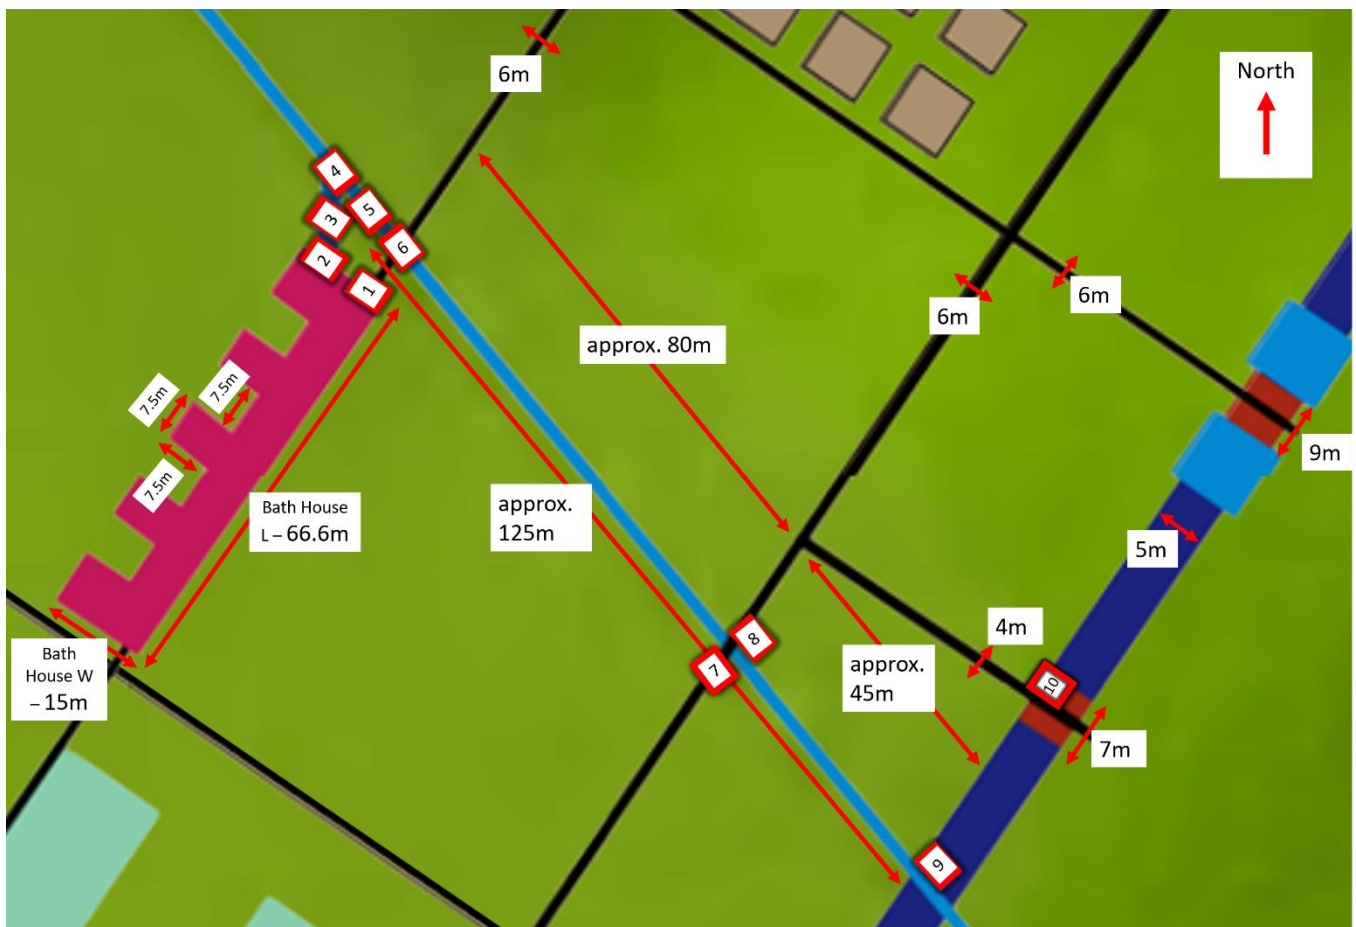
Exhibit A – Investigation Trenches Layout.

Plan showing the spatial distribution of Trenches 1–10 in relation to the bathhouse structure, roadway alignment, waterway, and associated features.

Distances between features are indicated, including approximate alignments of c.80 m and c.125m across the site, and gateway/track widths of c.4m–7m.

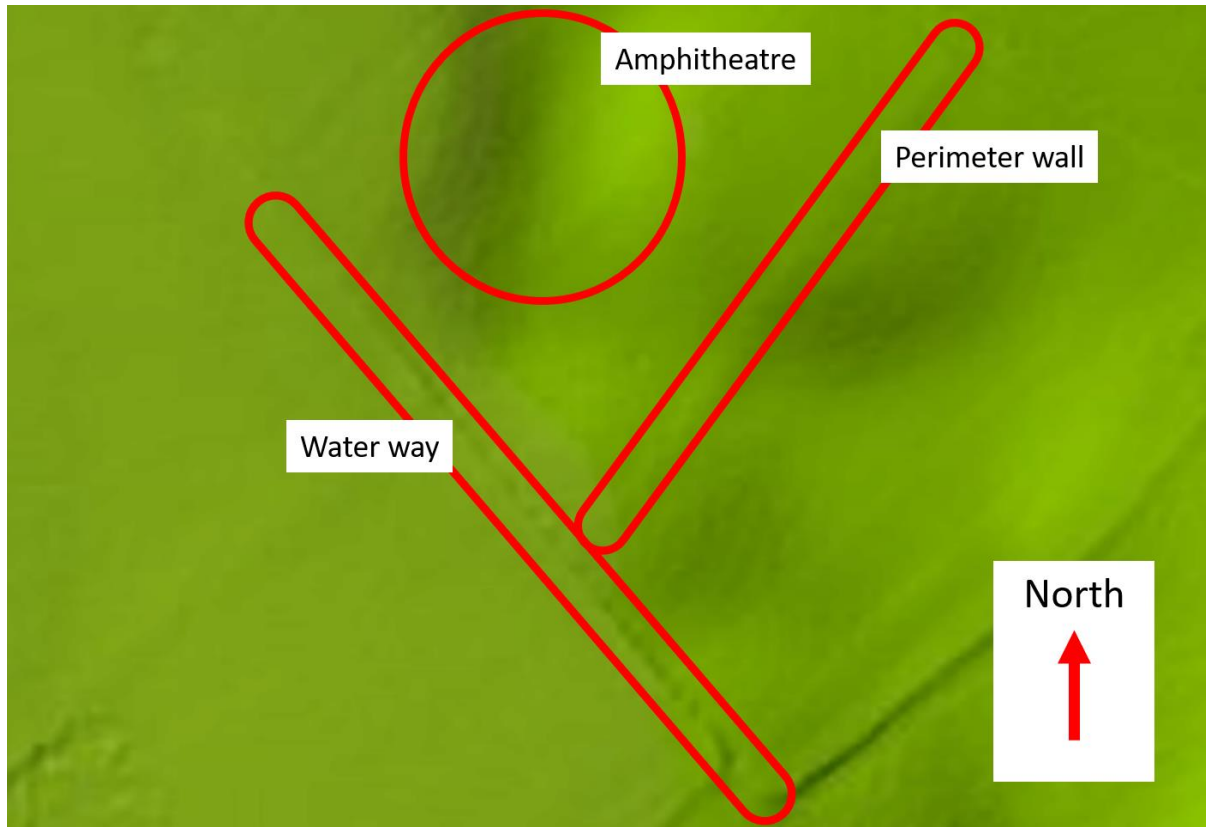
Exhibit B – LiDAR Structural Alignment

LiDAR-derived terrain model illustrating:

- Linear perimeter wall alignment
- Relationship to Trenches 8 and 9
- Amphitheatre earthwork
- Waterway corridor.

This exhibit demonstrates correlation between topographic expression and excavated features.

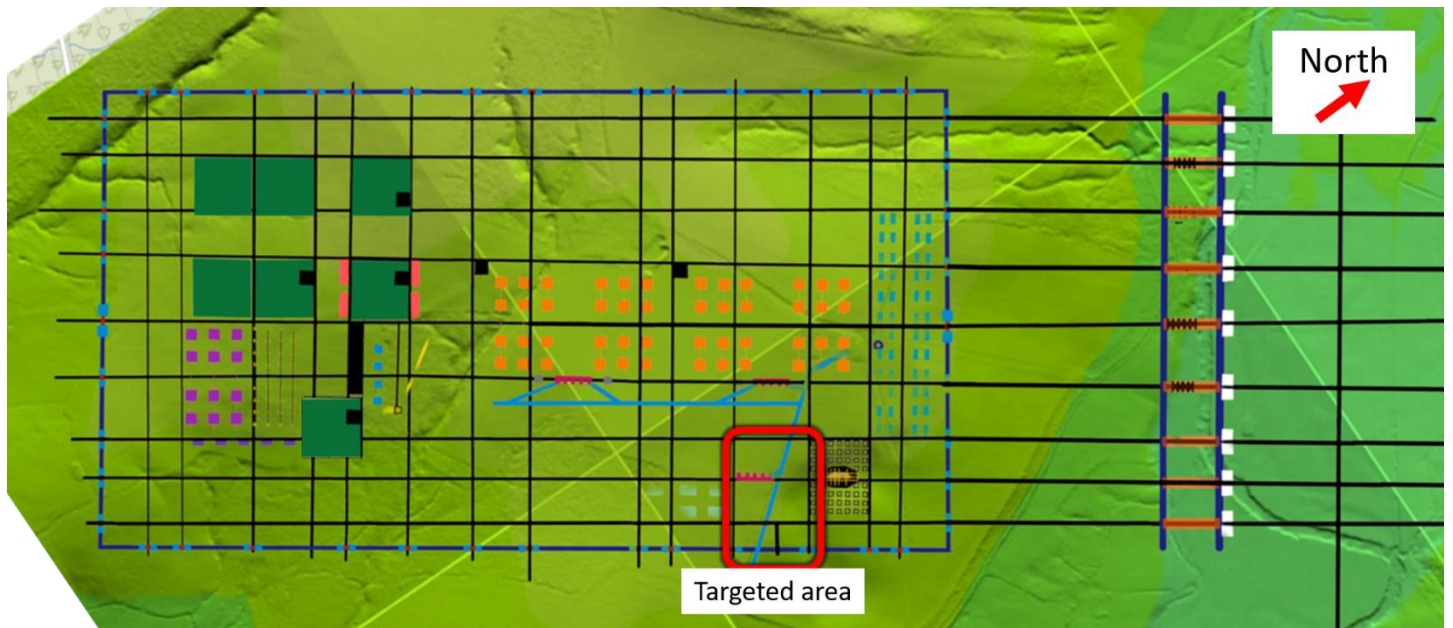
Exhibit C – Site Context within Wider Complex.

Composite plan showing the targeted excavation area within a larger rectilinear complex. The figure illustrates the scale and organisation of the site and positions the excavation zone within a broader structured landscape.

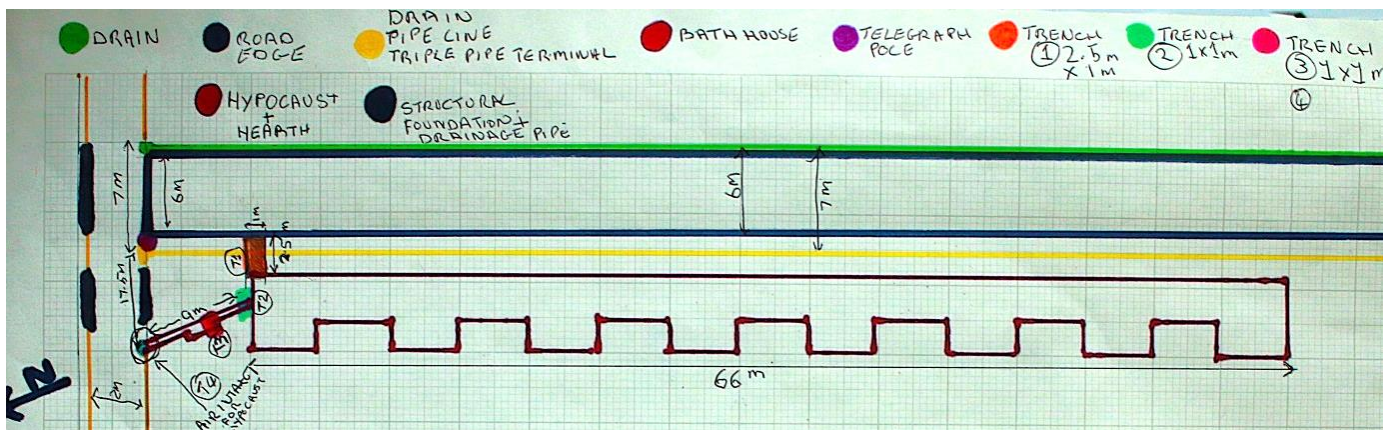
Figure 1: Simplified Site Plan (not to scale) showing trench locations, Roman road alignment, waterway, drainage infrastructure and bathhouse heating system.

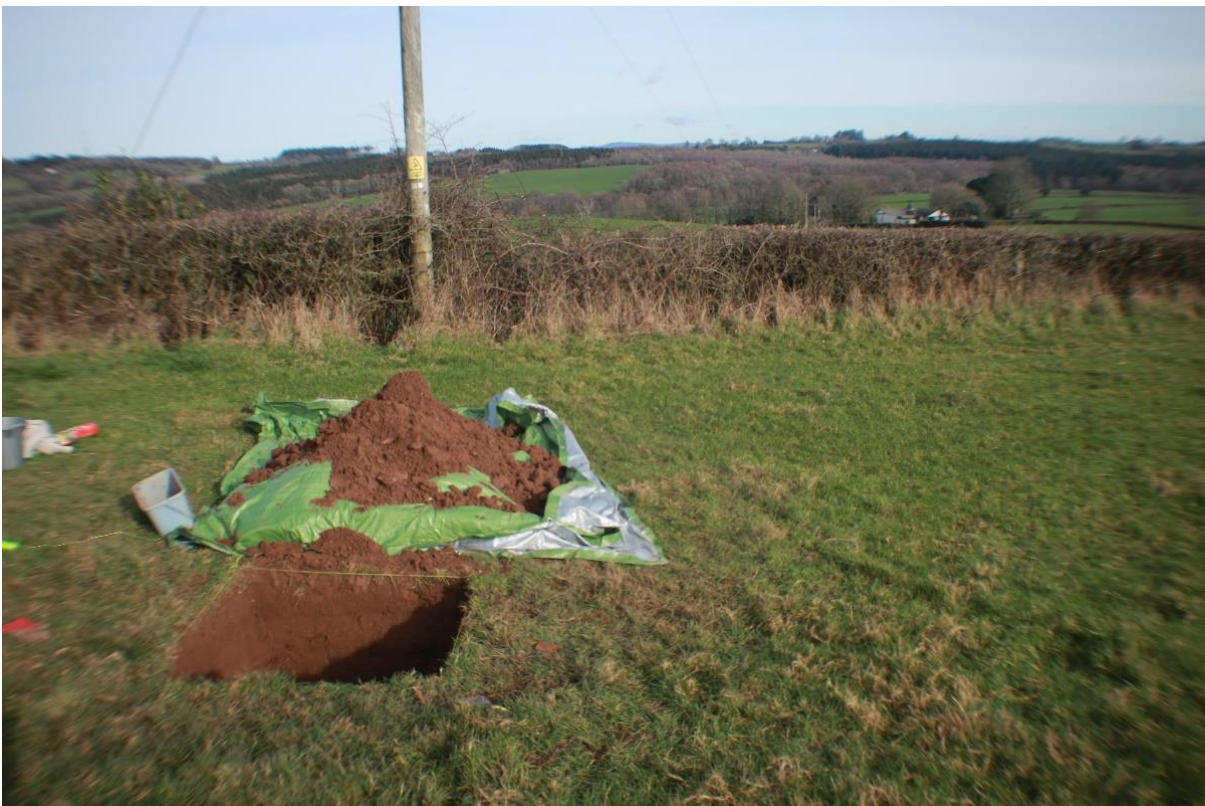
- Roadside edge definition
- Ceramic pipe
- Structural foundation material
- Indicating integration of transport and drainage infrastructure.

Figure 2: Location of Trench 1 positioned to investigate the predicted pipeline, roadside edge and bathhouse foundations.

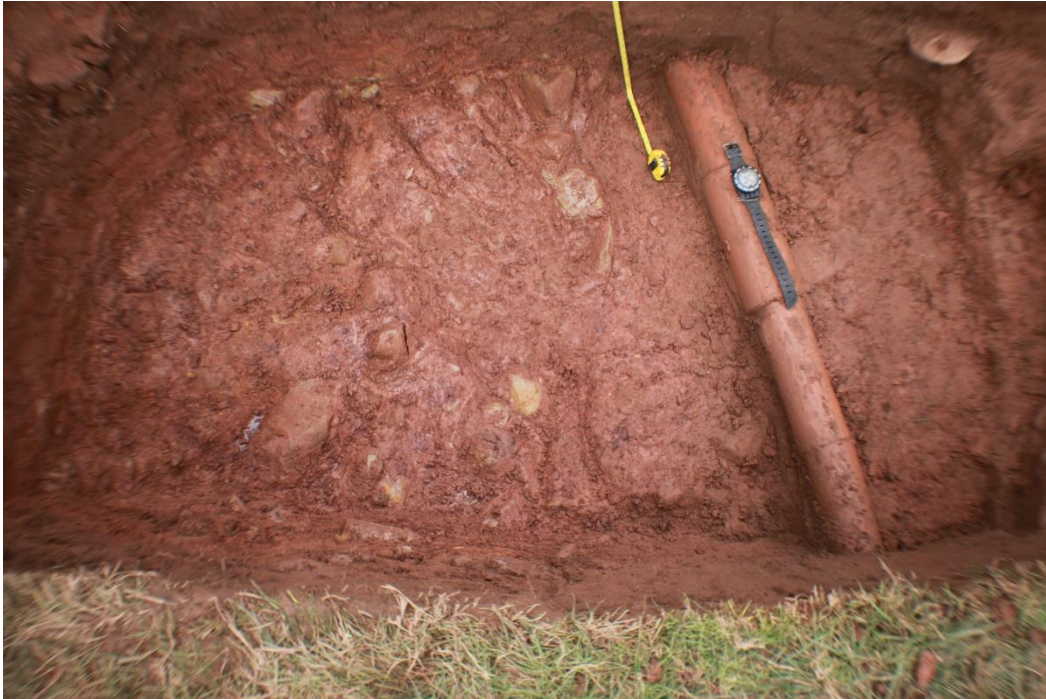
Figure 3A: Trench 1 extended west showing foundation stone adjacent to drain pipe and road correlation.

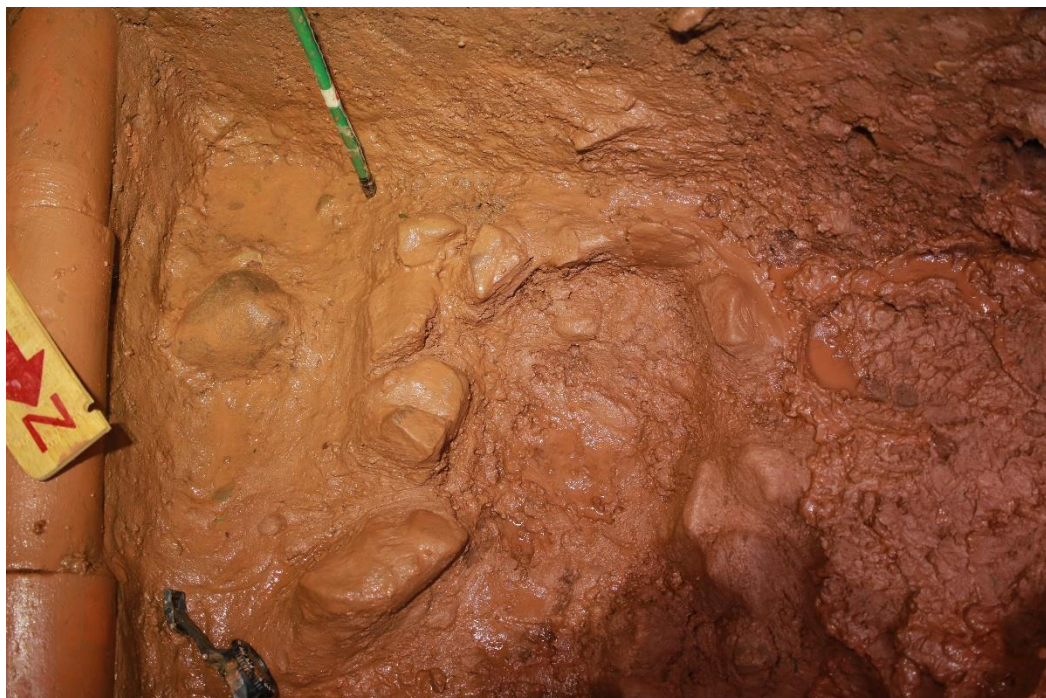
Figure 3B: Close-up view showing structural intent and stone placement.

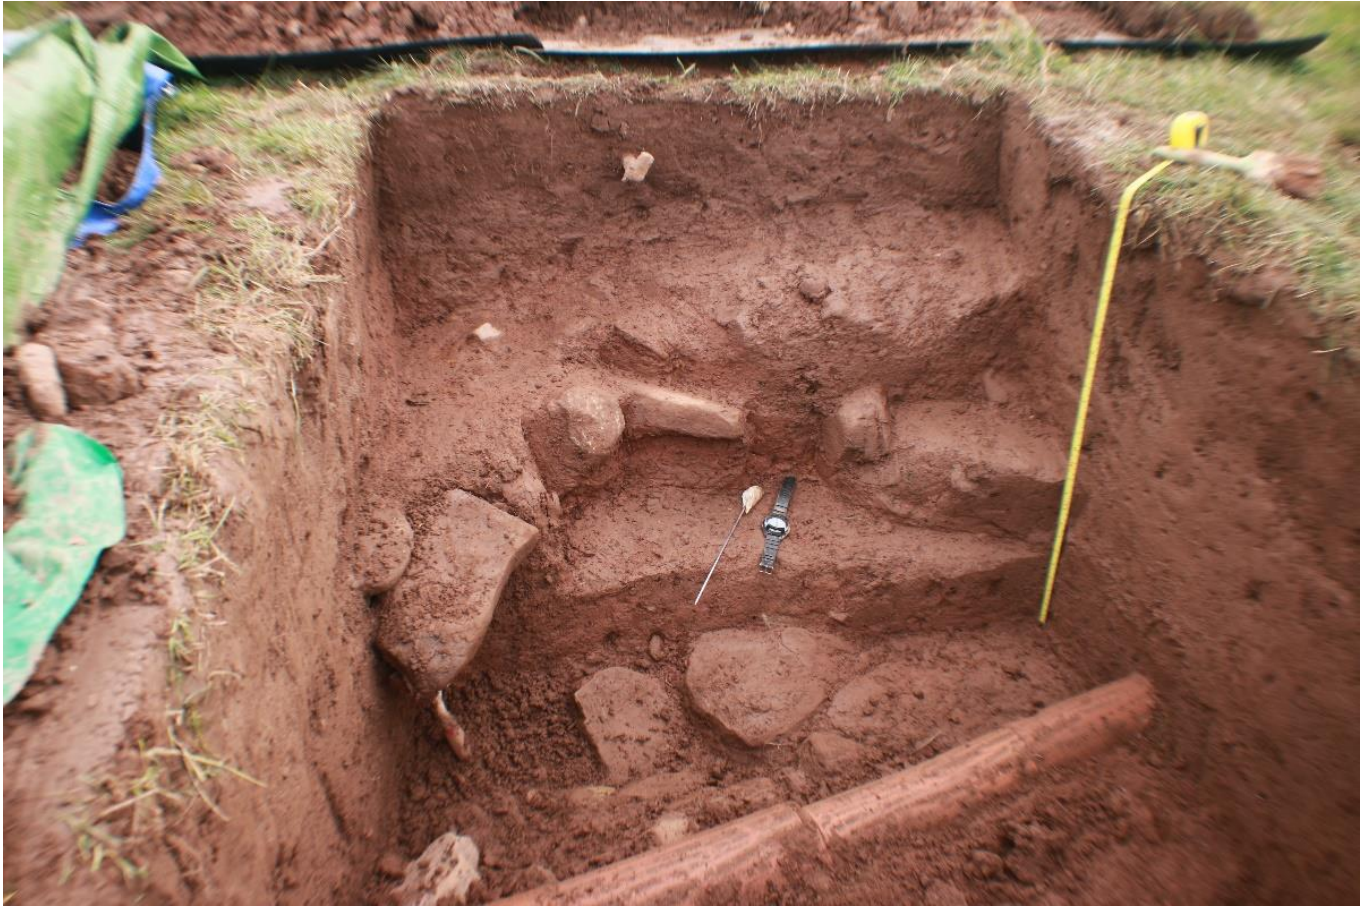
Figure 4: Eastern trench extension revealing further roadside edge and metalling deposits.

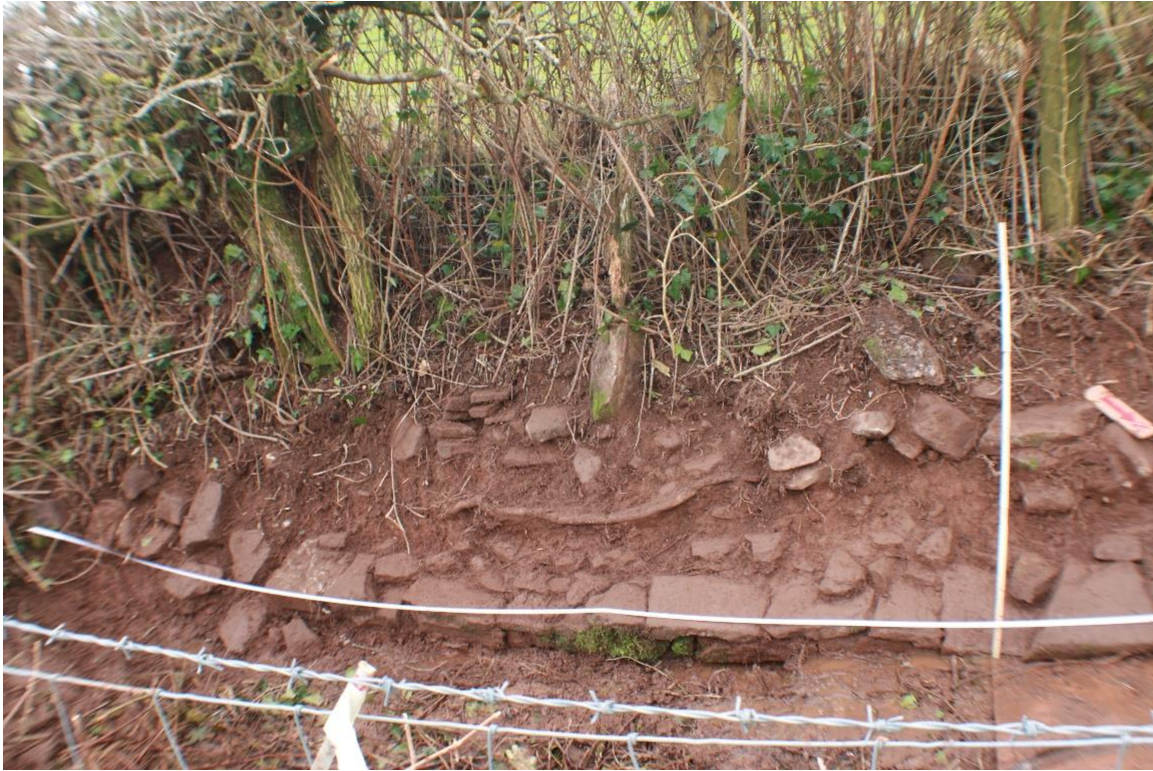
- Road surface continuation
- Triple pipe terminal system
- This confirms continuity with Trench 1 and demonstrates engineered service infrastructure.

Figure 5: Exposed road face at waterway crossing showing roadside edge and metalling.

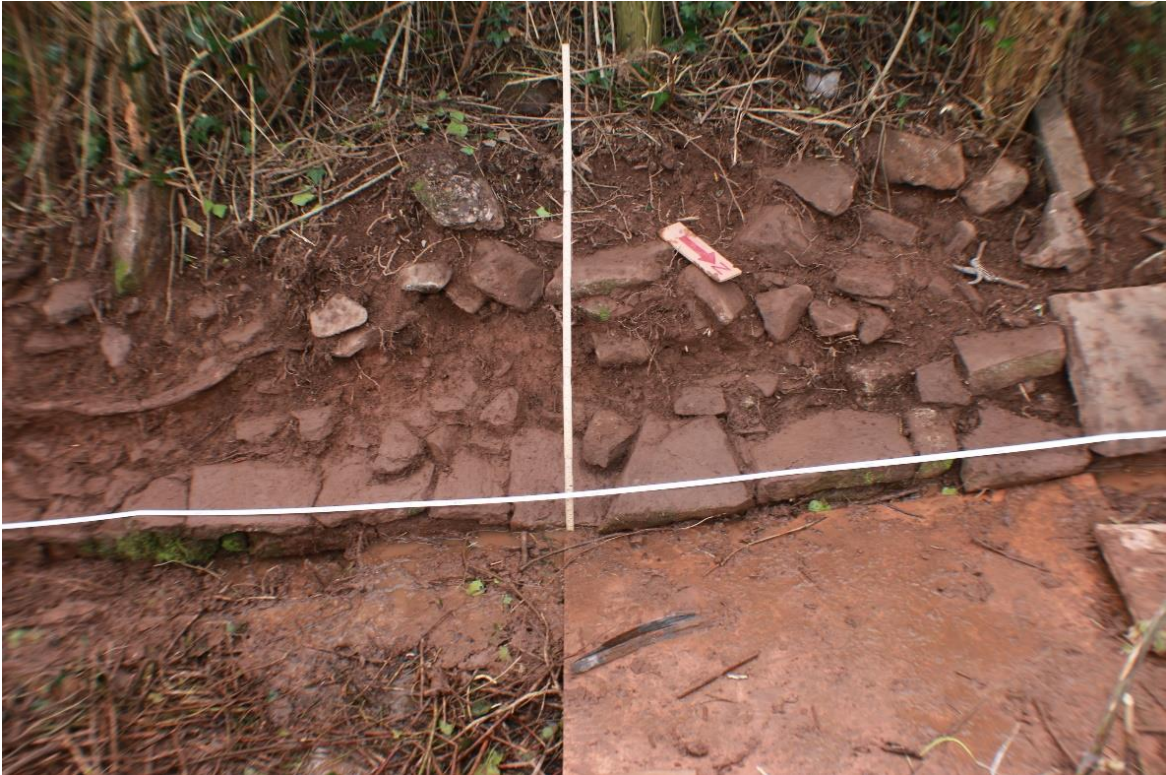
Figure 6: Road support structure and bearing stones.

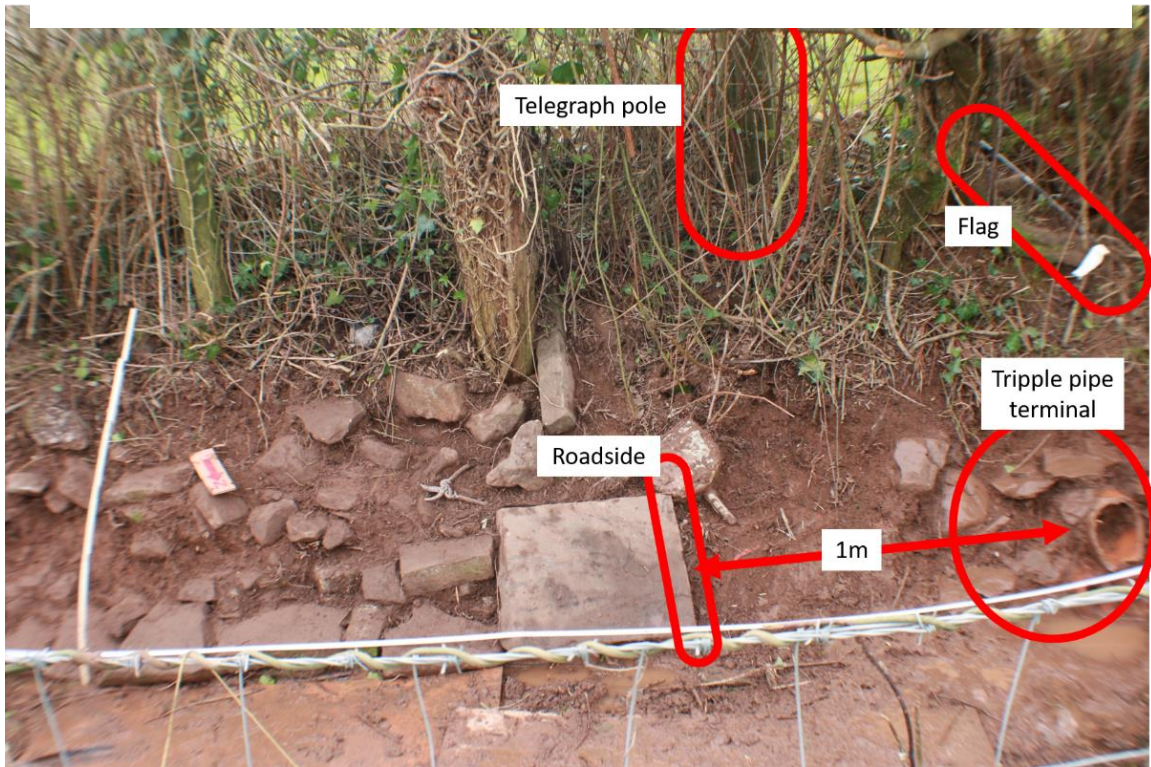
Figure 7: Road alignment showing position relative to the telegraph pole marker and triple pipe terminal.

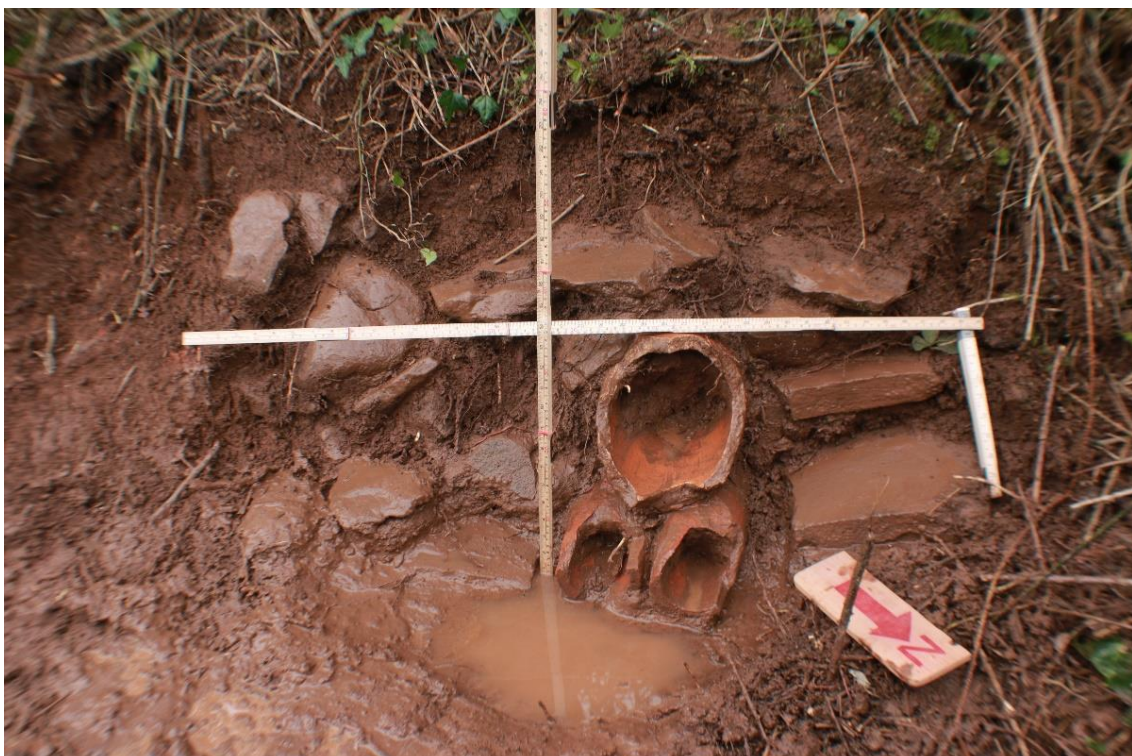
Figure 8: Triple ceramic pipe drainage terminal exiting the waterway bank with measurement scale.

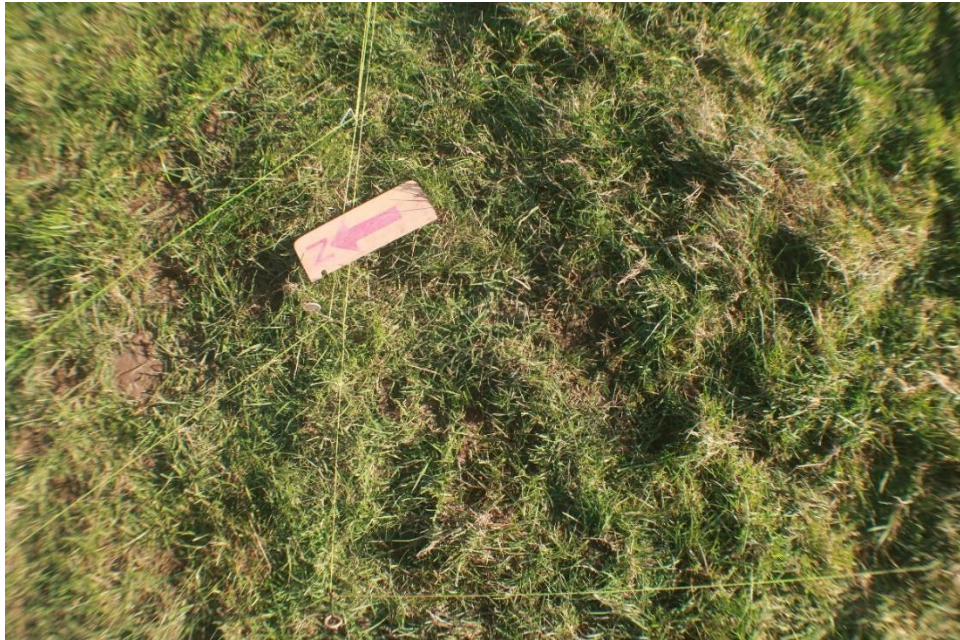
Trench 2 (1m × 1m × 1m) revealed features consistent with a hypocaust intake system, suggesting heated building infrastructure.

Figure 9: Position of trench 2 and predicted hypocaust route heading north.

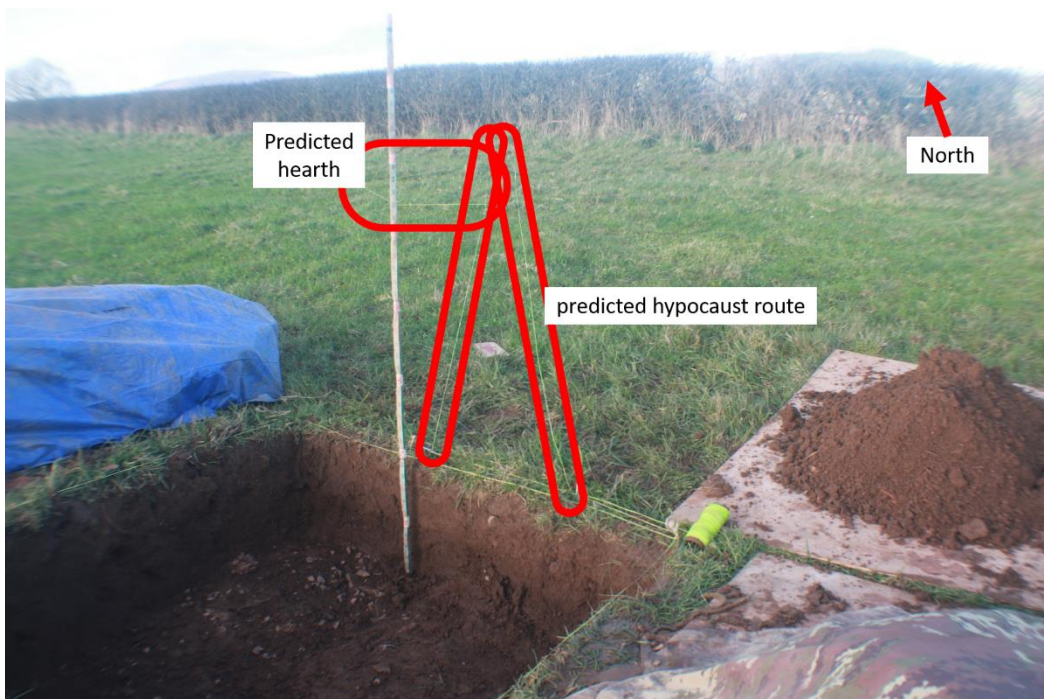
Figure 10: Showing trench 2 and the predicted hypocaust route heading north to its predicted inlet terminal (see trench 4) at water way SW face. Please note mid-way along route the predicated hearth.

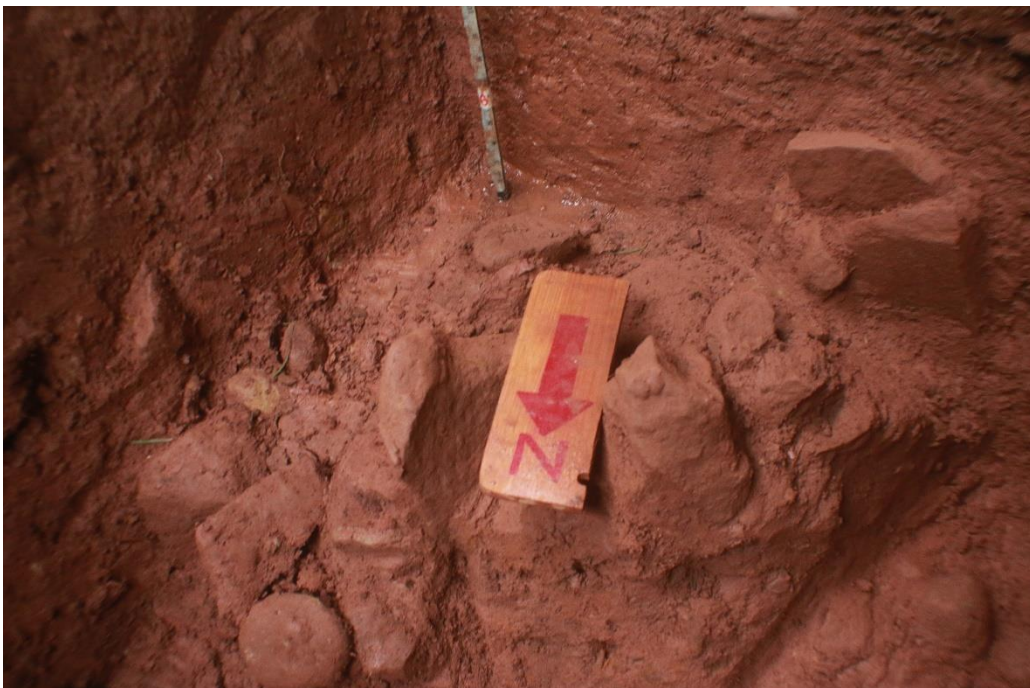
Figure 12: Flue terminal interface in trench 2.

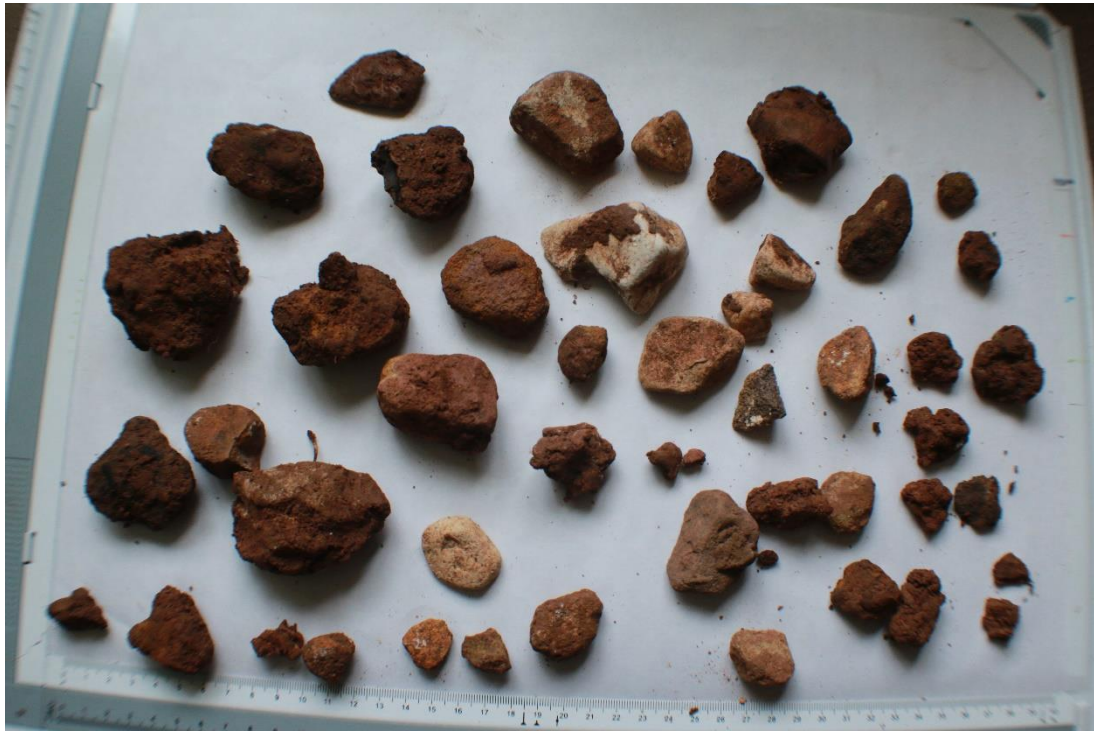
Figure 13: Recovered heat affected materials from trench 2.

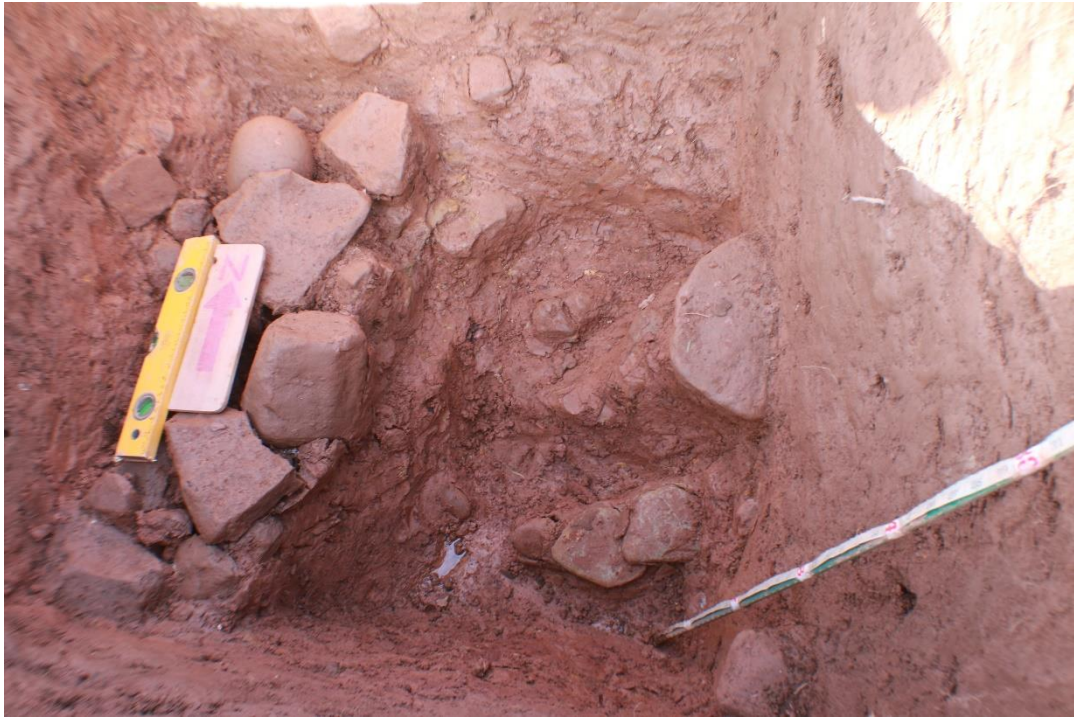
- Burnt deposits.
- Stone collapse.
- Heat-affected soils.

Consistent with a hearth or combustion feature.

Figure 16: Completed trench 3.

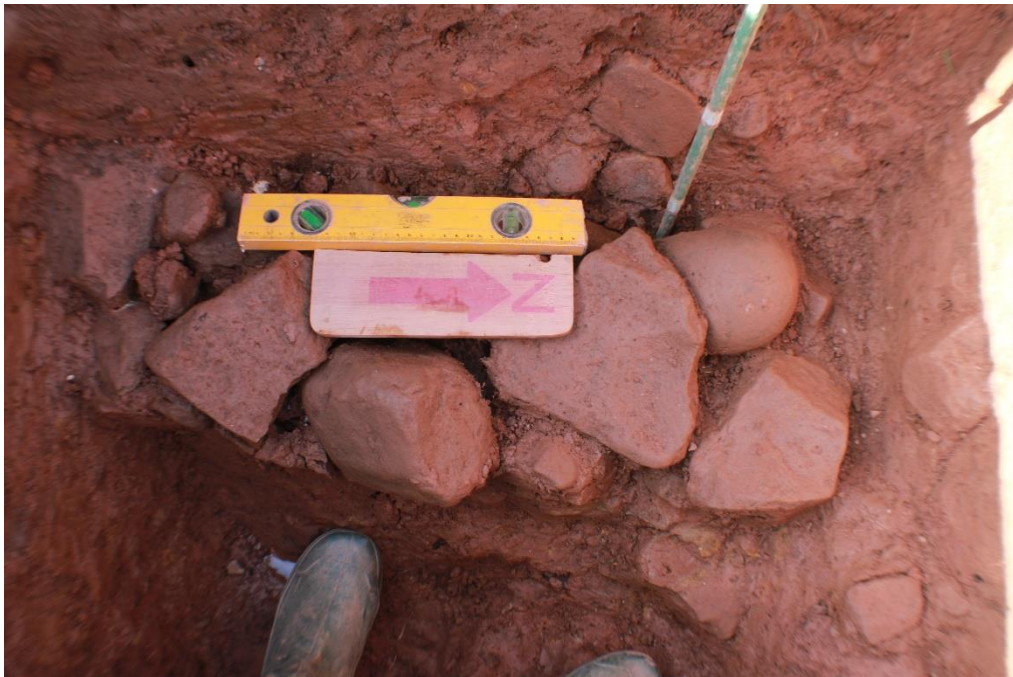
Figure 17: Structural collapse and hearth remains.

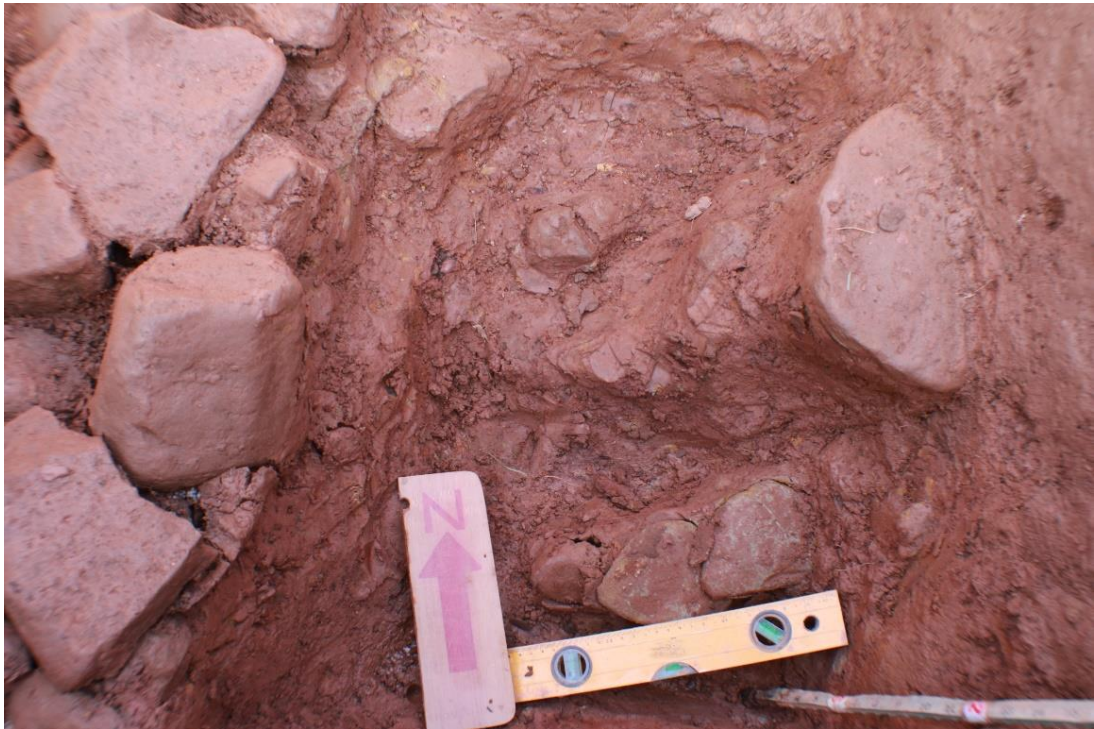
Figure 18: Structural collapse and hearth remains.

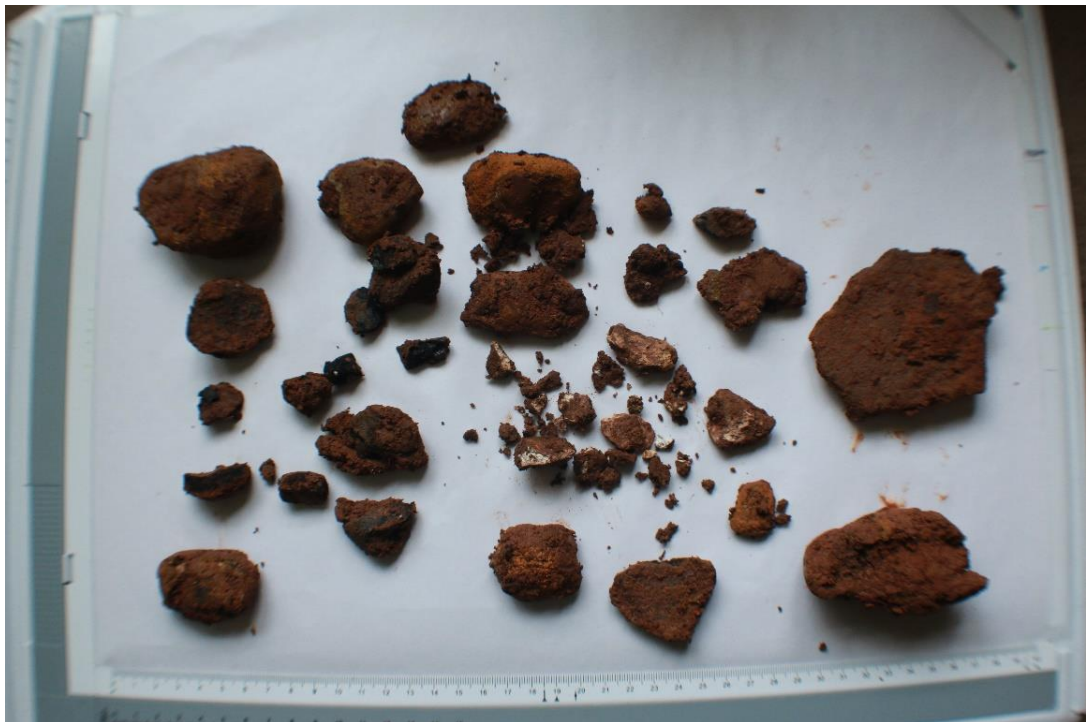
Figure 19: Recovered hearth materials.

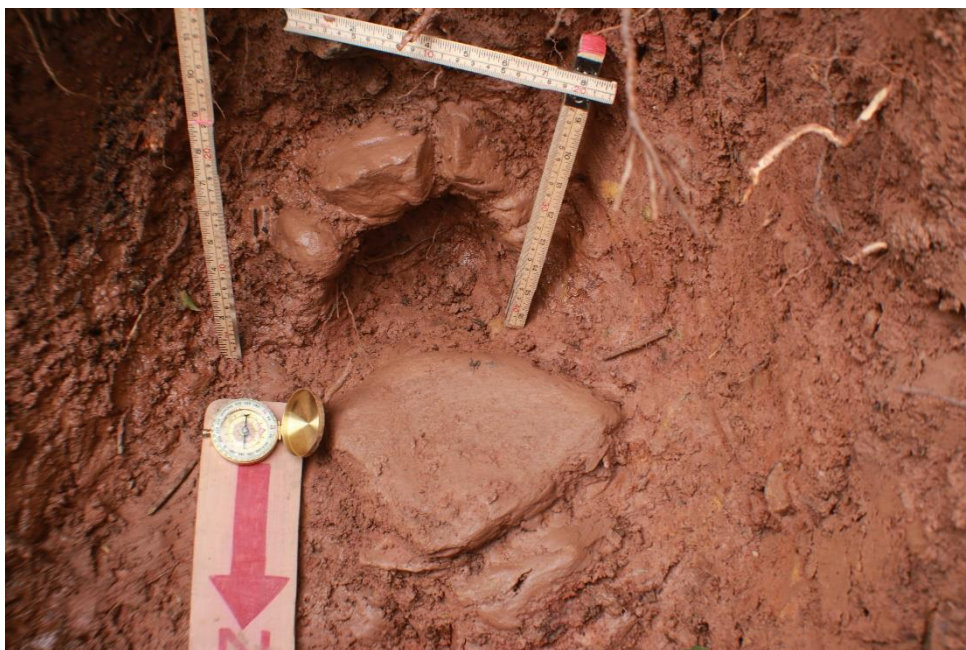
- Airflow channelling
- Structural interface

Supporting interpretation of a managed heating system.

Figure 23: Air intake arch close-up

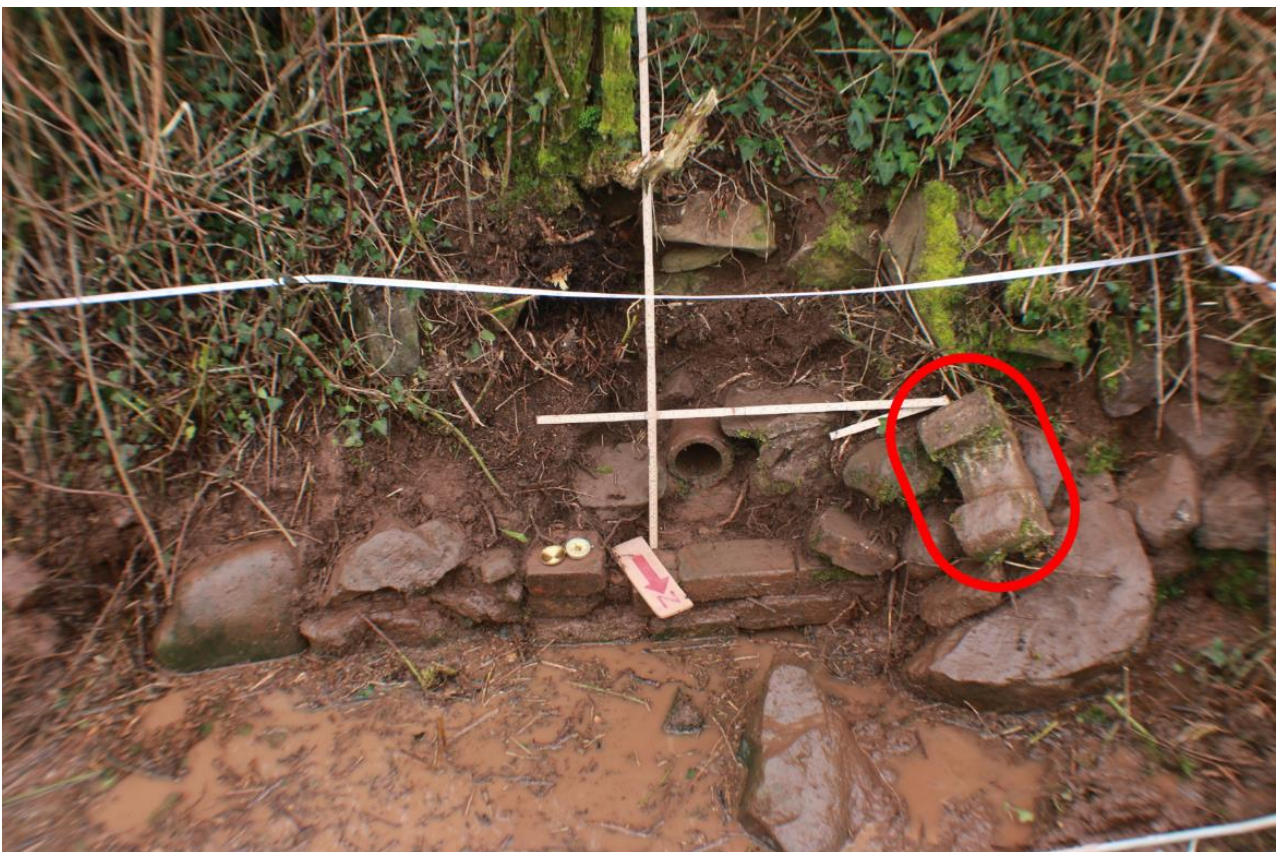
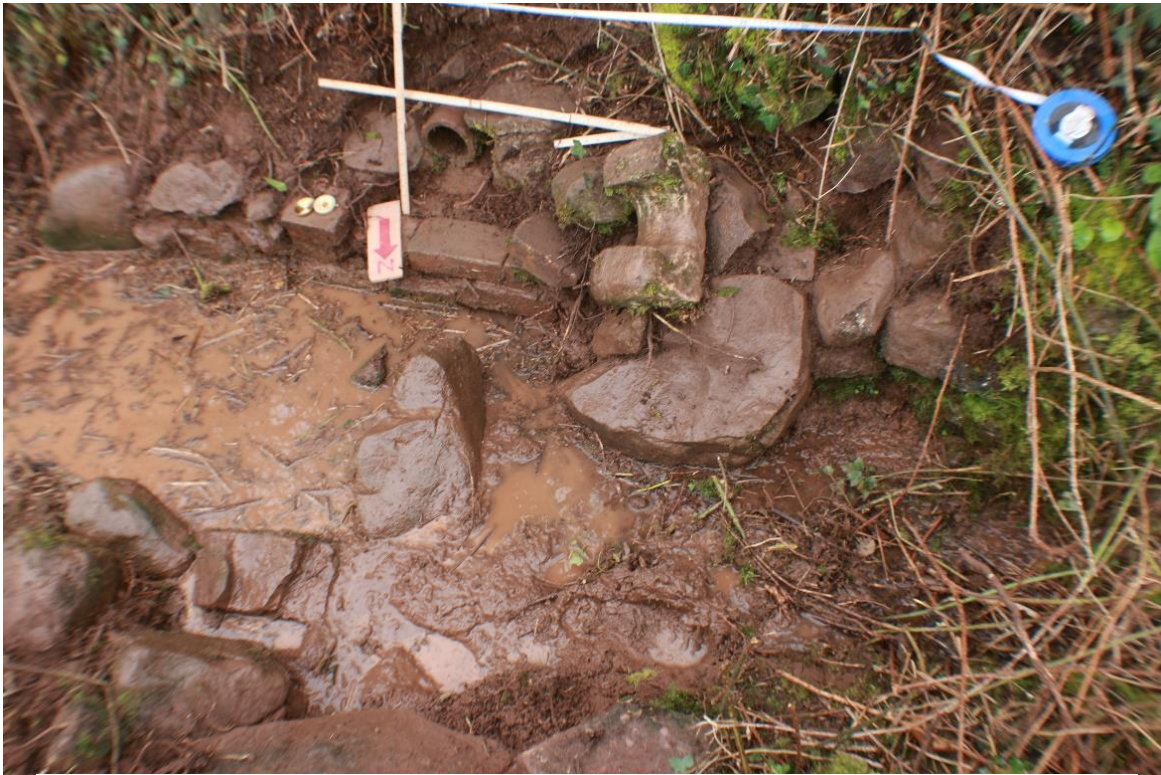
- Drainage channel
- Structural base material

Indicating coordinated water management and building support systems.

Figure 24: Masonry remains in waterway

Figure 25: Masonry remains in waterway

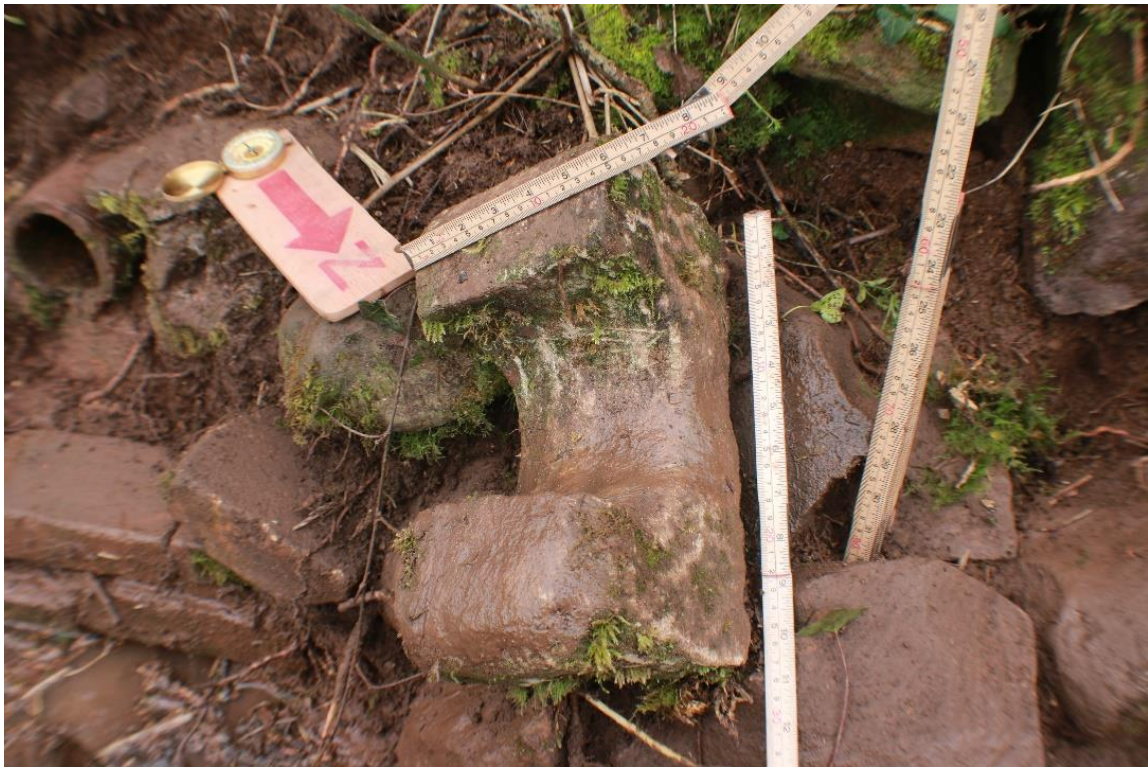
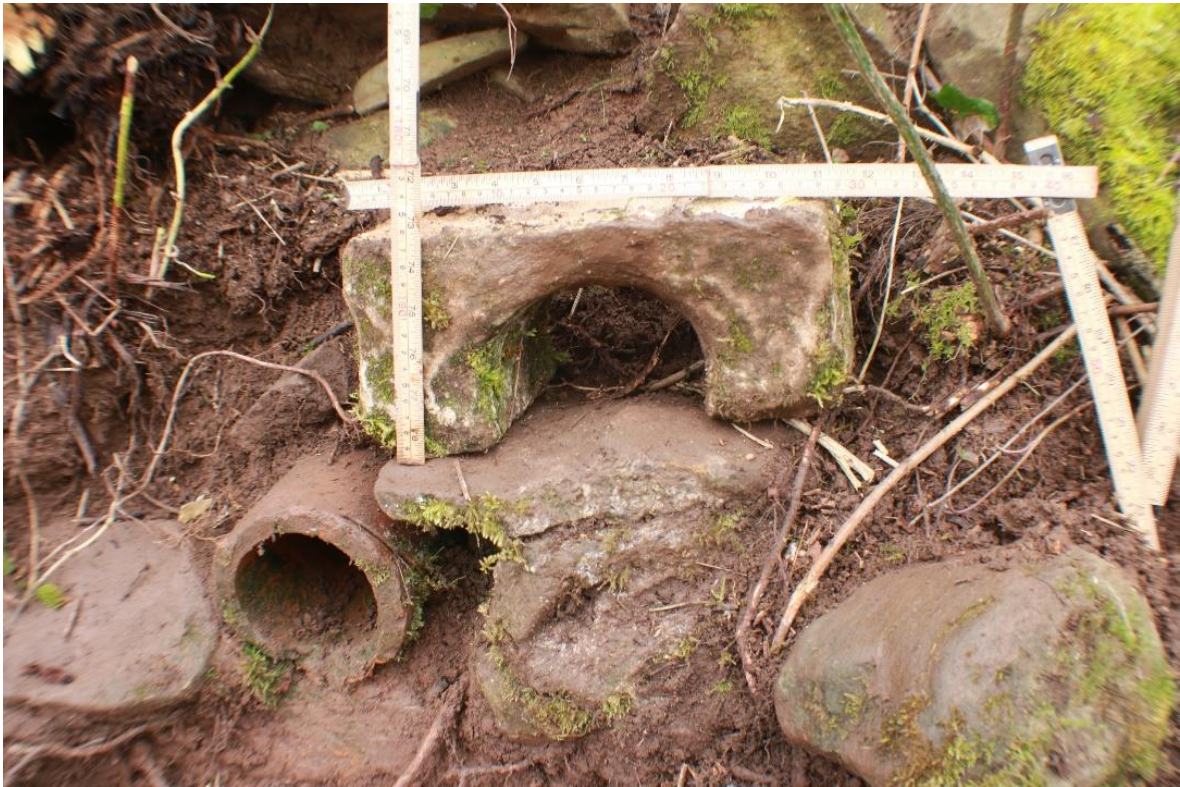
Figure 26: Bath stone arch block

Figure 27: Bath stone arch block

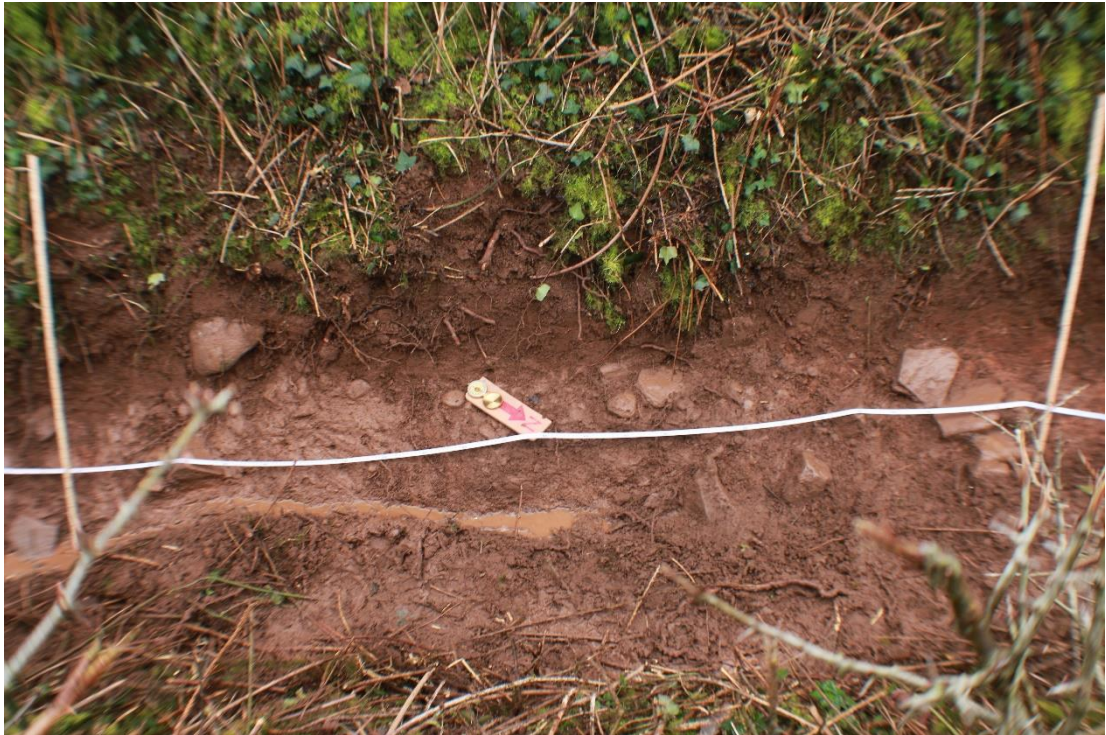
South-west face of metalled road

Located opposite Trench 8 across the waterway, suggesting a crossing point.

Figure 28: Initial exposure of Trench 7 showing the south-western edge of a metallated surface, representing the continuation of a roadway approaching the watercourse.
