Oak Archaeology Wales

MASTER INTEGRATED DBA

Targeted Exploratory Excavations and Structural Investigation

Ruperra–Machen Landscape, South-East Wales

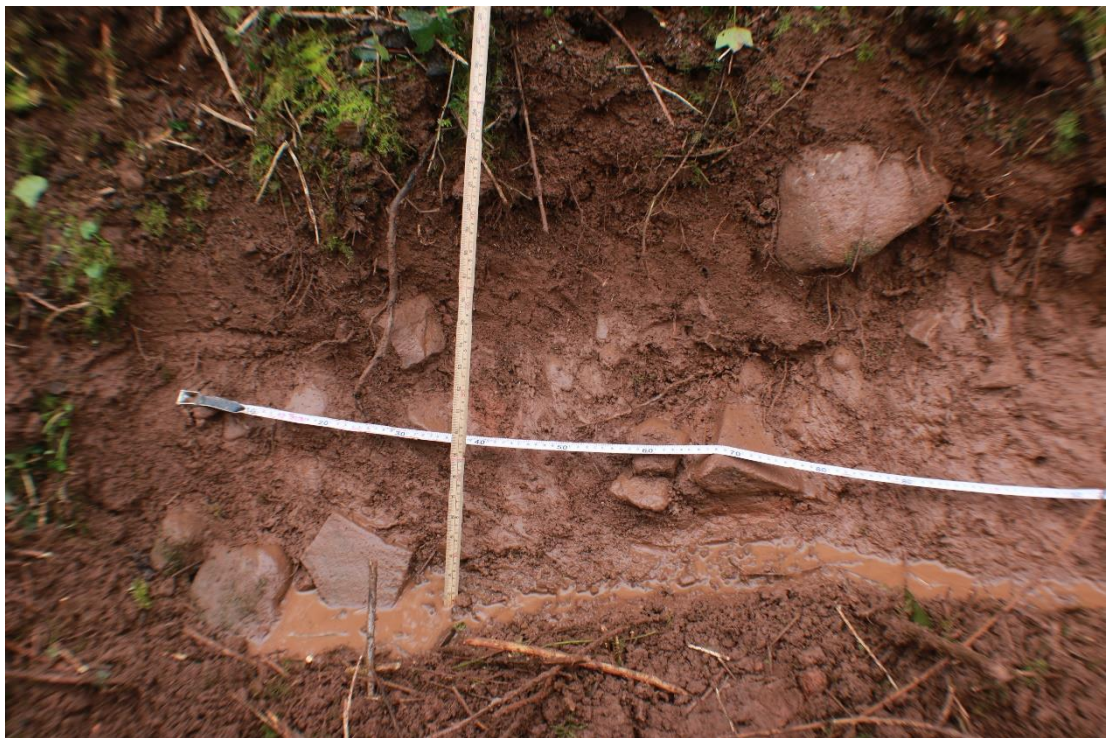
Figure 29: Further definition of the road surface in Trench 7, illustrating compacted metallating and a gradual edge slope consistent with drainage design.

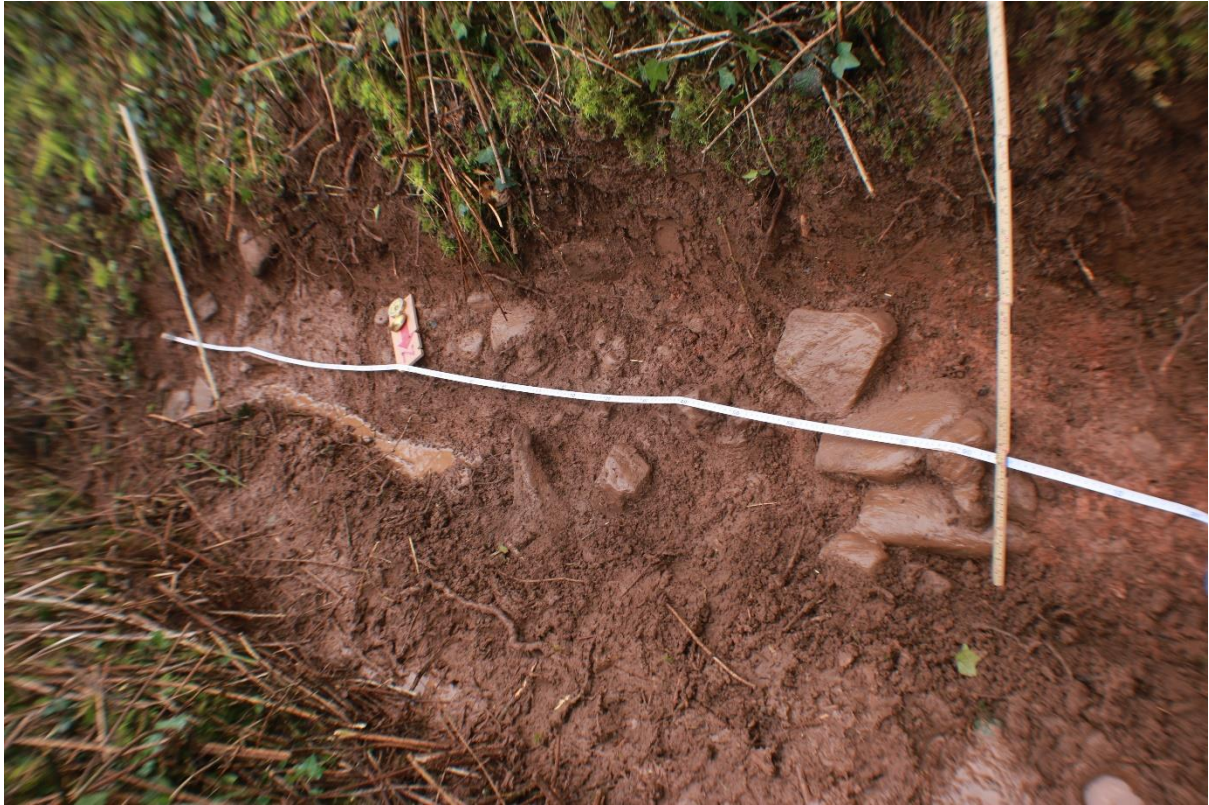
Figure 30: Detail of the road edge in Trench 7, highlighting the transition from compact surface to softer adjacent material, indicating lateral runoff or drainage.

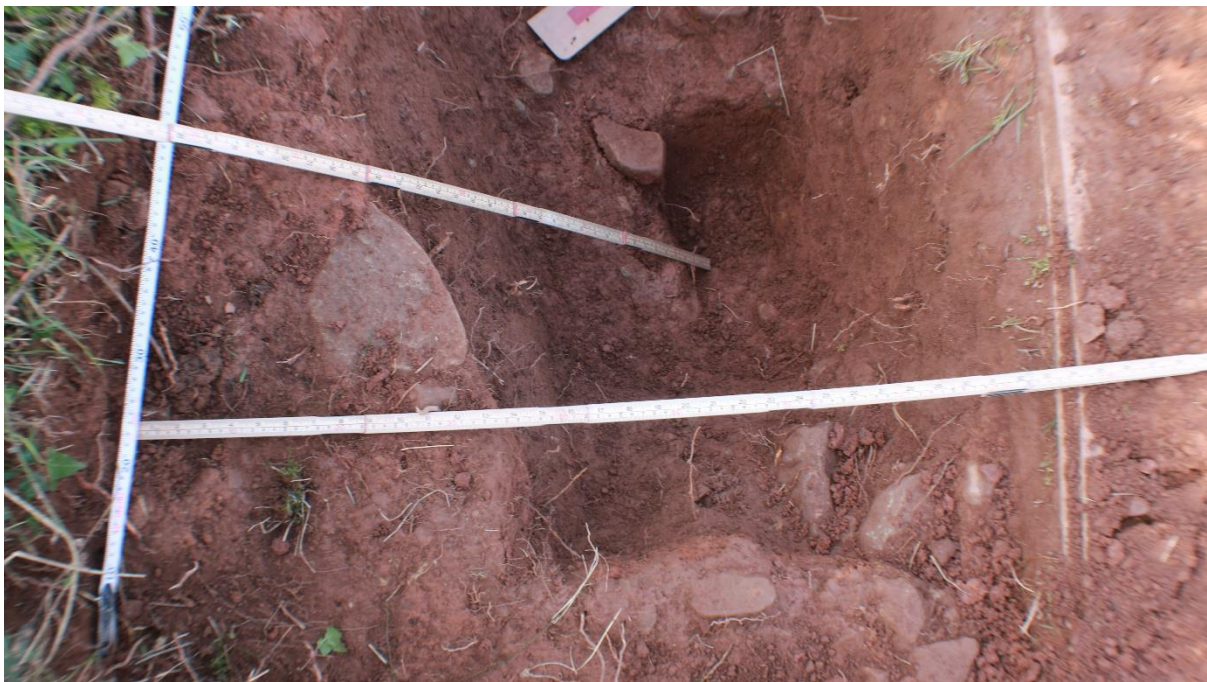
- Metalled surface
- Softer gravels (drainage layer)
- Compacted base

Consistent with engineered road construction across a watercourse.

Figure 32: Trench 8 showing stratified layers beneath the road surface, including softer gravels consistent with a drainage or bedding layer.

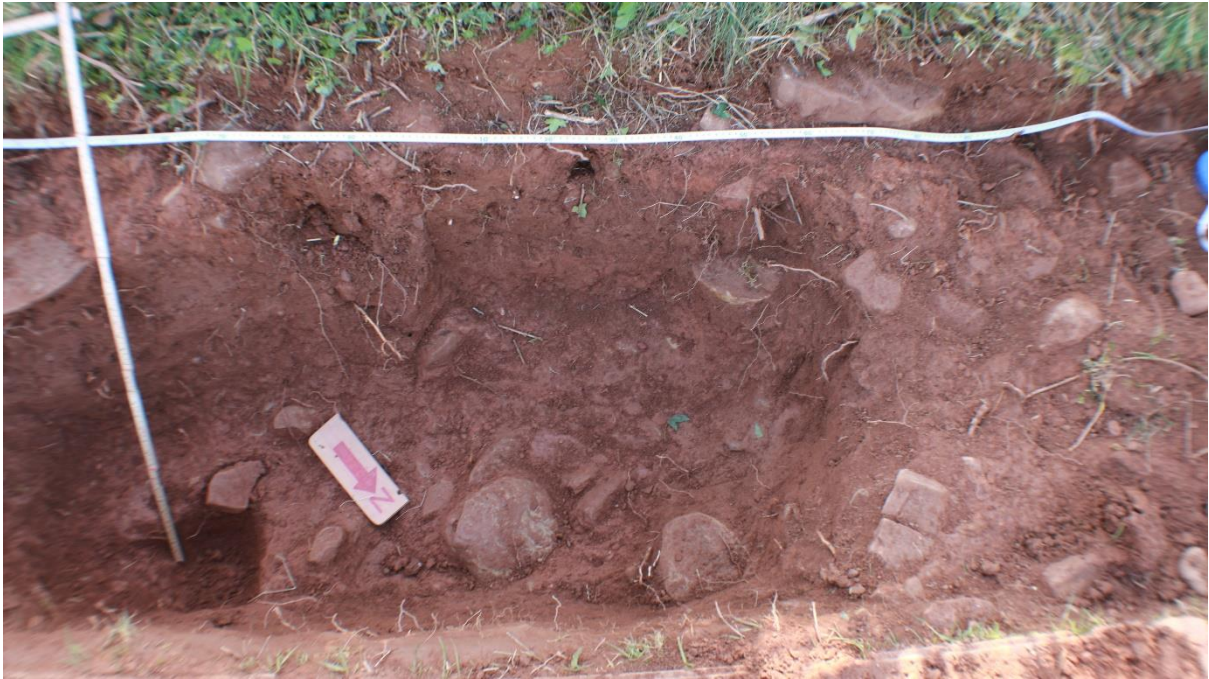
Figure 33: Detail of compacted base material within Trench 8, supporting interpretation of an engineered road foundation.

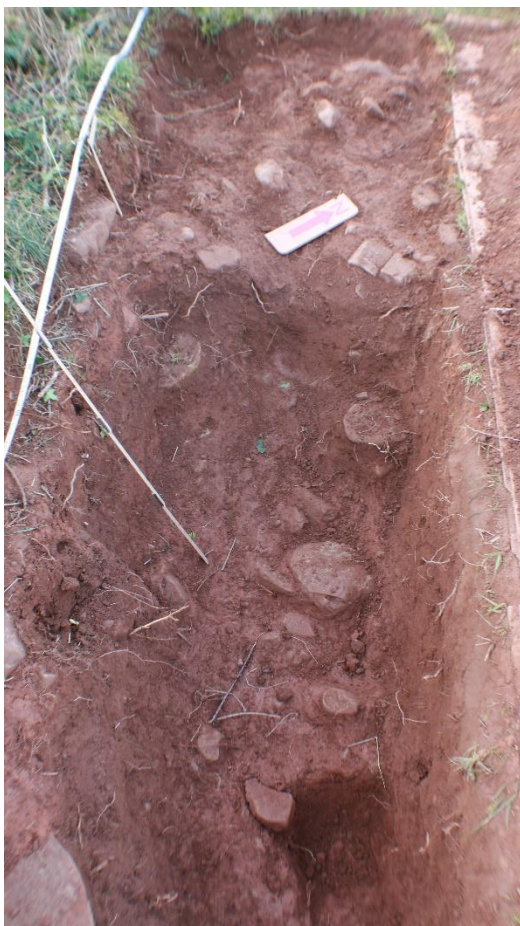
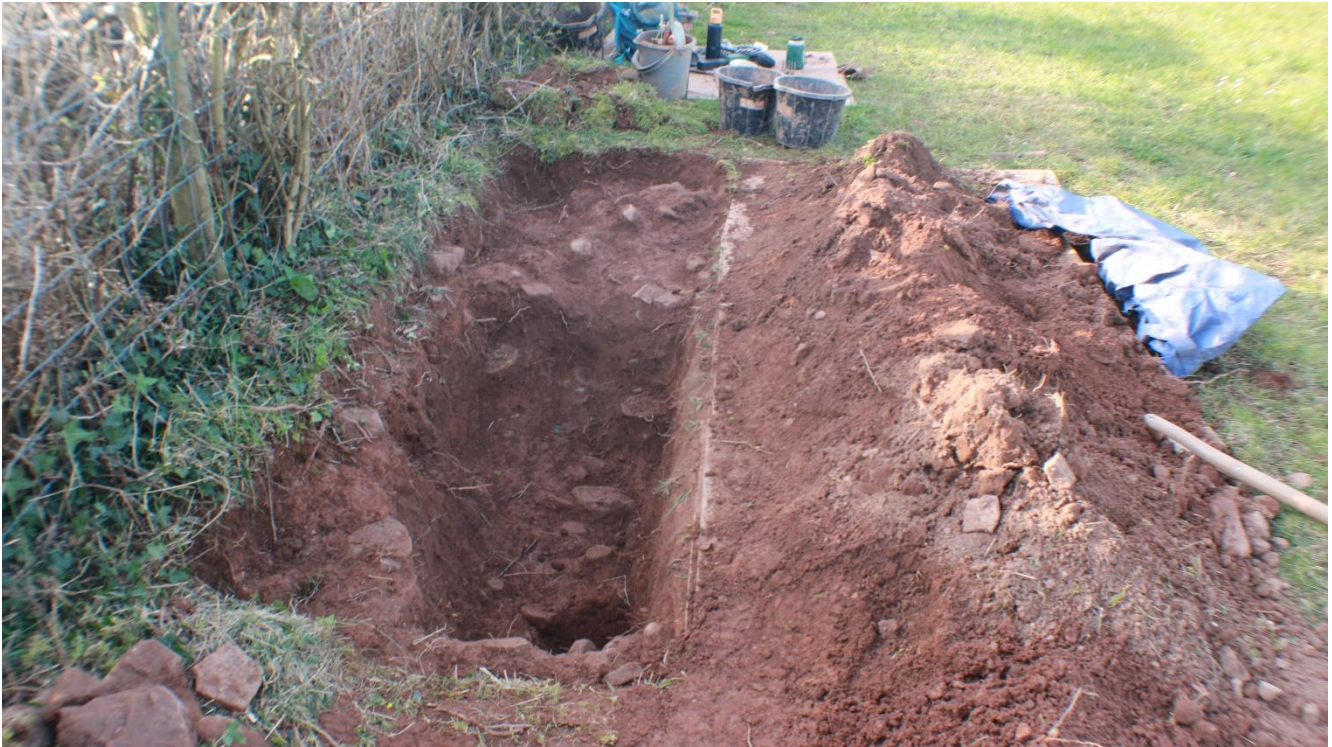
Measured road width approximately 4m, aligning with Exhibit A.

Figure 34: Expanded view of Trench 8 illustrating the width and composition of the metallised surface across the crossing point.

Figure 35: Expanded view of Trench 8 illustrating the width and composition of the metallated surface across the crossing point.

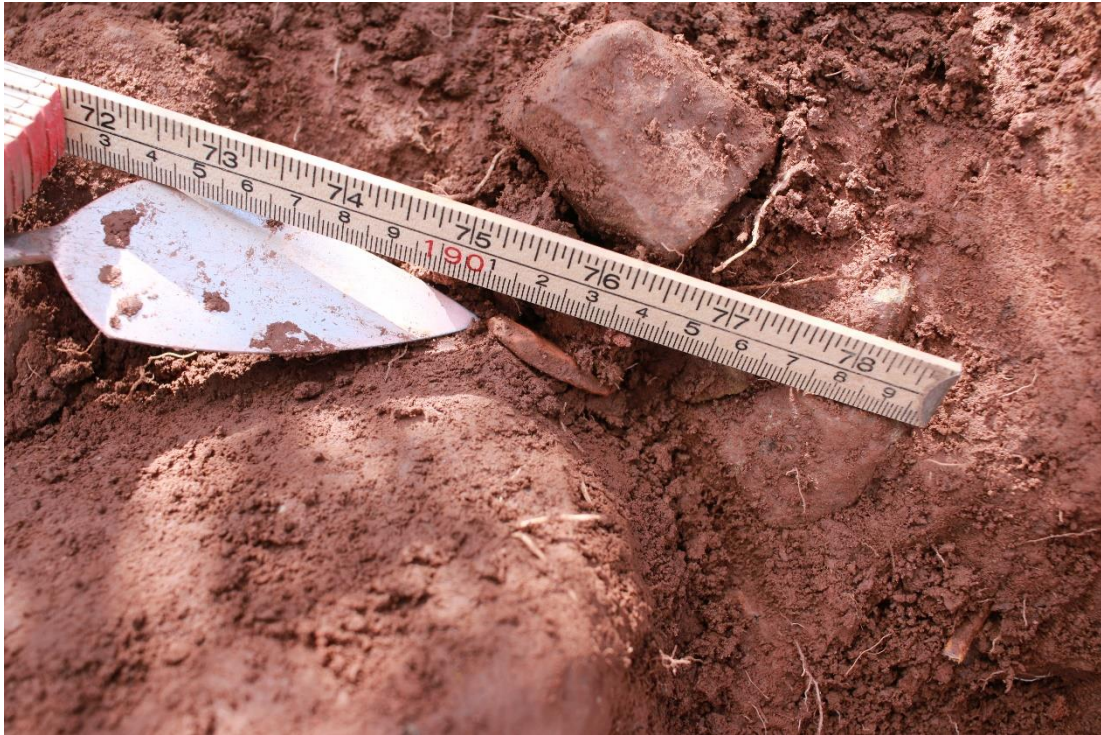
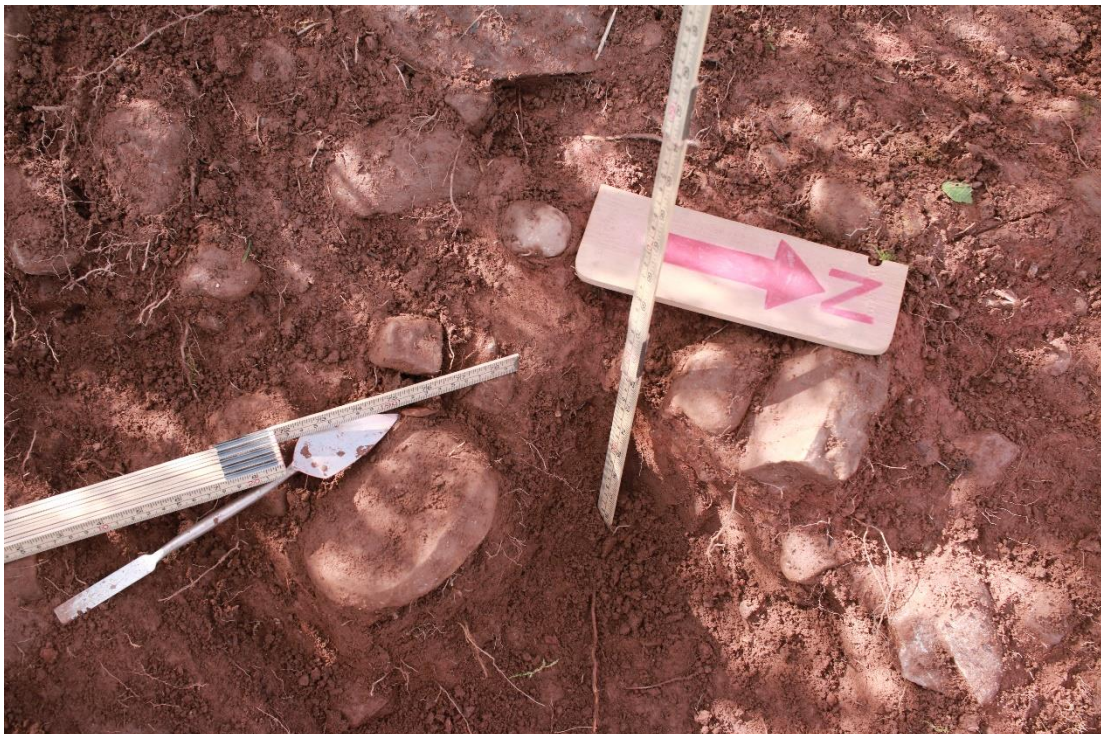
Figure 36: Close-up of ceramic fragment recovered from Trench 9, showing fabric and surface characteristics consistent with structural or domestic material associated with the perimeter wall context.

Figure 37: Close-up of ceramic fragment recovered from Trench 9, showing fabric and surface characteristics consistent with structural or domestic material associated with the perimeter wall context.

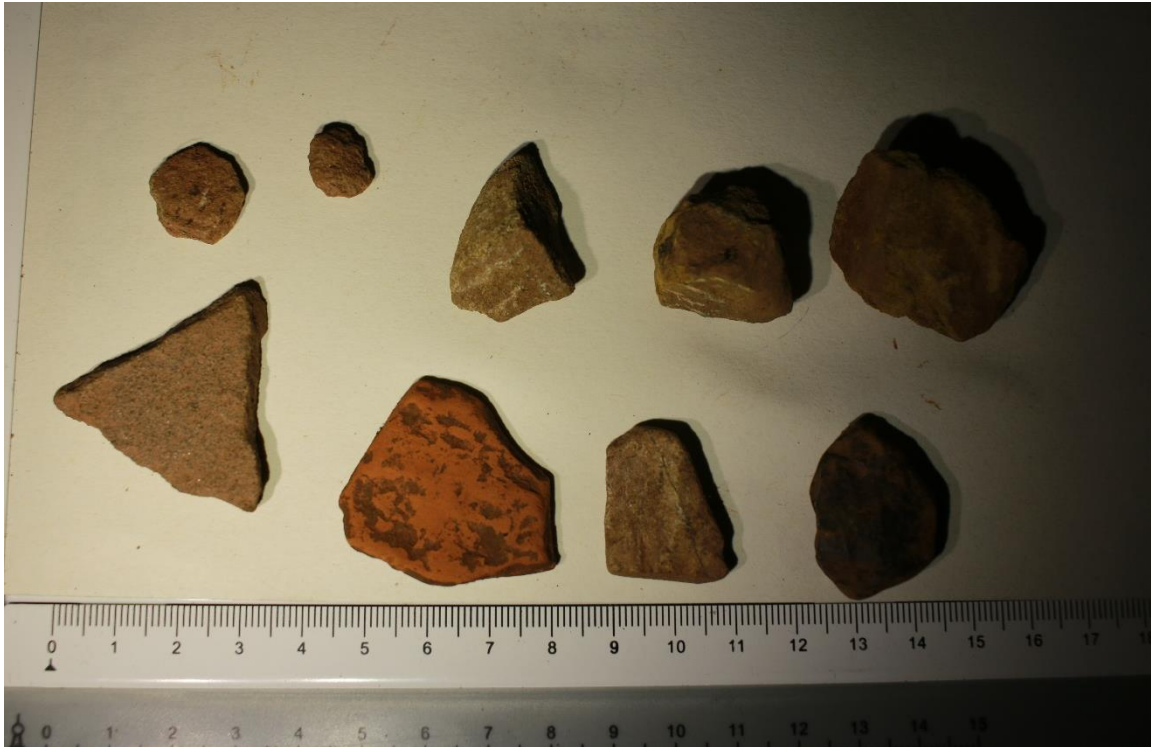
Figure 38: Recovered material assemblage from Trench 9, including pottery, mortar structural fragments supporting interpretation of constructed surfaces and associated features.

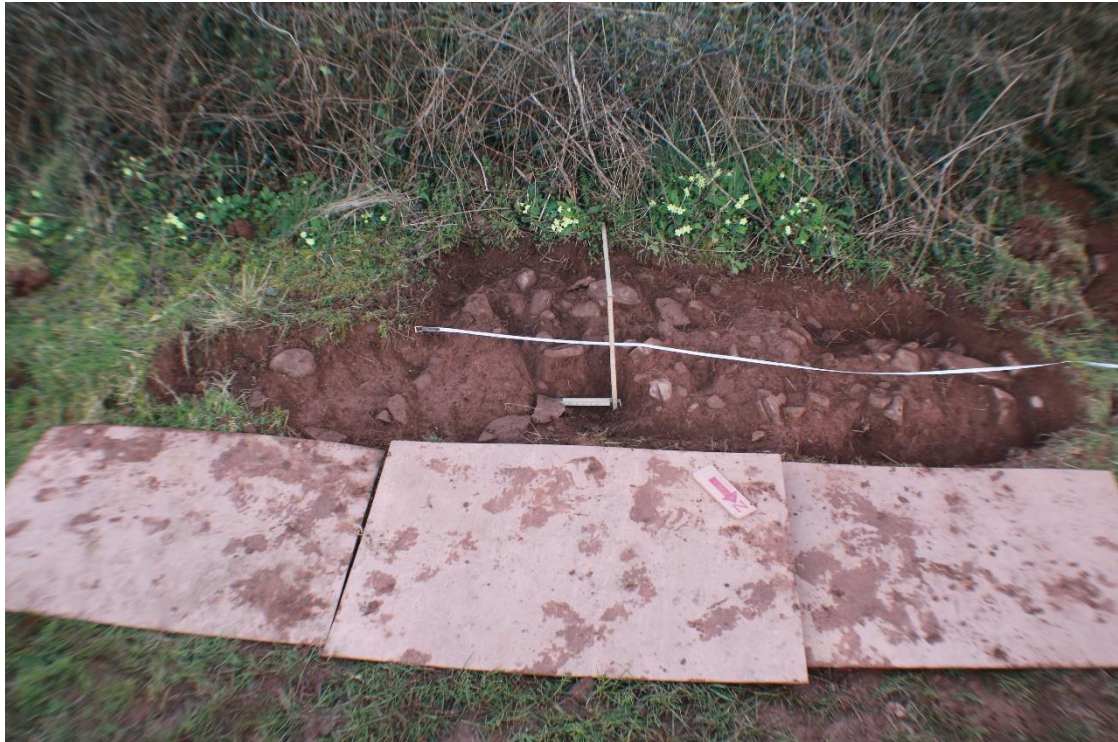
- Hard-packed structural alignment
- Foundation material

Consistent with a perimeter wall, correlating with LiDAR alignment (Exhibit B).

Figure 39: Clearer definition of the linear feature in Trench 9, interpreted as part of a perimeter wall foundation.

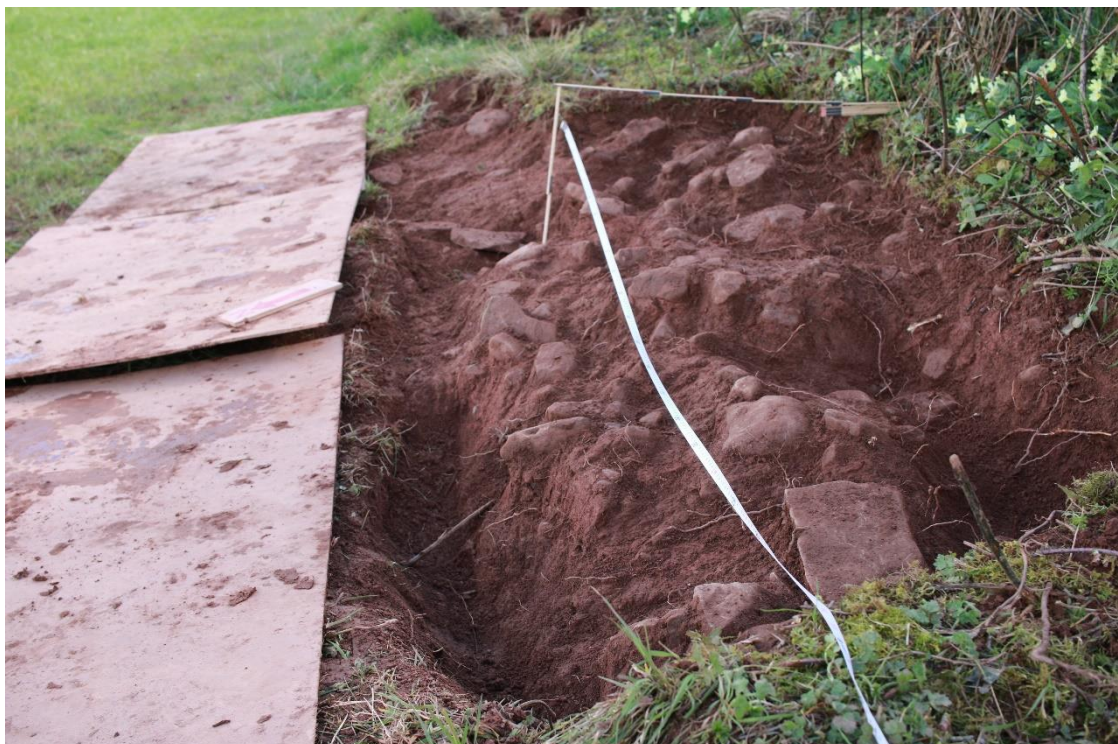
Measured alignment corresponds to broader linear feature extending across the landscape.

Figure 40: Extended view of Trench 9 showing alignment of the foundation feature consistent with LiDAR-derived linear anomalies.

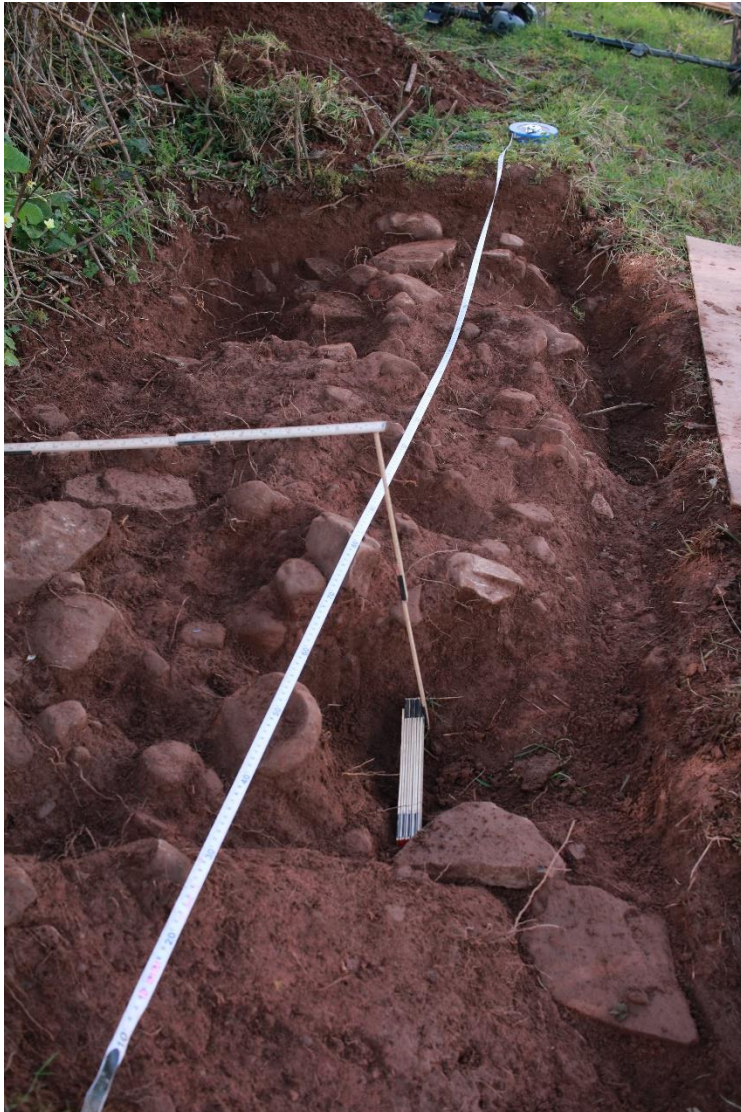
Figure 41: Sectional view of Trench 9 illustrating depth and composition of the wall foundation in relation to surrounding deposits.

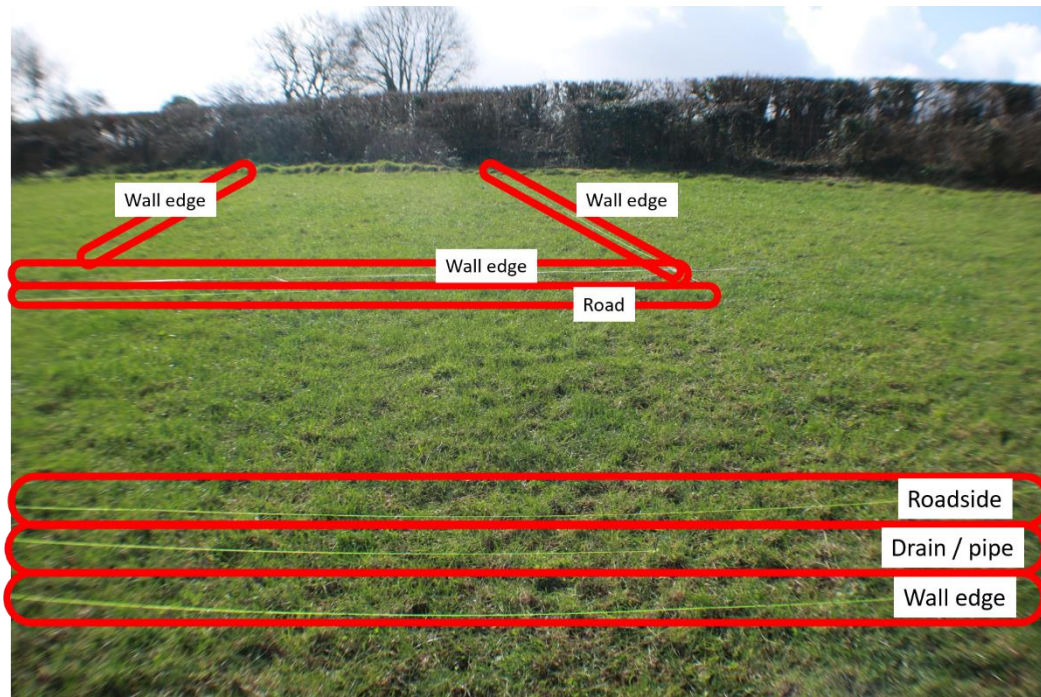
Figure 42: Pre-excitation view of Trench 10 location, showing surface indicators suggesting underlying structural alignment.

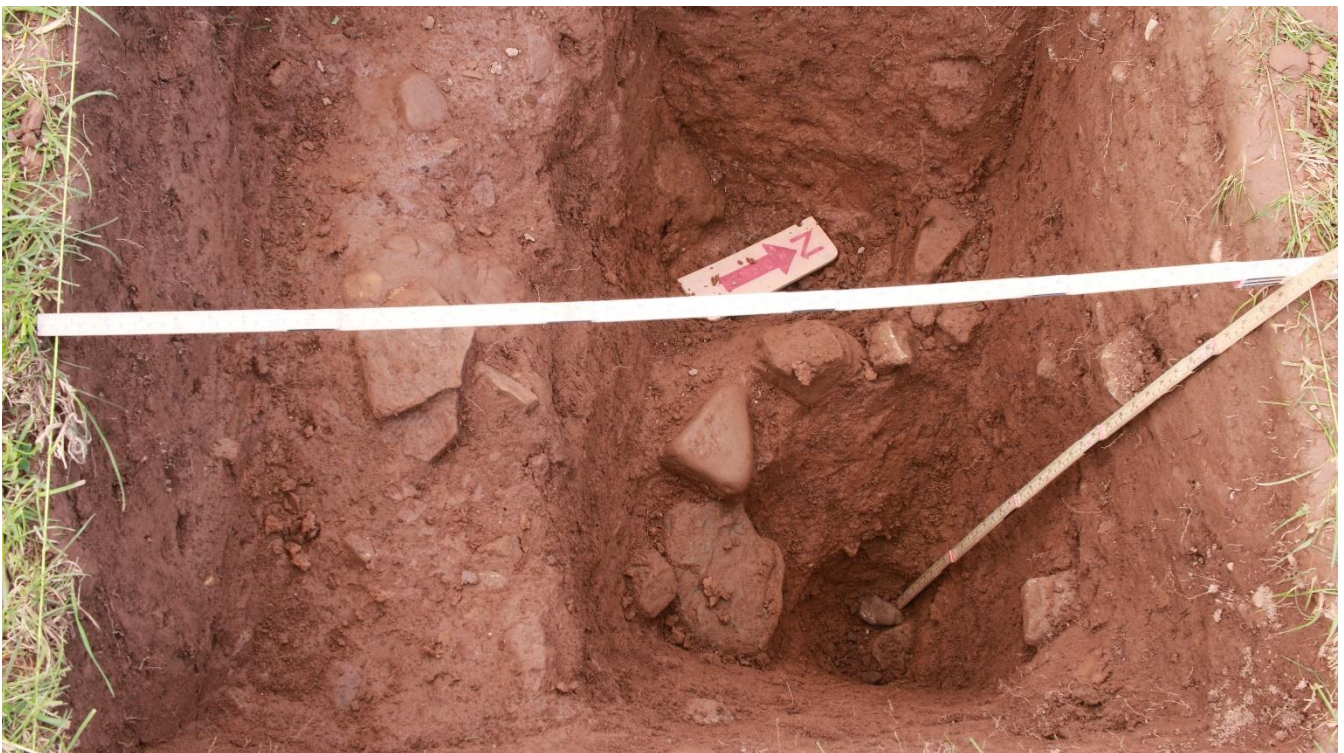
- Metalled surface
- Gutter formation
- Hard-packed edge

Figure 44: Exposed metalled track surface within Trench 10, showing compacted material and defined edge formation.

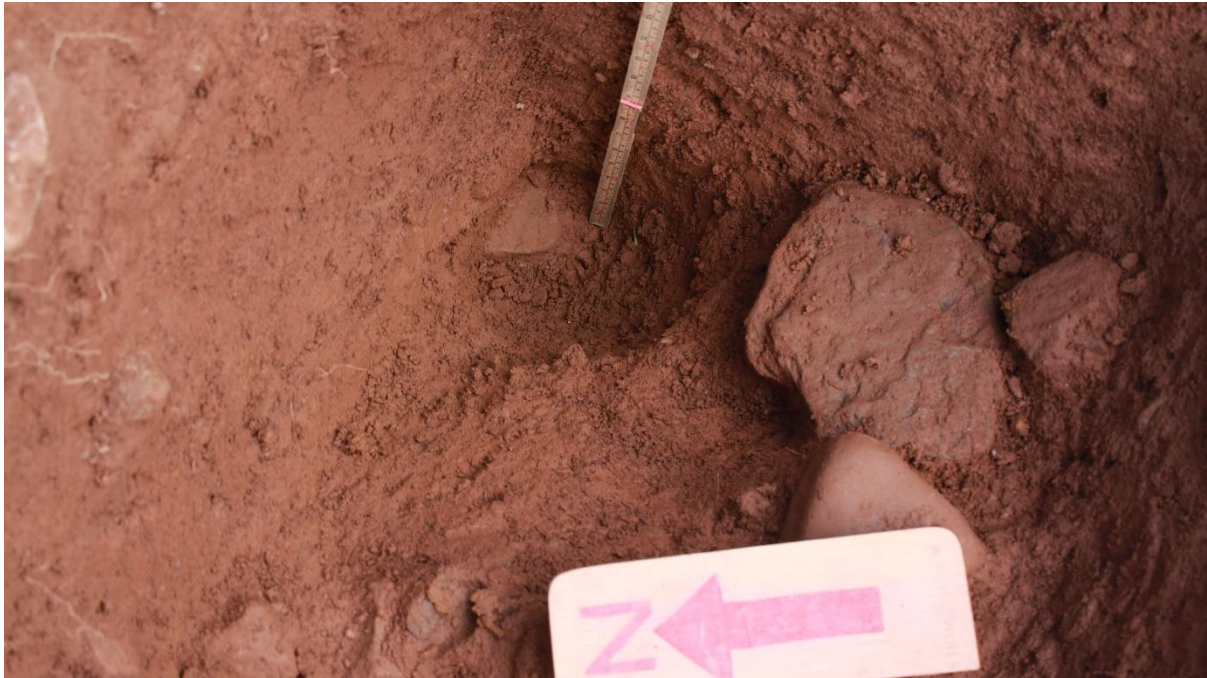
- Softer gravel layers
- Stratified drainage profile

Figure 45: Detail of drainage gutter adjacent to the track surface, demonstrating softer gravel deposits and stratified runoff channel.

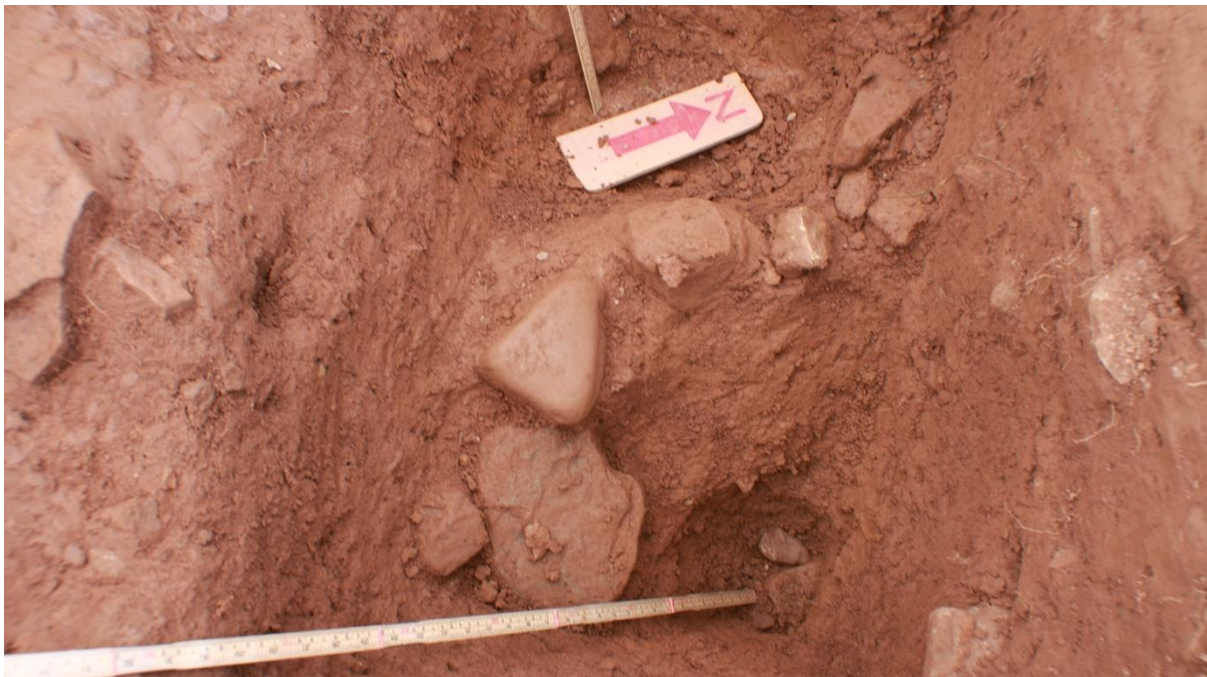
- Defined edge of track
- Transition into perimeter structure
- Track width approximately 4m, with gateway/transition zone measuring c.7m, consistent with Exhibit A.

Figure 46: Interface between track edge and adjoining structural alignment, indicating transition into a boundary or terminal feature.

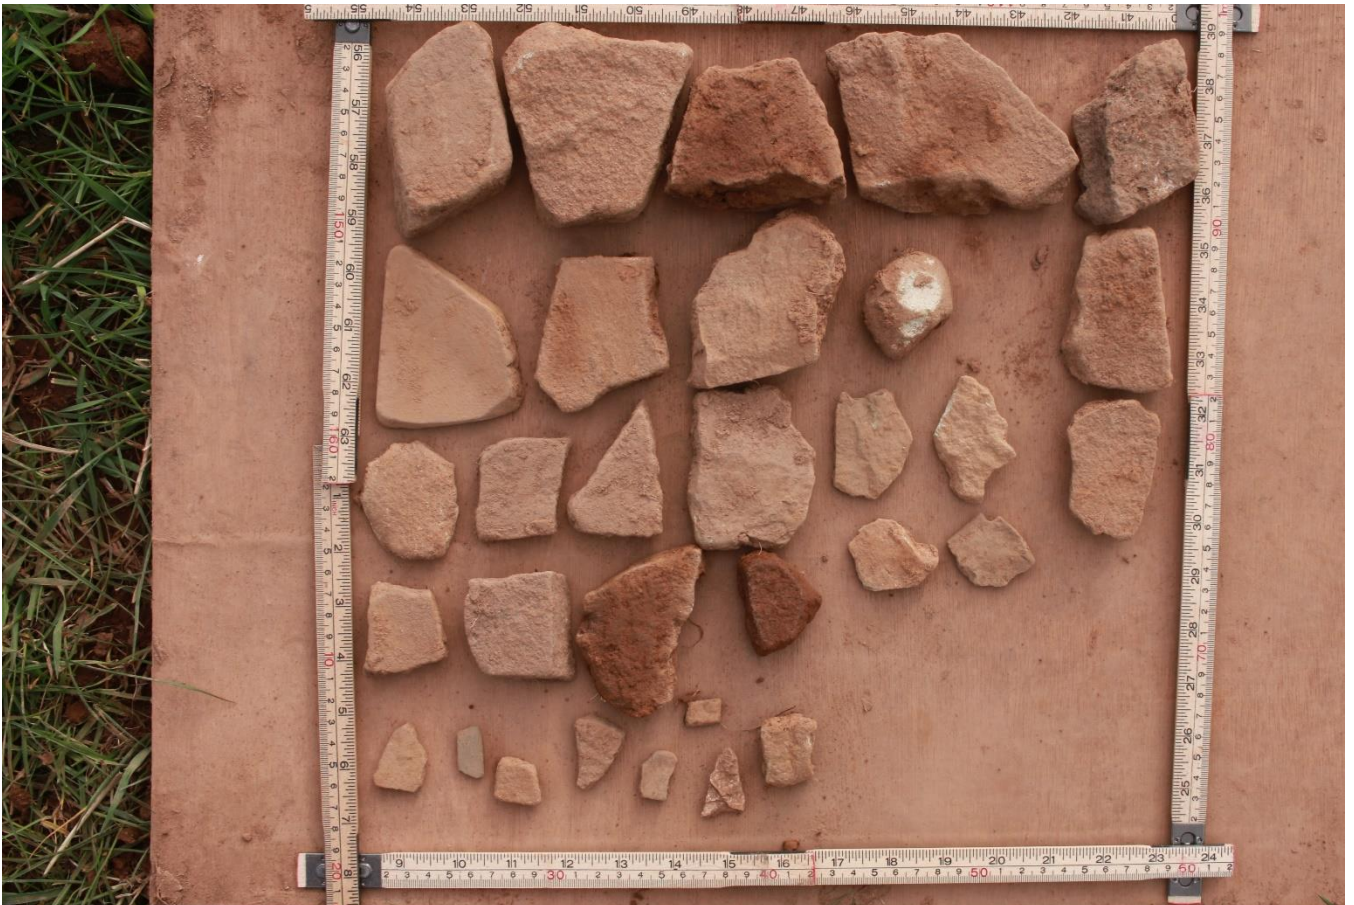
Assemblage of recovered material from Trench 10, supporting structural interpretation.

Figure 47: Recovered material assemblage from Trench 10, including structural fragments supporting interpretation of constructed surfaces and associated features.

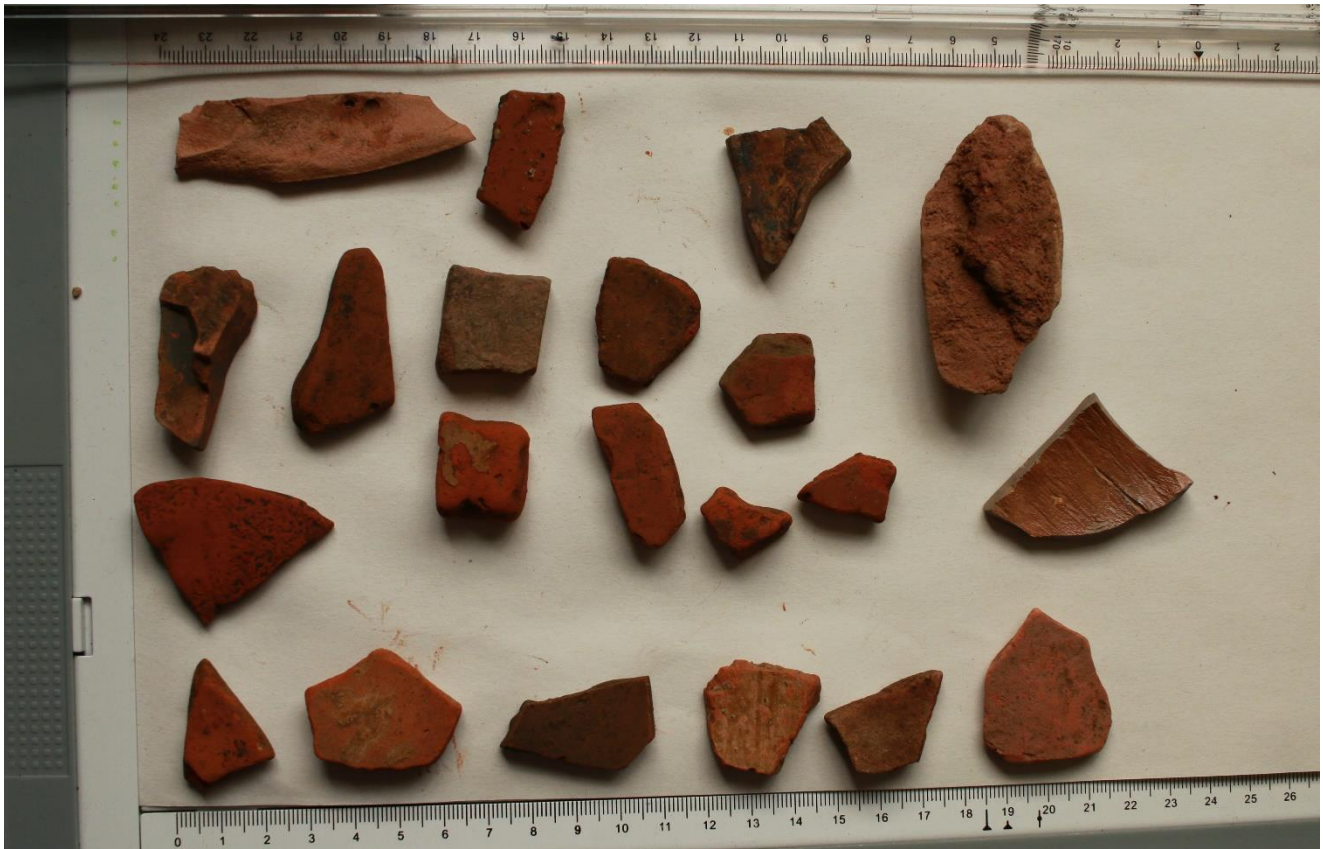
Across Trenches 8, 9, and 10, a small quantity of ceramic fragments was recovered through sieving of lower stratigraphic layers. These materials were not concentrated within a single discrete context but instead represent a dispersed and low-density assemblage.

This pattern may be consistent with a controlled and managed occupation zone, potentially of a logistical or organised character, where accumulation of domestic refuse was limited.

Figure 48 – Ceramic assemblage from Trenches 8–10, showing fragmented, low-density material recovered from lower deposits, consistent with dispersed occupation or managed site conditions.
