Archaeological Desk-Based Assessment
Targeted Exploratory Excavations and
Structural Investigation

Ruperra–Machen Landscape
South-East Wales

Oak Archaeology Wales CIC

May 2026

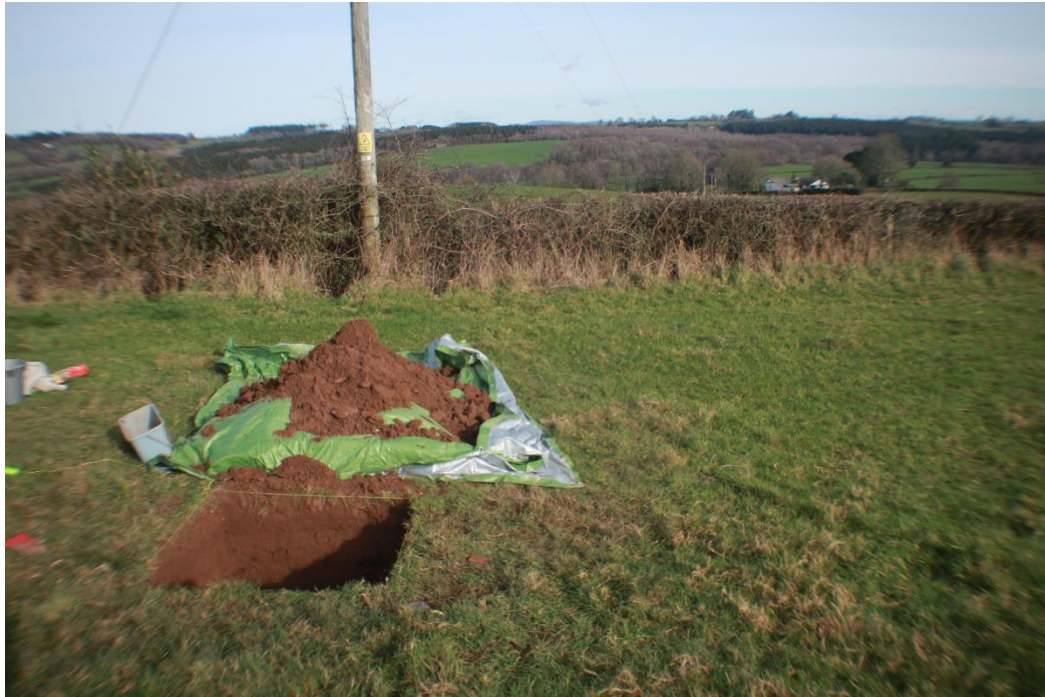
Figure 2: Location of Trench 1 positioned to investigate the predicted pipeline, roadside edge and bathhouse foundations.

Trench 1 was initially opened as a 1 m × 1 m exploratory trench positioned over the predicted alignment of a subsurface pipeline and roadside edge associated with the SW–NE aligned roadway.

The trench location is illustrated in Figure 2.

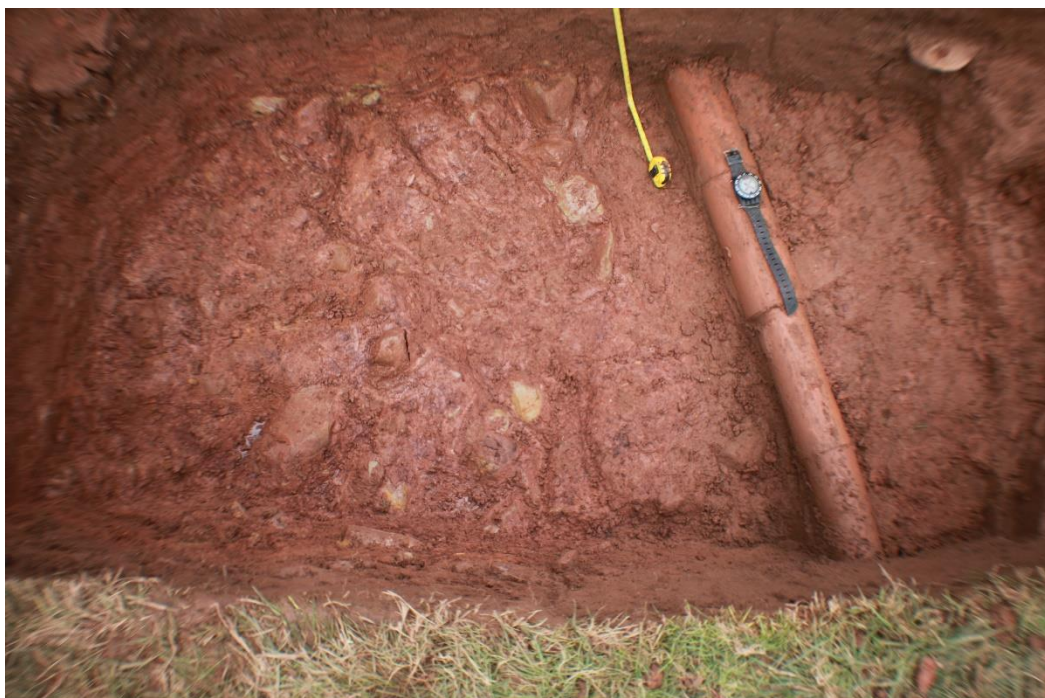
- 0.5 m west to further expose structural stonework associated with the pipe alignment and road interface
- **1 m east** to reveal additional roadside metalling and structural correlation

- a ceramic drainage pipe aligned toward the waterway
- structural stone packing associated with the pipe
- foundation stone deposits on the bathhouse-facing side of the trench
- compacted metalled layers interpreted as road construction material

Figure 3A: Trench 1 extended west showing foundation stone adjacent to drain pipe and road correlation.

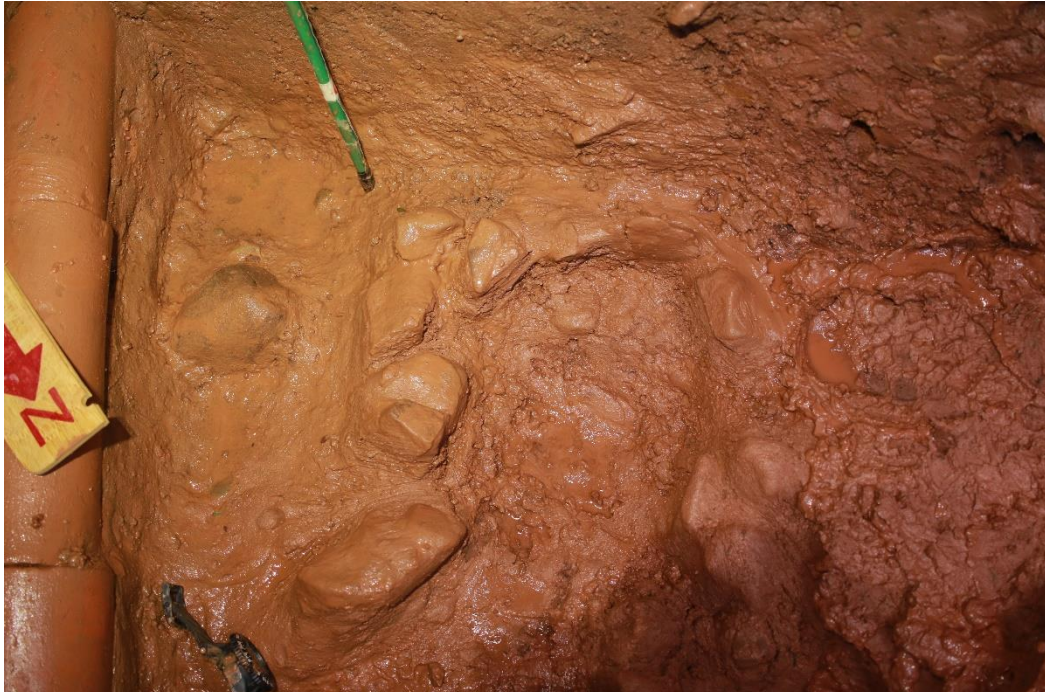
Figure 3B: Close-up view showing structural intent and stone placement.

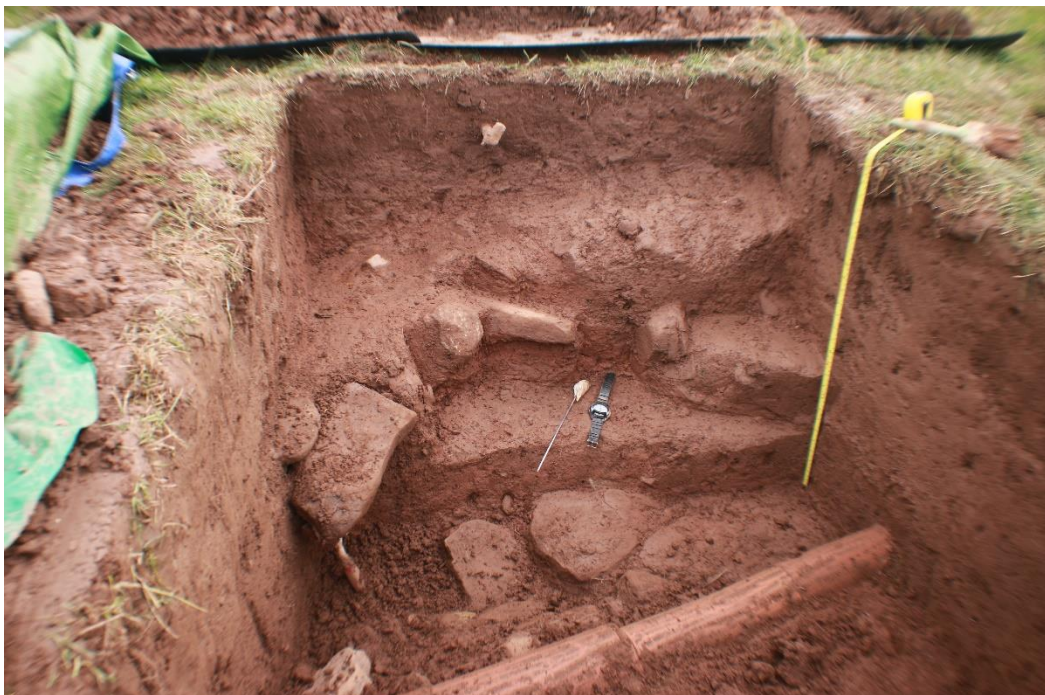
Figure 4: Eastern trench extension revealing further roadside edge and metalling deposits.

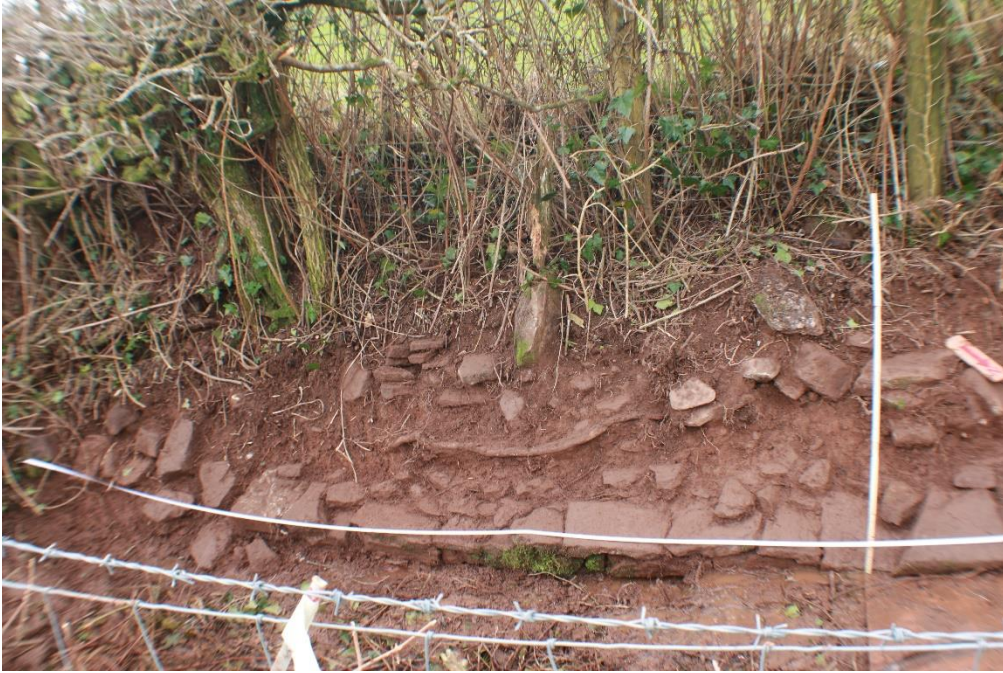
The exposed face of the road revealed several construction elements including:

- roadside edge definition
- a stone bearing support layer
- compacted road metalling
- evidence of drainage activity on the downslope side of the road

Figure 5: Exposed road face at waterway crossing showing roadside edge and metalling.

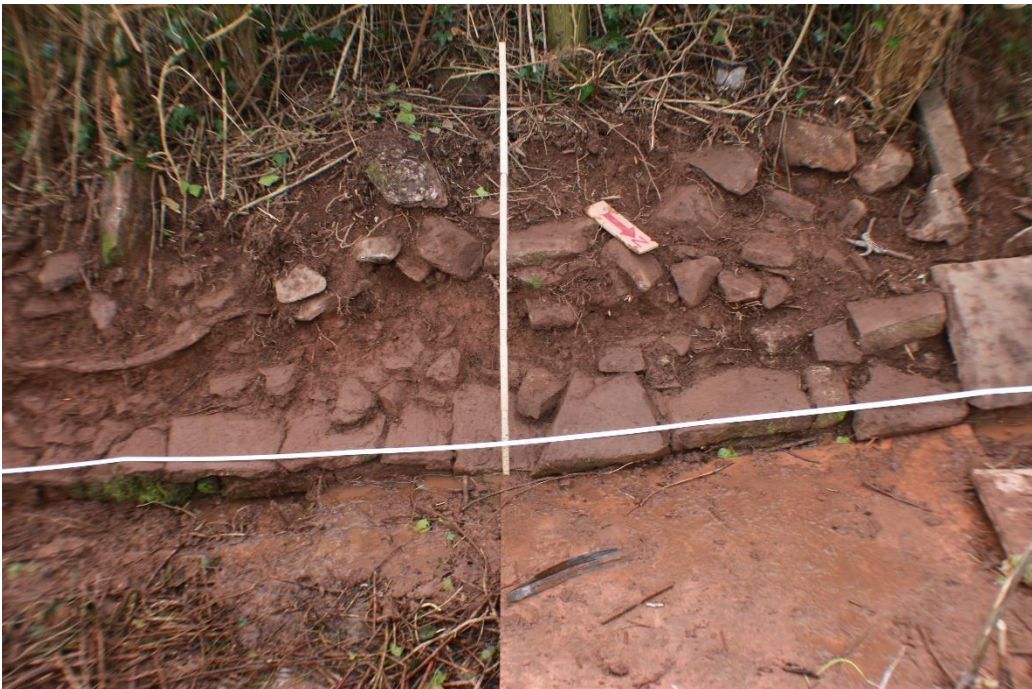
Figure 6: Road support structure and bearing stones.

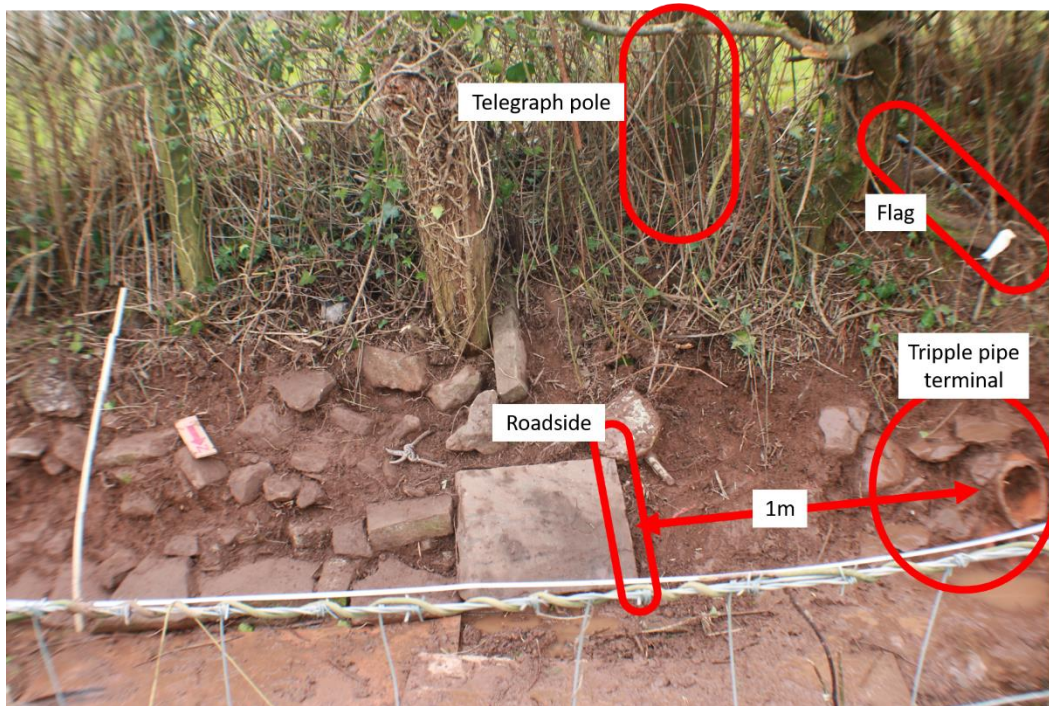
Figure 7: Road alignment showing position relative to the telegraph pole marker and triple pipe terminal.

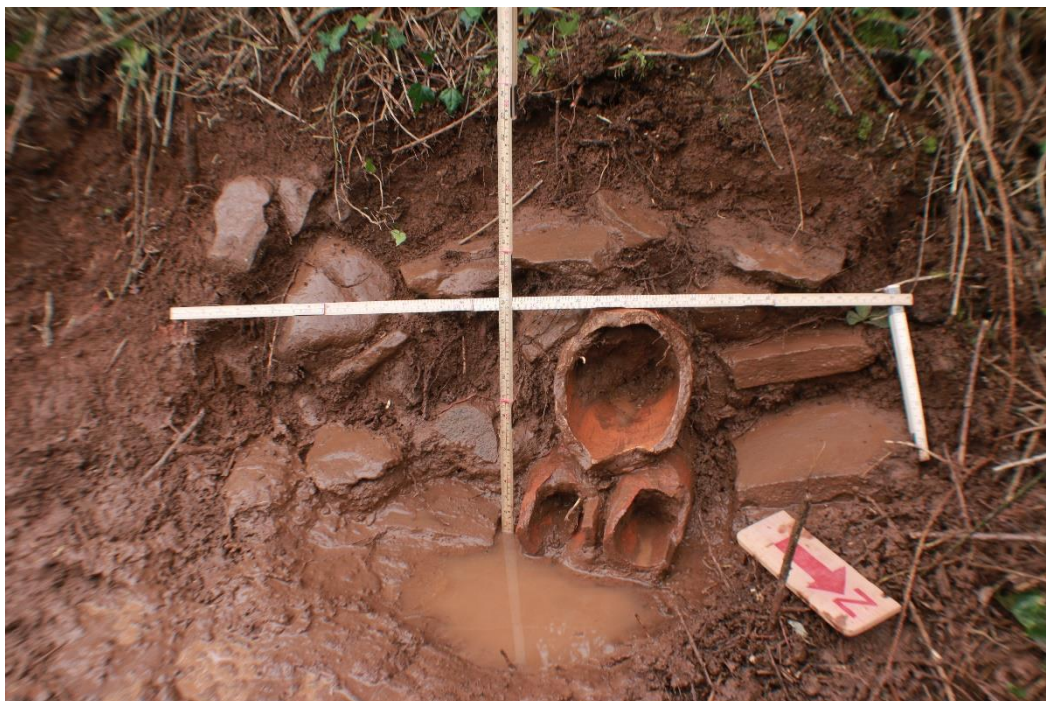
Approximately 1 m from the roadside edge, a triple ceramic pipe drainage terminal was identified exiting the waterway bank.

The three ceramic pipes appear to have been deliberately arranged within a protective stone packing formation, forming a consolidated drainage outlet structure.

The alignment of these pipes corresponds directly with the ceramic pipe identified within Trench 1, strongly suggesting that the trench feature forms part of the same drainage system.

Figure 8: Triple ceramic pipe drainage terminal exiting the waterway bank with measurement scale.

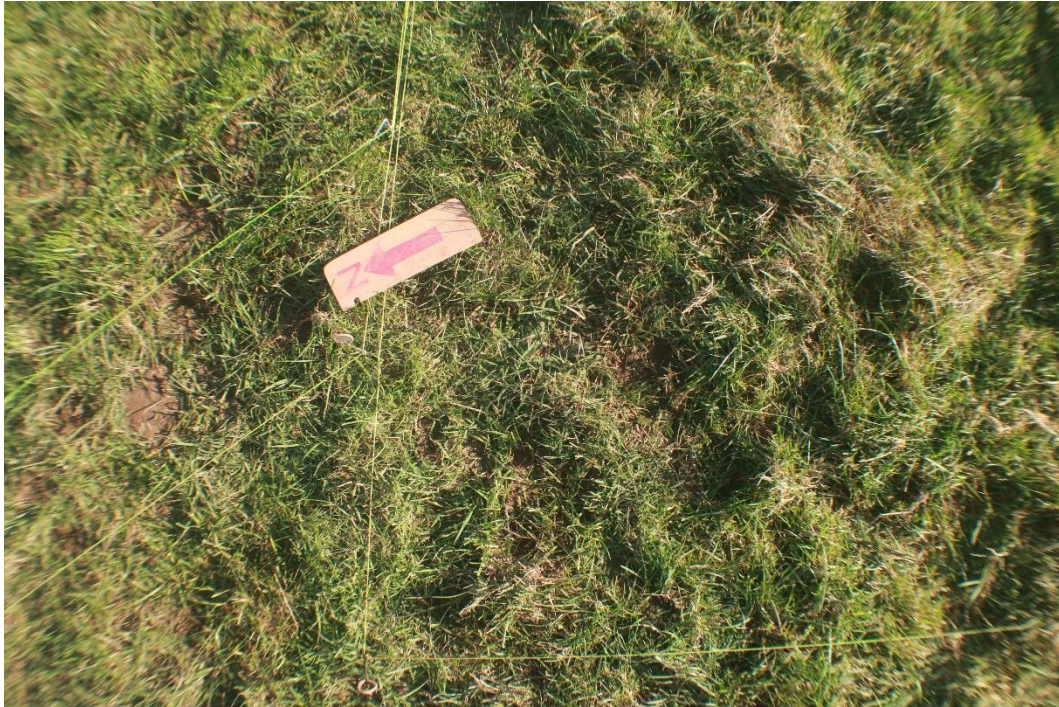
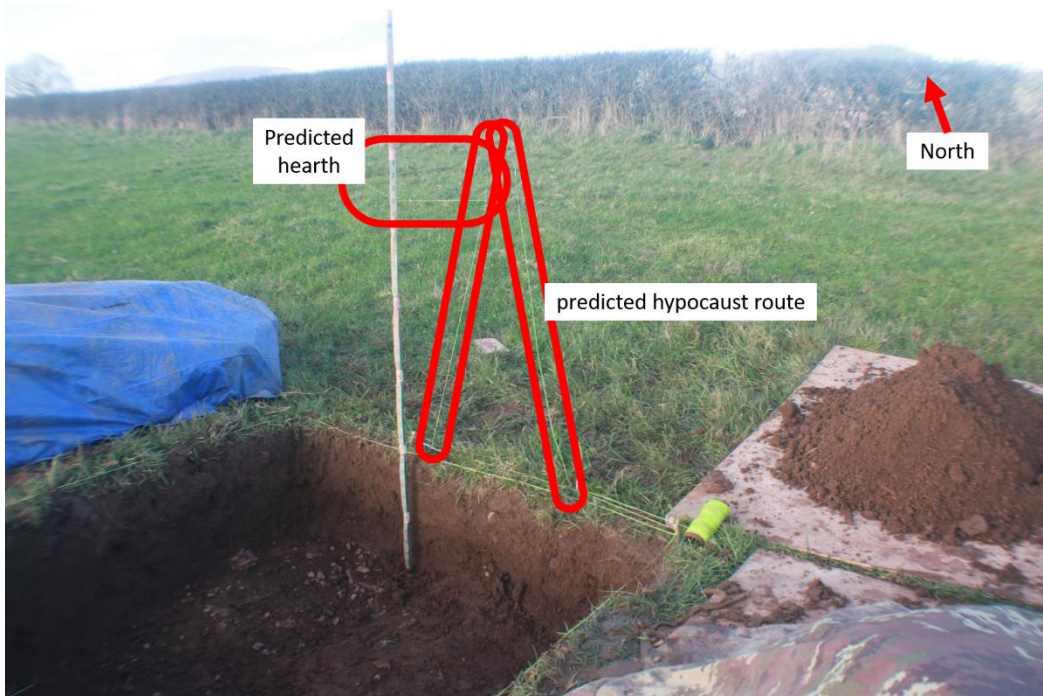
Trench 2 was positioned over the predicted location of a structural interface interpreted as the north-eastern edge of a bathhouse structure.

Figure 9: Position of trench 2 and predicted hypocaust route heading north.

Figure 10: Showing trench 2 and the predicted hypocaust route heading north to its predicted inlet terminal (see trench 4) at water way SW face. Please note mid-way along route the predicted hearth.

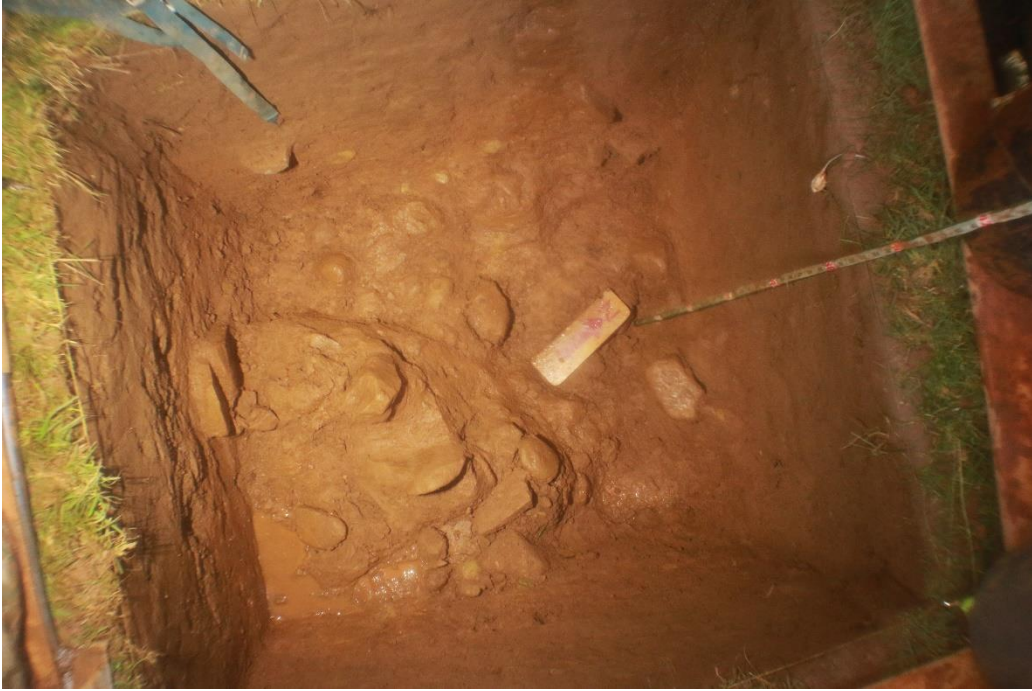
Figure 11: Completed trench 2.

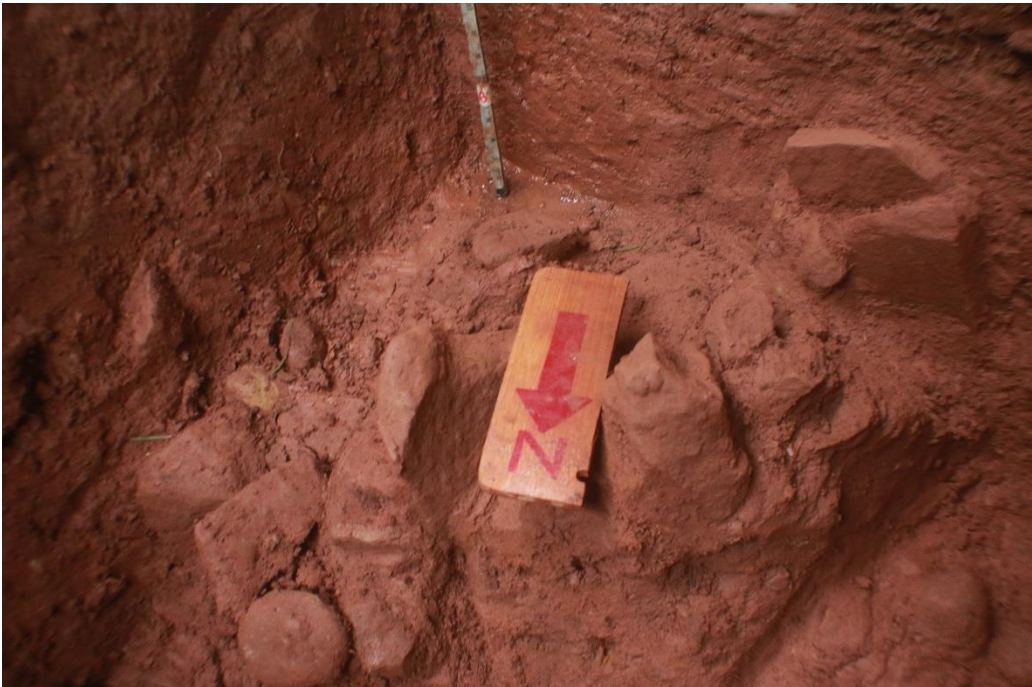
Within the trench a distinctive fan-shaped stone arrangement was identified, interpreted as a terminal interface associated with a flue or heating conduit entering the bathhouse structure.

The stone configuration suggests the presence of a heat buffer zone at the building interface, potentially associated with a hypocaust heating system.

Figure 12: Flue terminal interface in trench 2.

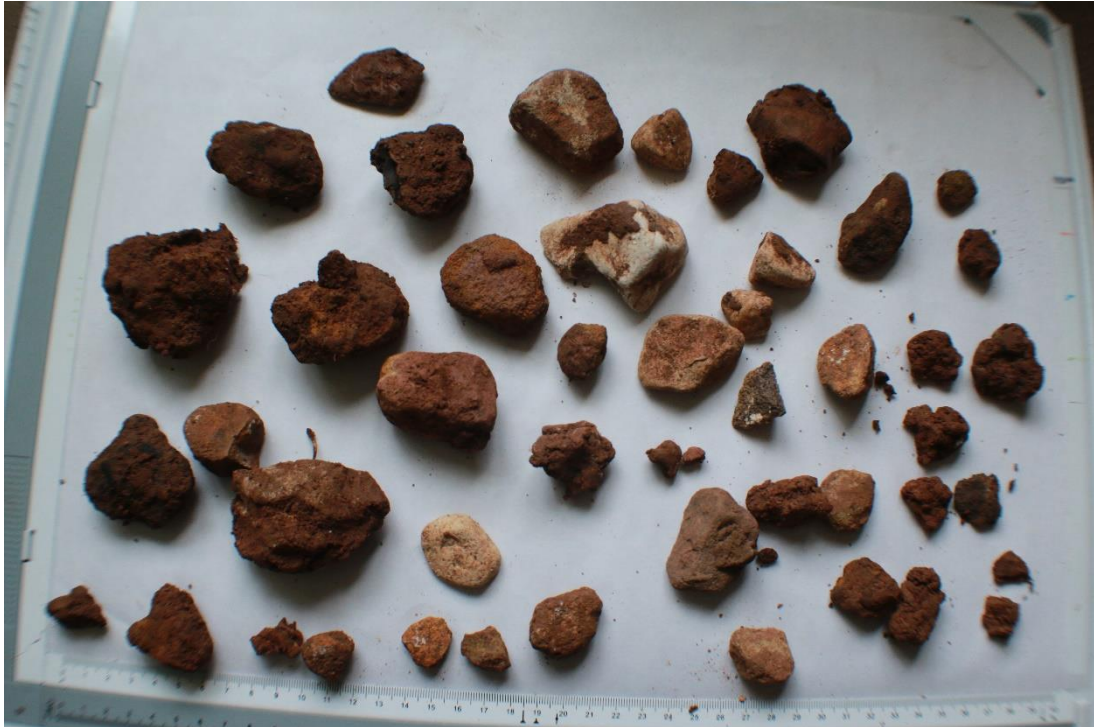
- mortar fragments
- charcoal
- heat-reddened clay
- burnt stone
- calcified material

The presence of heat-affected materials within the structural layers strongly suggests that the area experienced sustained exposure to elevated temperatures consistent with furnace or heating activity.

Figure 13: Recovered heat affected materials from trench 2.

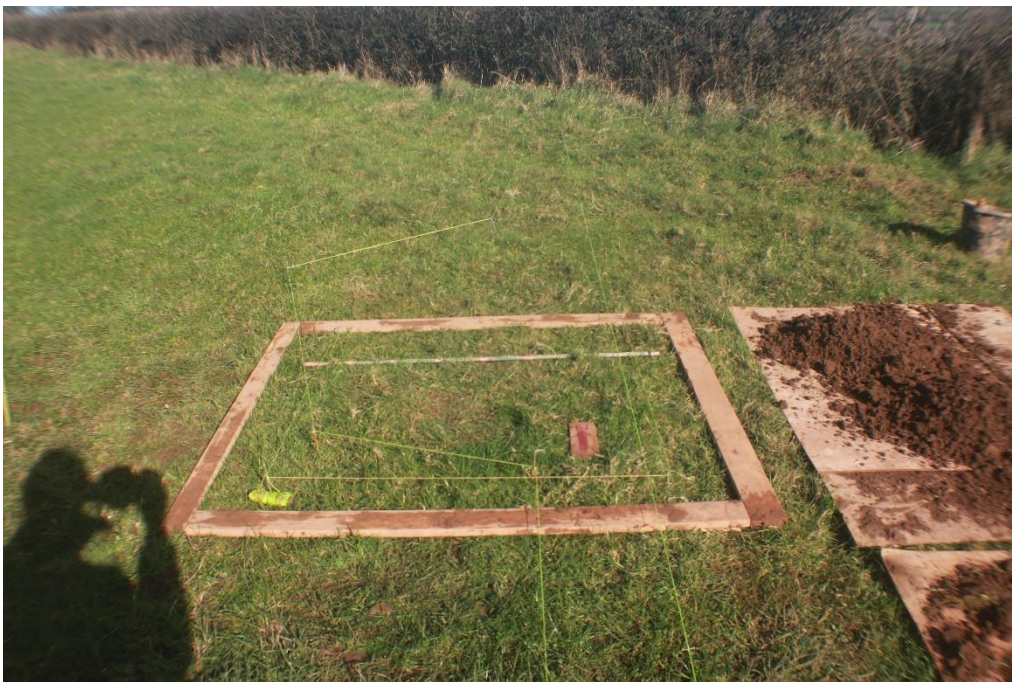
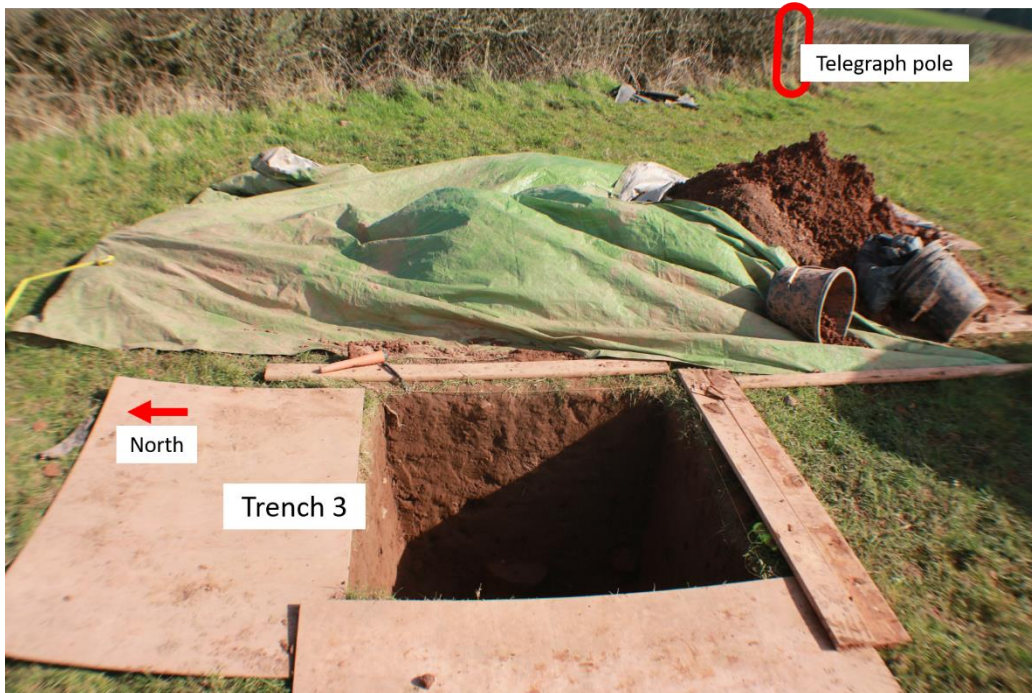
Trench 3 was positioned midway along the predicted flue route between the bathhouse and the suspected air intake structure.

Figure 14: Trench 3 location.

Figure 15: Alignment view of trench 3.

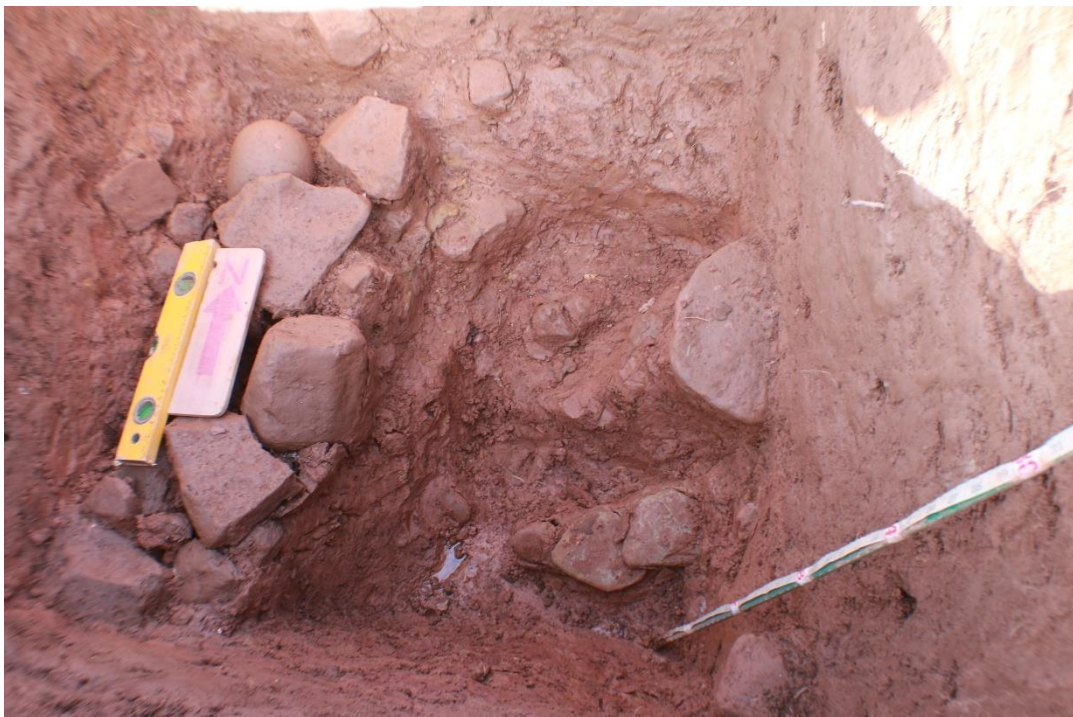
Within the trench, structural deposits consistent with a hearth or furnace installation were identified.

Figure 16: Completed trench 3.

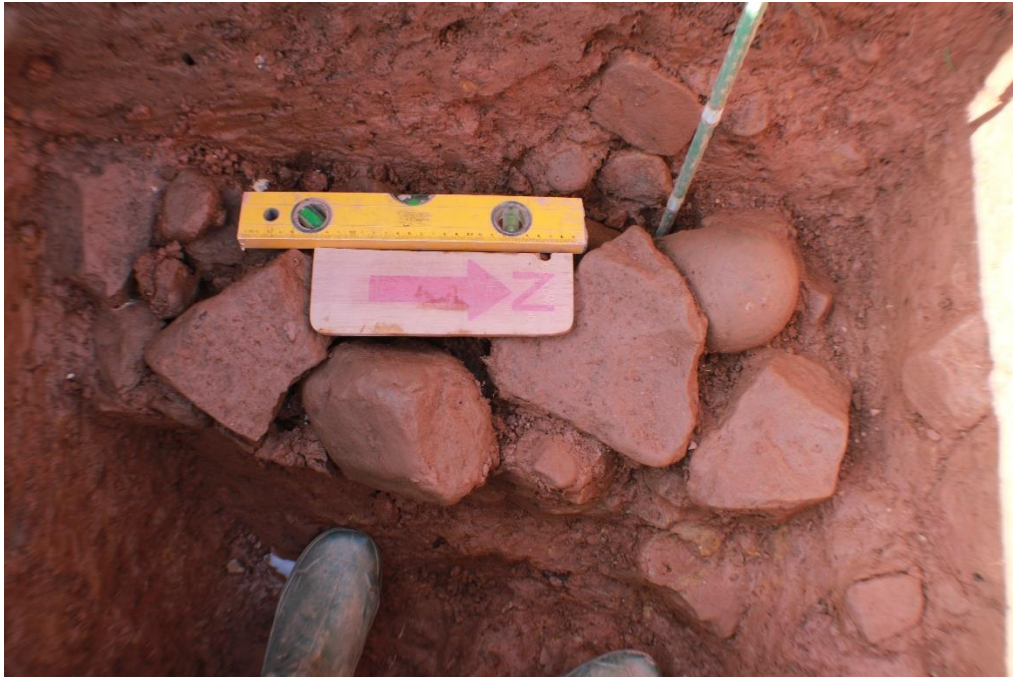
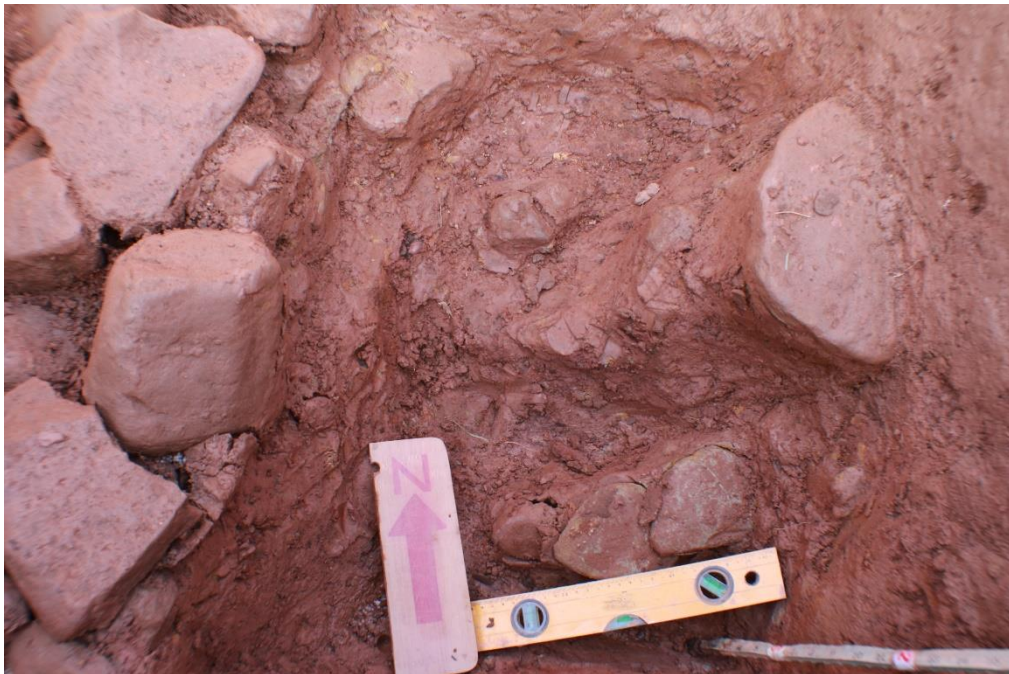
Possible structural collapse associated with the hearth structure is visible in Figures 17 and 18.

Figure 17: Structural collapse and hearth remains.

The presence of heat-affected materials and structural collapse within this trench suggests that the furnace area experienced prolonged heating activity.

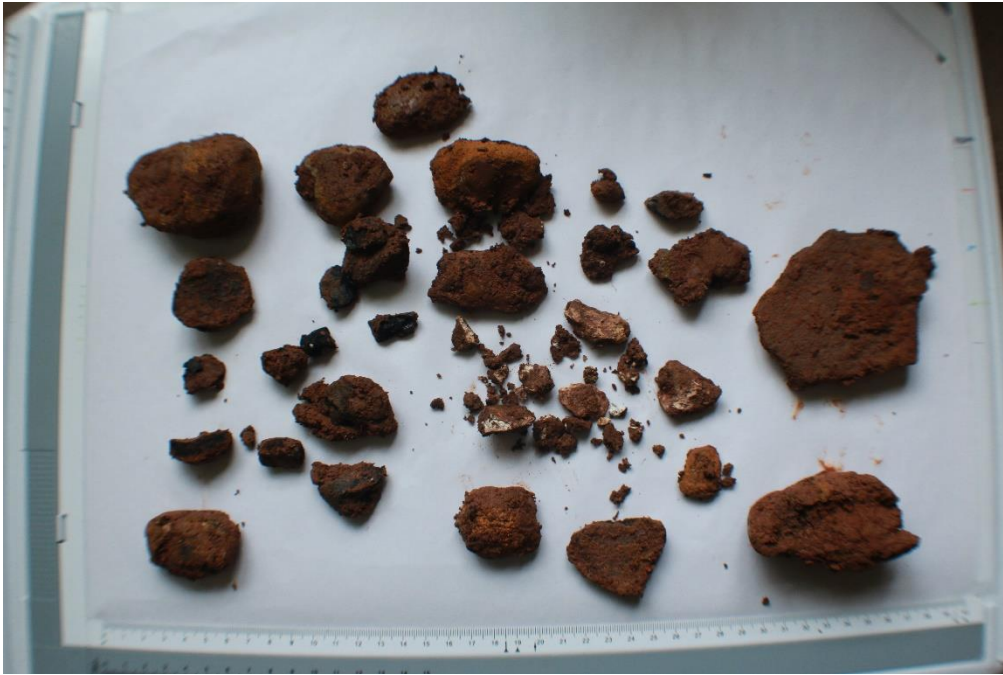
- mortar fragments
- charcoal
- burnt stone
- reddened clay deposits
- calcified material

The distribution and condition of the materials indicate exposure to sustained high temperatures, consistent with furnace operation.

Figure 19: Recovered hearth materials.

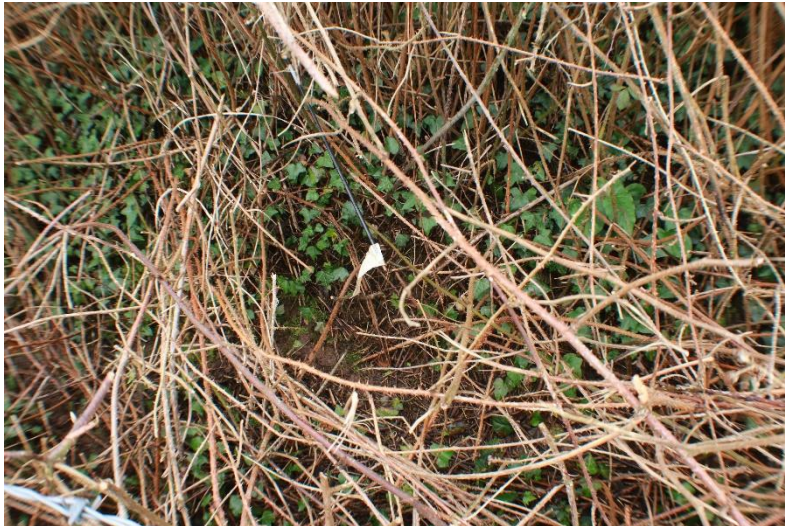
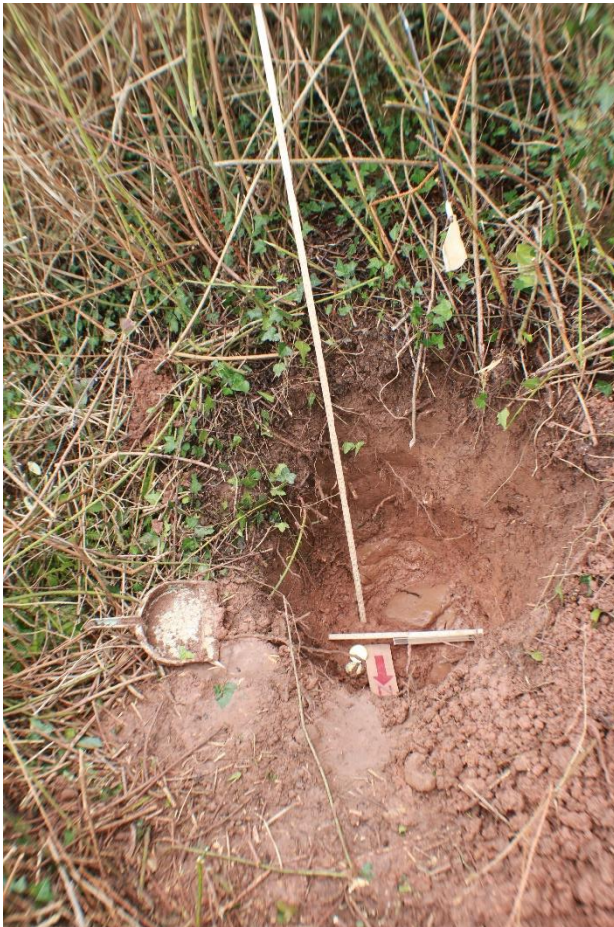
The trench was positioned on the south-west facing bank of the waterway, approximately 17.5 m upstream from the triple pipe drainage terminal.

Figure 20: Predicted intake alignment

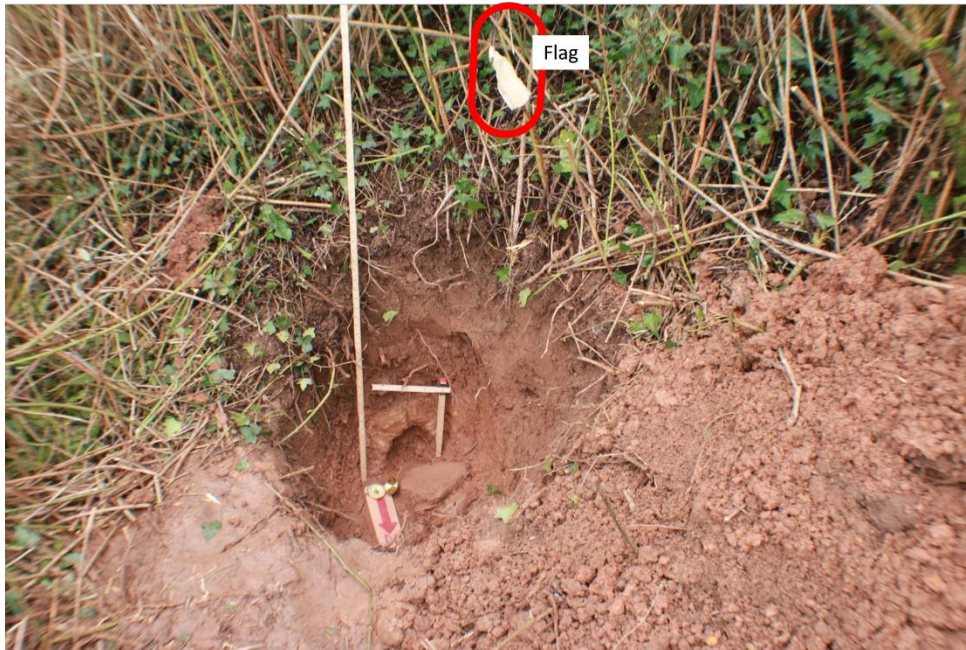
Excavation revealed a stone-built arch structure containing a hollow internal chamber, interpreted as a potential air intake structure associated with the furnace system.

Figure 22: completed trench 4

To preserve the integrity of the structure, excavation was halted and the trench was backfilled following documentation.

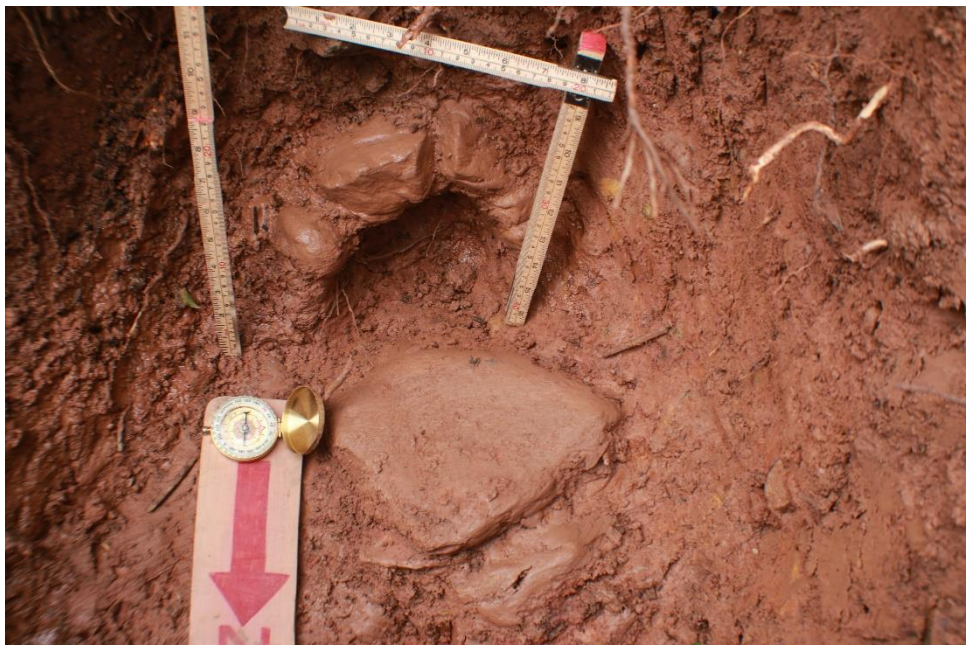
The form and position of the arch suggests that it functioned as a controlled airflow intake supplying oxygen to the furnace or hearth installation identified in Trench 3.

Figure 23: Air intake arch close-up

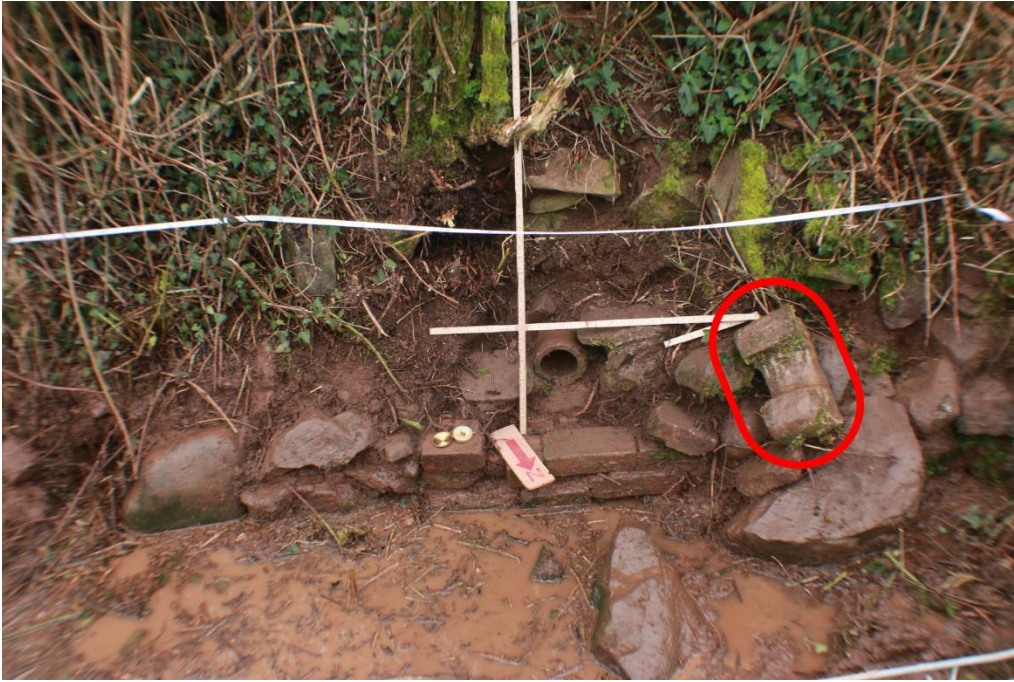
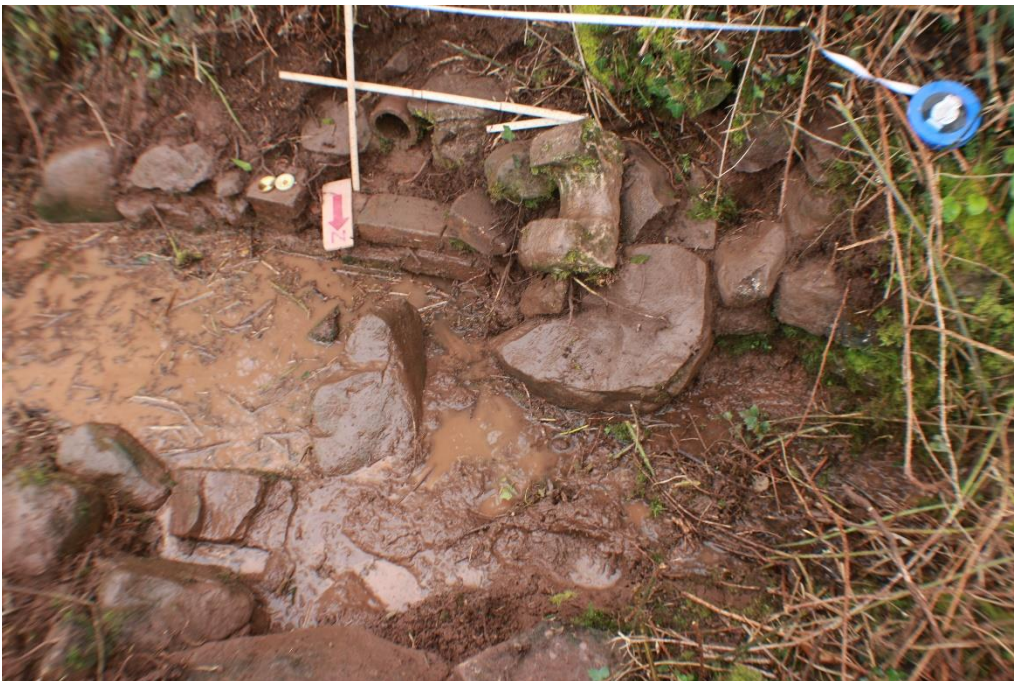
Further structural remains were identified approximately 3 m upstream from the telegraph pole marker along the waterway.

- stone-built drainage elements
- structural masonry
- ceramic brickwork
- dressed stone blocks

The masonry appears to form part of a structure crossing the waterway, illustrated in Figure 25.

- a revetment or retaining structure
- a bridge base or crossing platform associated with the roadway

Figure 24: Masonry remains in waterway

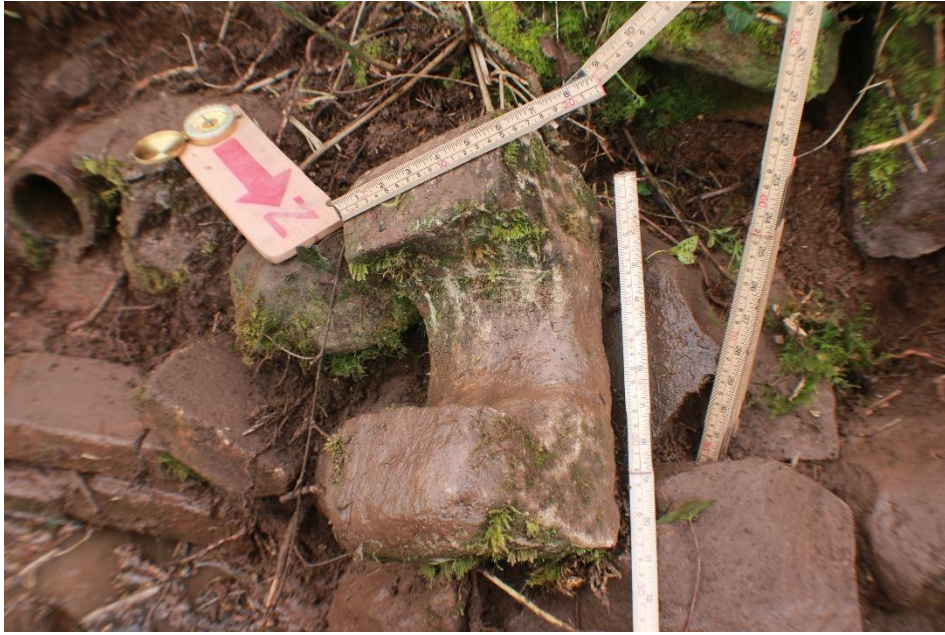
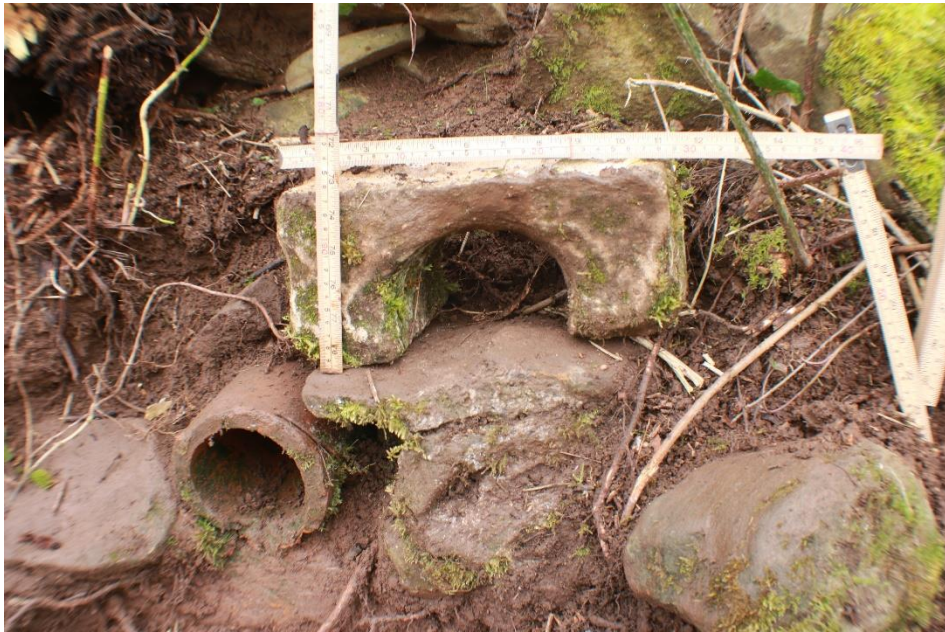
Of particular interest is the presence of a pale chalk or bath stone block exhibiting a curved face and dressed surfaces, potentially representing a component of an arch construction.

Figure 26: Bath stone arch block
