Oak Archaeology Wales CIC

DBA – Provenance Links Between the Craig Ruperra Quarry Scarp and the Ruperra–Machen Roman Military Complex: Evidence for On-Site Stone Dressing, Material Transport, and Architectural Use

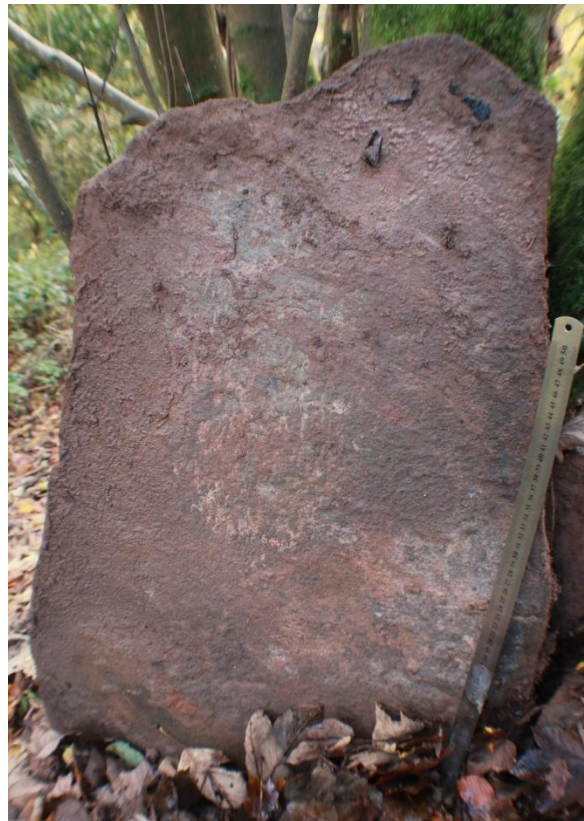
Plate 1 – Large Rough-Dressed Quarry Block with Broad Flattened Face

Plate 1: A substantial sandstone block located approximately two-thirds up the Craig Ruperra extraction scarp. The stone displays a broad, intentionally flattened face indicative of early-stage Roman quarry dressing. The rough but deliberate surface preparation suggests waste removal and shaping carried out directly at the quarry before transport. The ruler provides scale, showing the block's significant size and suitability as a rough-out for subsequent architectural use at the Roman complex downslope.

- **Large, quarried sandstone block** with a broad, roughly flattened working face, consistent with early-stage extraction and primary shaping directly on the Craig Ruperra scarp.

- **Surface shows deliberate tooling and waste removal**, with uneven but purposeful levelling typical of Roman rough-outs prior to finer dressing at a secondary working site.
- **Ruler provides scale**, demonstrating the block's substantial dimensions and suitability for architectural reuse, aligning with other quarry-derived material linked to the Machen–Ruperra Roman complex.

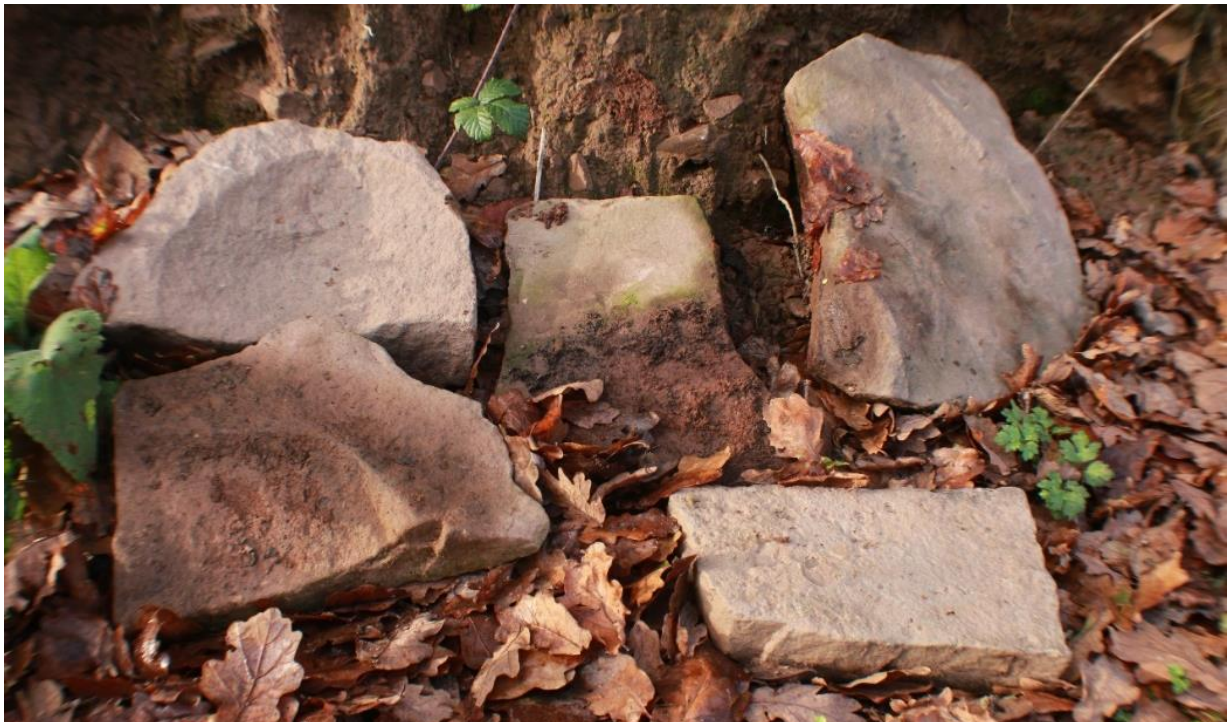
Plate 2 – Cluster of Rough-Out Quarry Fragments Beneath the Extraction Face

Plate 2: A tightly grouped assemblage of partially worked sandstone fragments located approximately two-thirds up the Craig Ruperra scarp. Each block displays at least one intentionally flattened or trimmed face, consistent with Roman rough-out dressing performed directly at the quarry. The presence of multiple shaped offcuts in a concentrated area strongly indicates on-site working and the discard of unusable or incomplete pieces. This deposit sits immediately below the extraction face, supporting interpretation of an active Roman quarrying and shaping zone.

- Five sandstone blocks displaying partially dressed faces and planar surfaces, consistent with early-stage shaping rather than natural fracture.
- Mixed geometries (rectangular, trapezoidal, and squared forms) typical of quarry-face waste produced during Roman ashlar preparation.
- Location directly against the extraction scarp, supporting interpretation that these are discarded working pieces associated with on-site stone dressing.

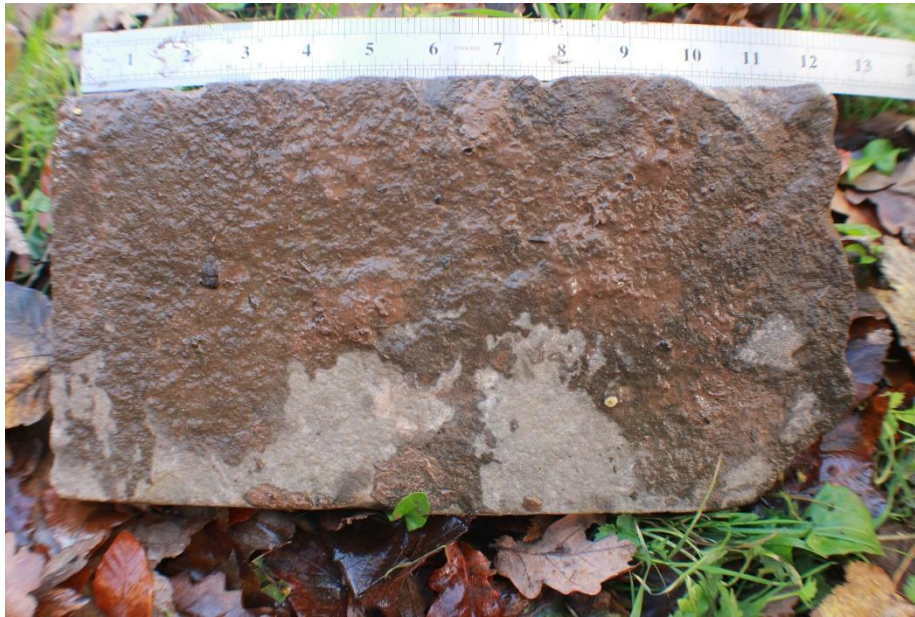
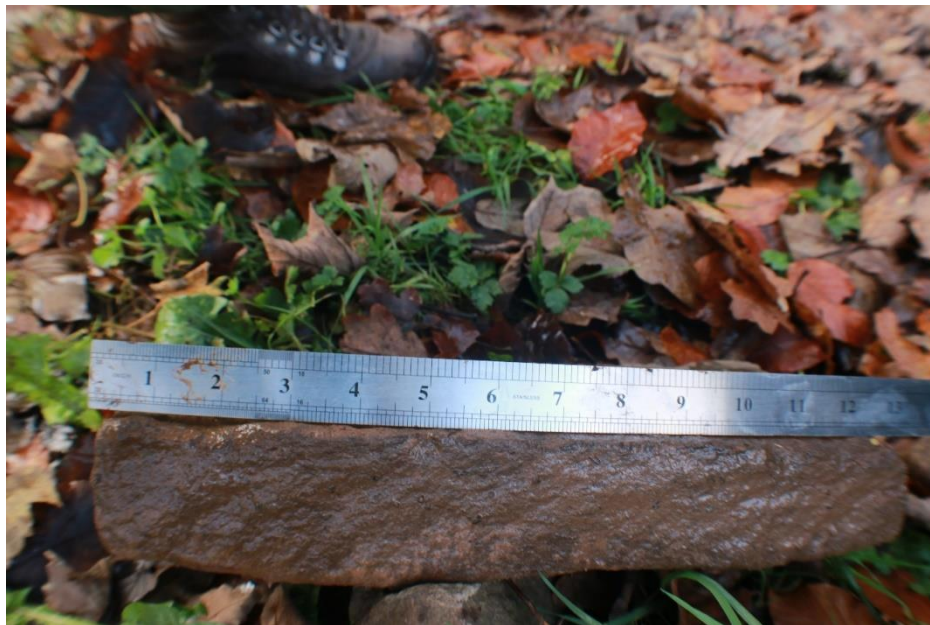
Plate 3 – Rectangular Worked Sandstone Block from Craig Ruperra (Two Views)

Plate 3: Two views of the same rectangular worked sandstone block recovered c. $\frac{2}{3}$ of the way up the Craig Ruperra extraction scarp. The block shows a uniform, artificially flattened face and clear straight-edge geometry, indicating deliberate shaping rather than natural fracture. The even thickness, rectilinear edges and tooling-consistent surface texture strongly support interpretation as a discarded or unfinished Roman ashlar or potentially an early roof/tiling element. The presence of weather-softened strike marks is consistent with Roman-period stone dressing, matching debitage characteristics recorded at other auxiliary fort quarries. The block's location upslope from the main quarried face reinforces the assessment that it represents on-site shaping waste, left behind before transport.

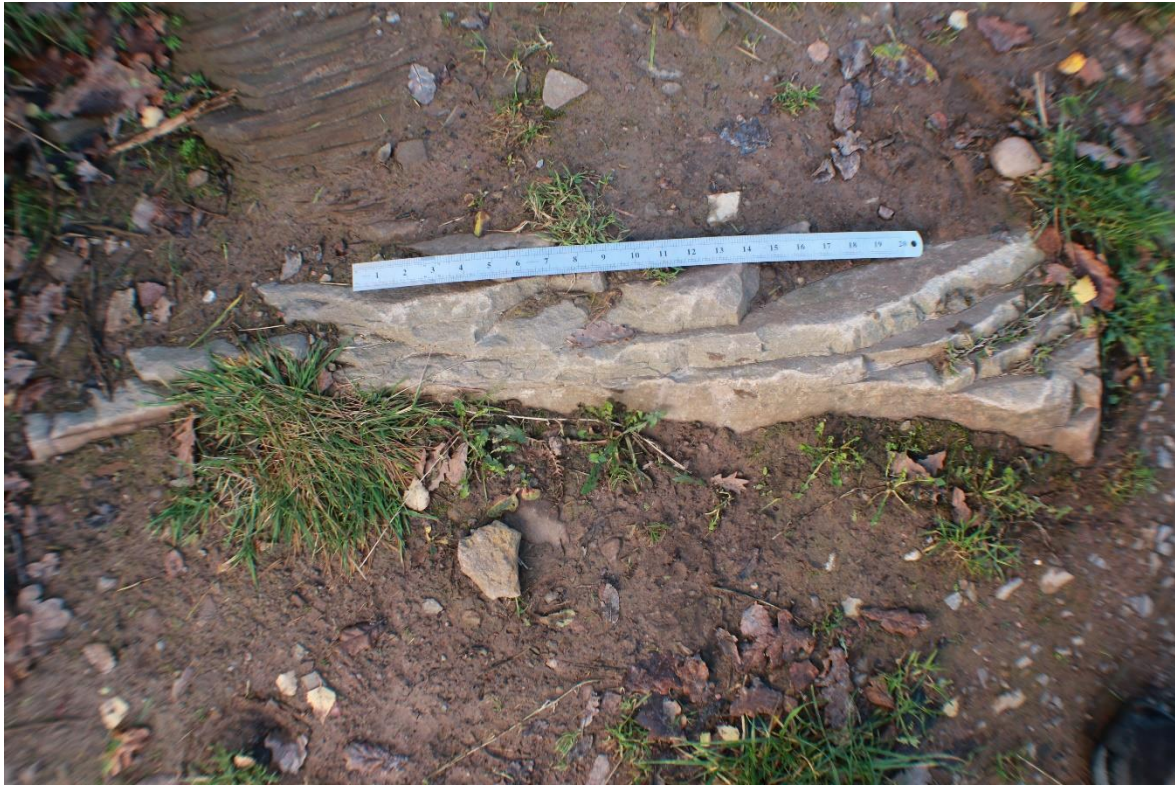
Plate 4 – Exposed Quarry Extraction Scar Showing Sequential Chisel Removal

Plate 4: An exposed extraction scar on the Craig Ruperra quarry face showing distinct stepped chisel removals created during the removal of a long sandstone block. The parallel ridges and negative impressions reveal systematic dressing with a straight-edged tool, consistent with Roman quarrying technique, where blocks were freed by cutting vertical and horizontal channels around the intended piece.

- Clear stepped tool marks where successive slices of stone were removed.
- A long, linear extraction channel running beneath the ruler — matching the width of slabs found discarded on the terrace below.
- The sharpness and spacing of the tool traces correspond to Roman-period point and claw chiselling, not later post-medieval quarrying methods.

This scar provides rare in situ evidence of Roman extraction methodology on Craig Ruperra, directly linking the site to the rough-outs and shaped blocks found downhill.

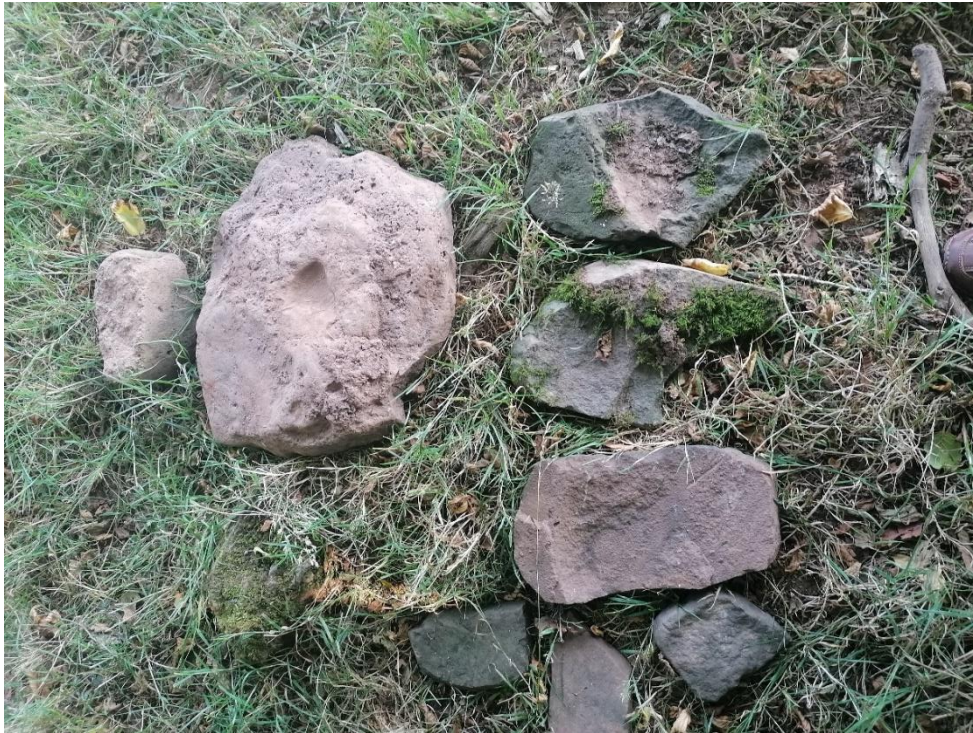
Plate 5 – Partially Worked Stone Assemblage Found 800 m Downslope from Craig Ruperra

Plate 5: A dispersed group of sandstone blocks located approximately 800 m south of the Craig Ruperra quarry scarp, on the projected route toward the Roman military complex. The assemblage includes stones showing clear evidence of preliminary shaping:

- The large block on the left displays a hollowed working depression (“cup-mark”) consistent with failed or abandoned quarry rough-out.
- Several mid-sized blocks (centre) show flat struck faces, moss-covered but still visibly tool-prepared.
- The lower right block has straight, regulated edges, indicating quarry-side preparation prior to intended transport.

This cluster provides strong circumstantial evidence for a transport corridor or working zone, where stones were roughed out at the Craig and then moved downslope in batches toward the Roman site, consistent with Roman logistical practice and the findings from the previous DBAs.

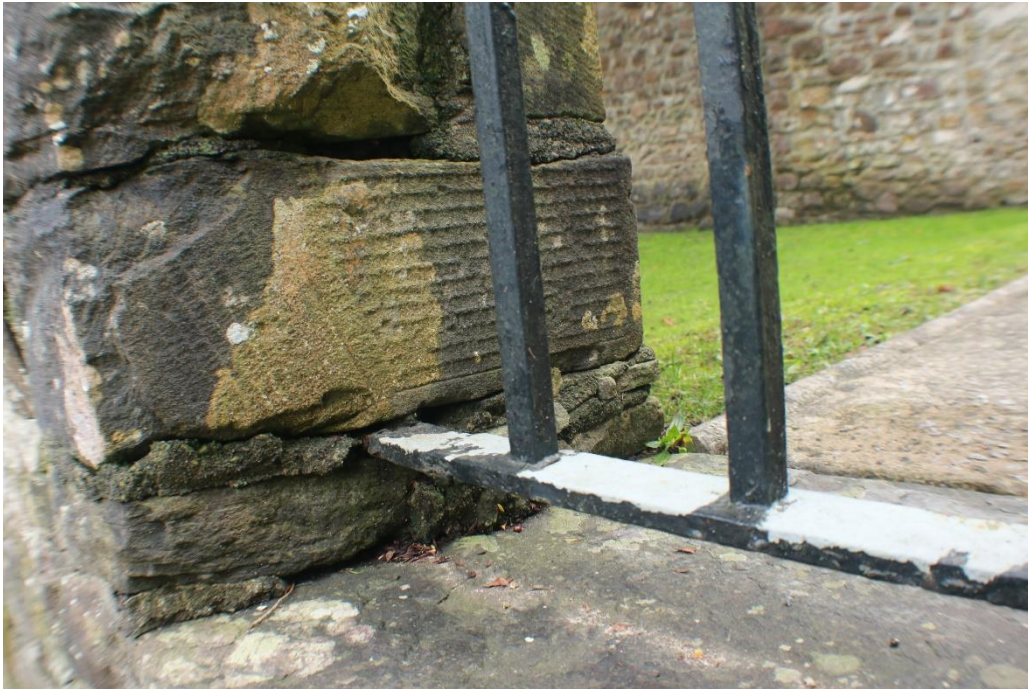
Plate 6 – Reused Roman Dressed Block in the Boundary Wall at St James’ Church, Rudry

Plate 6: A finely tooled sandstone block incorporated into the boundary wall of St James’ Church, Rudry, displaying distinctive parallel tooling marks (fluting) consistent with Roman-period ashlar dressing. The crisp, evenly spaced grooves are characteristic of Roman claw-chisel or comb-chisel finishing, not later medieval or post-medieval working techniques.

- A direct comparative example for identifying Roman tooling in the Craig Ruperra assemblages.
- Evidence of Roman dressed stone circulating in the immediate region, supporting the case that high-quality stonework was quarried locally and redistributed.
- A meaningful typological match with the heavily tooled surfaces visible on fragments found at the Craig scarp and within the Home Farm Roman complex.

This plate acts as a diagnostic reference for recognising Roman workmanship in the Ruperra landscape.

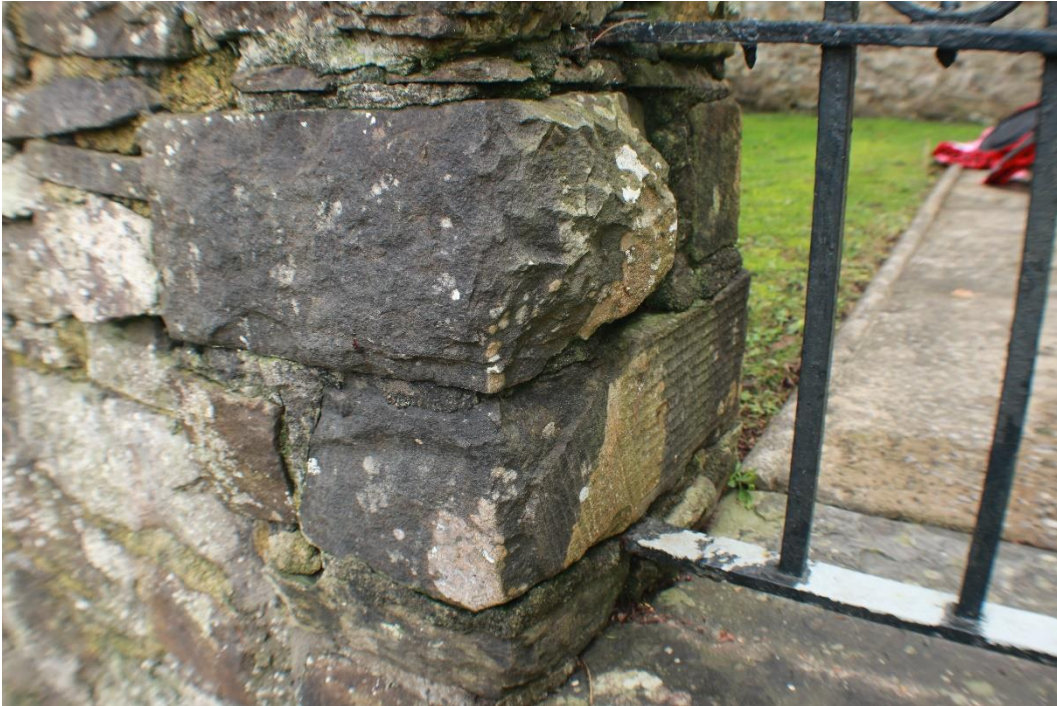
Plate 7 – Secondary Use of Roman Ashlar in the Rudry Churchyard Boundary Corner

Plate 7: Corner of the boundary wall at St James’ Church, Rudry, incorporating a heavily worked block with deep, regular claw-chisel grooves—a diagnostic hallmark of Roman ashlar finishing. The worked face is built sideways into the corner, demonstrating secondary use (“spolia”) in a later structure.

- Better dressed, with a uniformly flattened face;
- Marked by parallel, purposeful tooling, inconsistent with natural fracturing;
- Comparable in tooling style and sandstone type to the fragments recorded at the Craig Ruperra quarry and the Roman military complex at Home Farm.

This plate reinforces the DBA conclusion that Roman masonry circulated widely across the area and was repurposed in later historic buildings, providing a crucial comparative reference point for identifying Roman workmanship at Craig Ruperra.

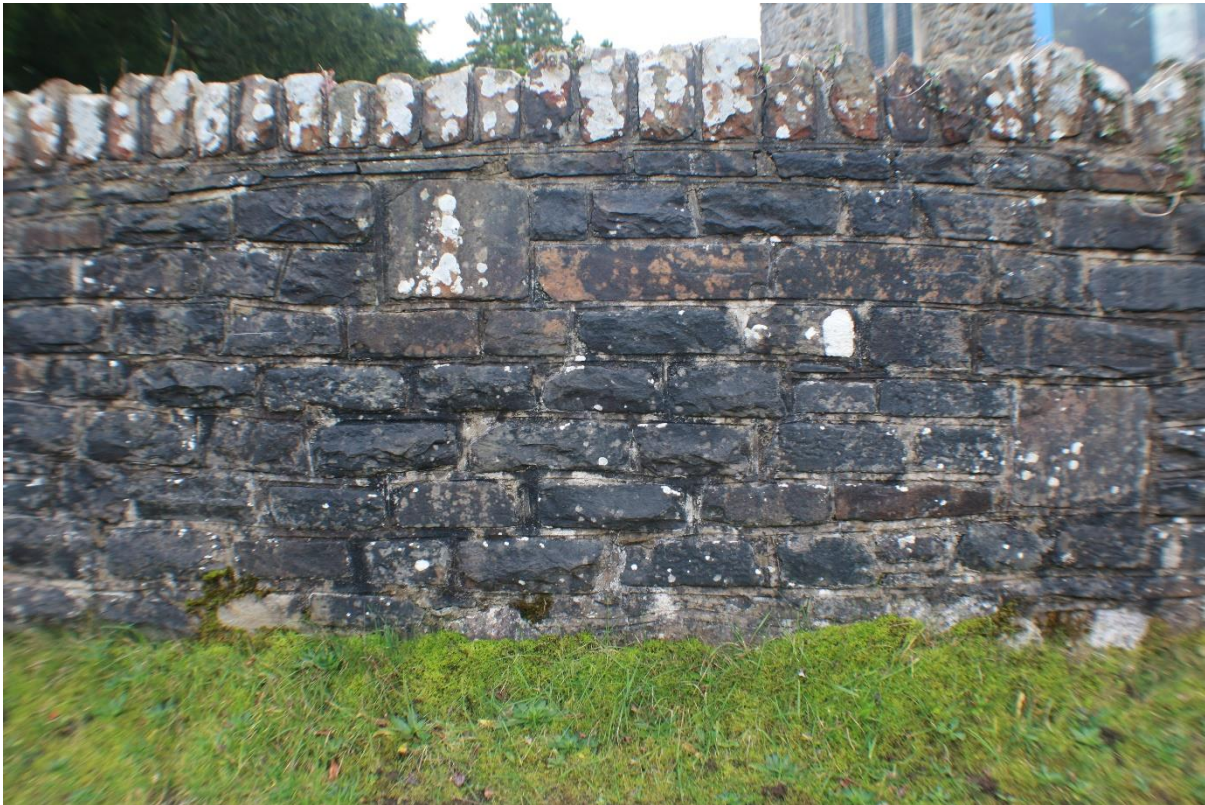
Plate 8 – Wider View of Boundary Wall at St James’ Church, Showing Reused Roman Block in Context

Plate 8: A wider elevation of the **south boundary wall** at St James’ Church, Rudry, showing the architectural context in which Roman ashlar fragments are reused. The wall is predominantly constructed of irregular dark rubble stone, typical of post-medieval boundary construction.

Within this matrix, one rectangular, lighter-coloured block near the centre (slightly right of middle) exhibits:

- A noticeably smoother worked face,
- More regular geometry than the surrounding stones,
- A likely reused Roman origin, matching the tooling and stone type observed in Plates 6 and 7.

This plate demonstrates how Roman masonry was selectively incorporated into later structures, often standing out due to its superior dressing, even after centuries of weathering.
