The Mystery of Rose Castle Tower

Brian John

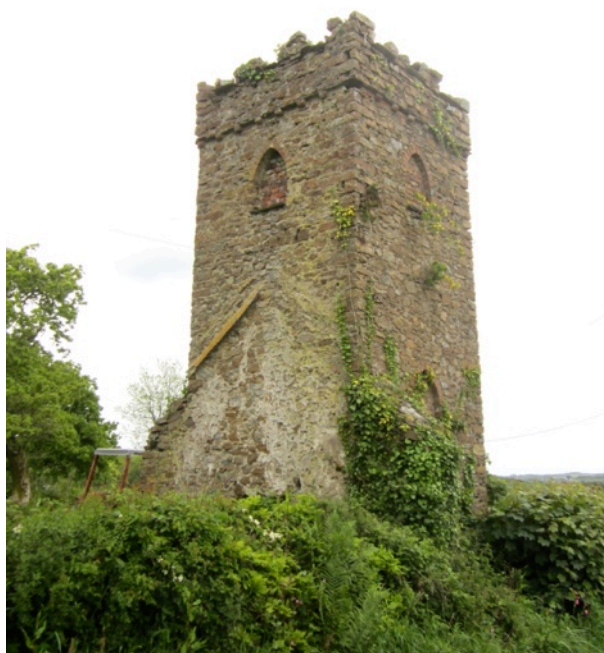
Rose Castle Tower as it appeared in 1948, and as it looks today. For most of the intervening period, it has been hidden behind a row of tall trees.

The earliest photo which we have of the tower is dated 1948. By then, it was ruinous, and the attached building or annexe had gone. Beyond the tower, we can see that Church House was in good condition, and we can also see the roofline of Church Cottage. According to the owner of Rose Caste Farm, the cottage was destroyed in a fire in the 1950's which resulted in the death of one budgerigar and one dog. Then, maybe less than 50 years ago, the tower's roof fell in, and it was abandoned to its fate as a quirky feature of the Church House garden. Church House was also rebuilt and extended.

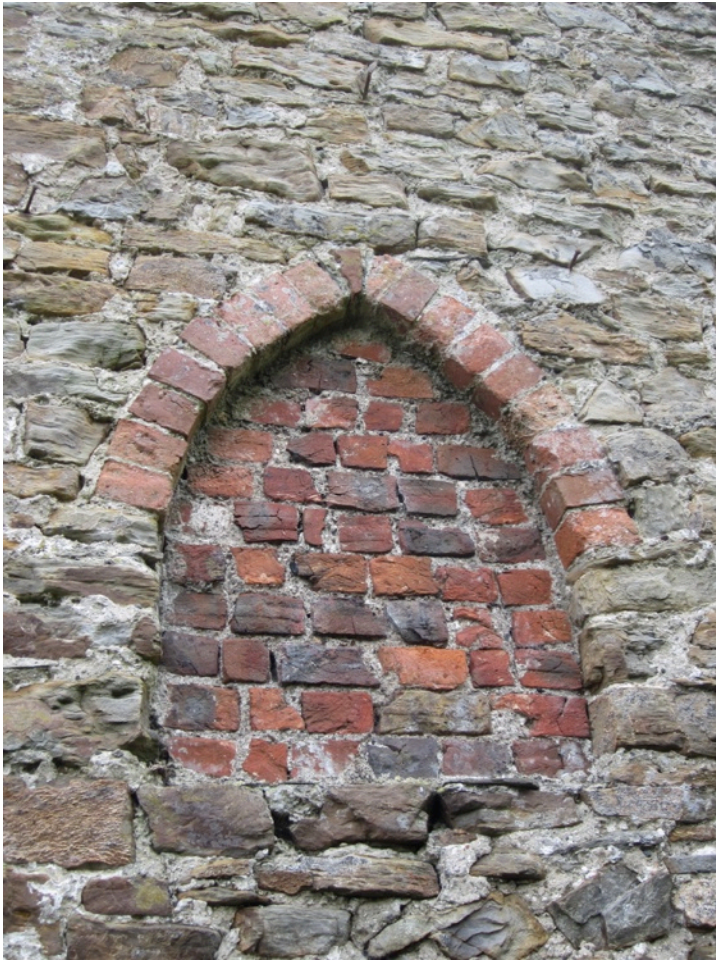
One of the high windows, showing the brick arch and the later brick infill. This window has no window sill.

The seven arched windows of the tower are enigmatic, to say the least. Internally they are all square, with shale or mudstone slabs or oak beams used as lintels. Four have external window sills. Externally, all of the windows have brick arches, flush with the outside walls. At some stage all of the windows have been blocked up on the inside with rough stonework. And all of the windows have been bricked up on the outside too, with the brickwork set back about 4 inches, making it appear from a distance that they were simply ornamental window recesses. So there have been several identifiable phases in the evolution of the tower windows. Over what period of time did these changes take place, and what might have been their purpose? One explanation for the bricking up of the windows might be the avoidance of the window tax which was not repealed until 1851.

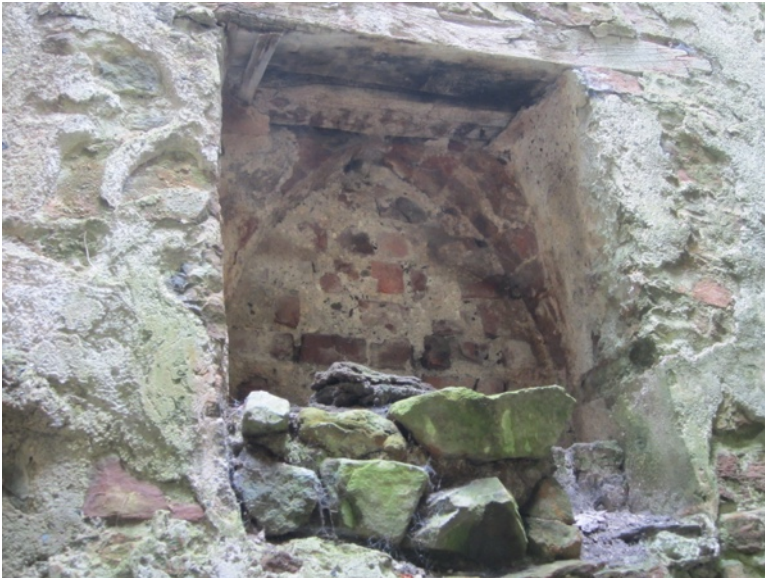
The internal appearance of one of the rectangular windows. This one has no window sill. We can see a wooden lintel, the inside face of the brick arch, the remains of a stone infilling and also the brick infill of the arch.

and “modern” bricks in the tower, and no doubt a building history could be worked out by a brick expert! Some of the bricks used in the arches appear to be sharp-edged and quite modern; but many of those used in the bricking up of the arches look older. That’s an anomaly, and maybe we should explain it by assuming that the filling-in was done by builders who simply used whatever they could find from ruinous buildings in the neighbourhood. Some “old” bricks also appear to have been used in the fabric of the tower itself, and this might give an expert the chance of getting an accurate “fix” on the tower’s age.

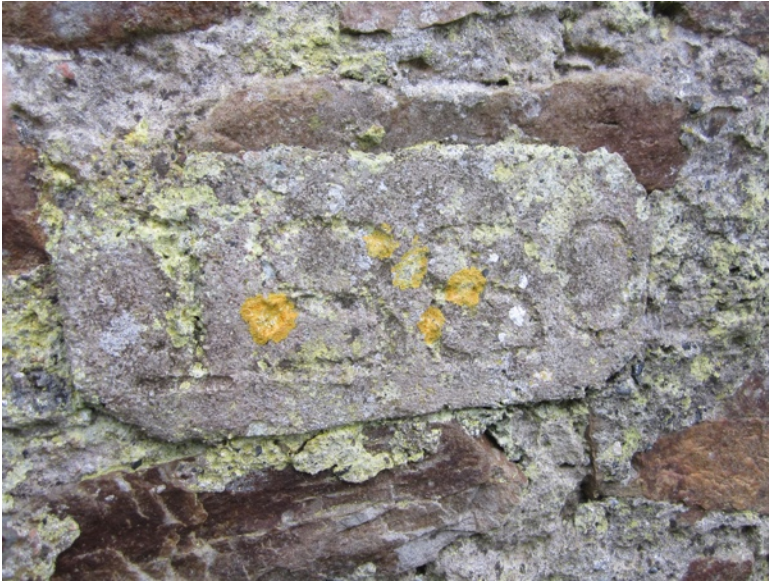
Purely by chance, on a visit in May 2017 I spotted a plaque above the roof-line on the NW tower wall, with the date "1880" just about visible. With the help of a ladder I examined it closely in October 2017 and discovered that the plaque is superficial, made with wet cement into which the numbers have been inscribed. It is not built into the wall -- and so it is a late
