Oak Archaeology Wales CIC

DBA ADDENDUM: PROPOSED HARBOUR / WATER-MANAGED INFRASTRUCTURE

Plas Machen – River Rumney

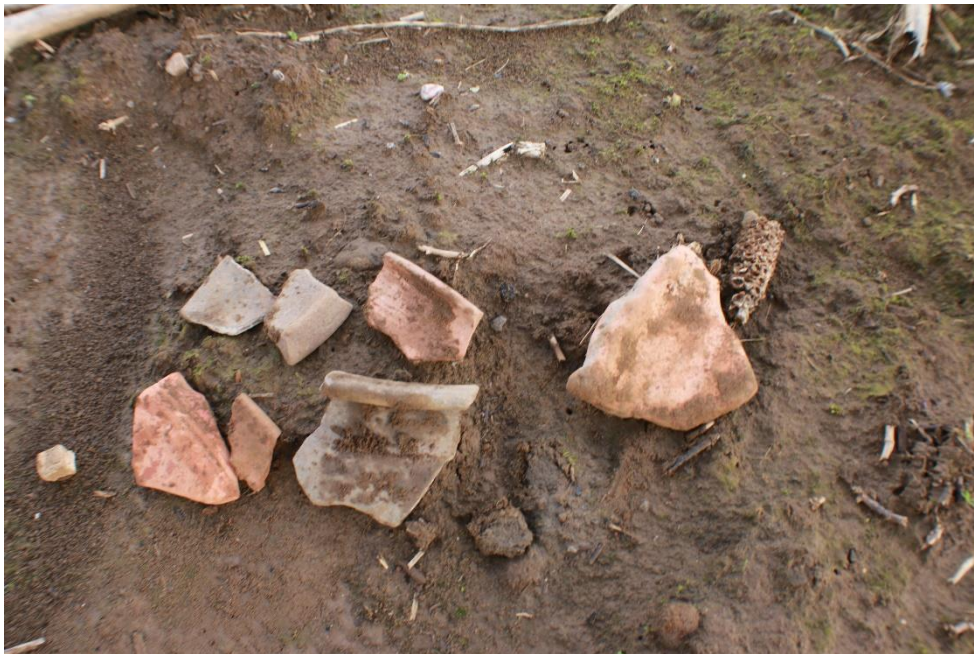
Figur 1 / Figure 1. Cymraeg: Darnau o grochenwaith wedi'u casglu o wyneb y cae ger yr ardal glan afon dan sylw. Mae'r casgliad yn cynnwys darnau o grochenwaith llwyd (greyware) a darnau coch wedi'u gwysgu, yn gyson â chrochenwaith Samiaidd Rhufeinig. Mae presenoldeb y deunydd hwn yn awgrymu gweithgarwch domestig neu logistaidd yn y cyffiniau, o bosibl yn gysylltiedig â seilwaith cludo neu gyflenwi ger yr afon. **English:** Pottery fragments recovered from the surface of the field adjacent to the riverine area under investigation. The assemblage includes greyware sherds and red-gloss fragments consistent with Roman samian ware. The presence of this material suggests domestic or logistical activity in the vicinity, potentially associated with transport or supply infrastructure near the river.

- **Figure 1** illustrates greyware and samian fragments recovered from the field, with findspots to be plotted separately.
- **Figure 2** presents the same assemblage positioned on edge to highlight diagnostic rim forms.

The presence of samian ware, in particular, is indicative of Roman-period occupation or activity of at least regional importance, and is consistent with supply, administrative, or military logistics rather than purely rural use.

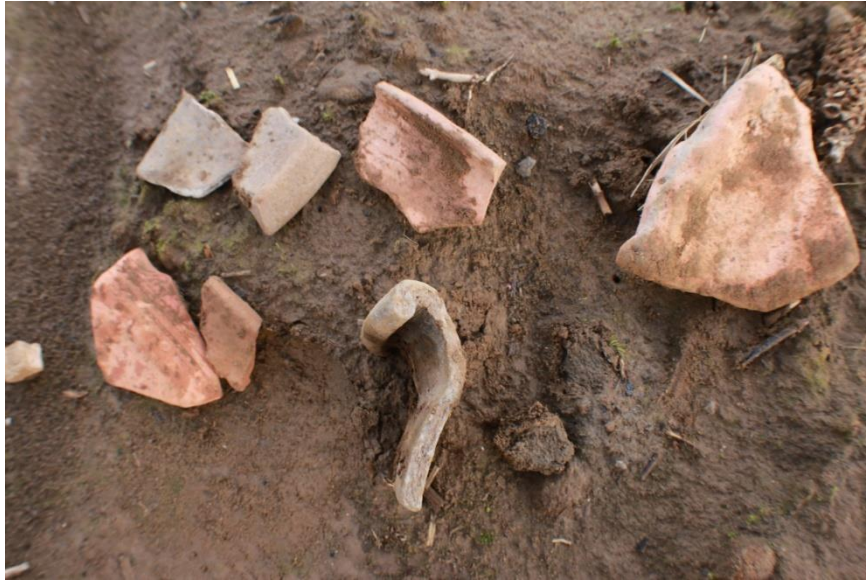
Ffigur 2 / Figure 2. Cymraeg: Yr un darnau o grochenwaith a ddangosir yn Ffigur 1, wedi'u gosod ar eu hymylon er mwyn tynnu sylw at siapiau'r ochr a thrwch y waliau. Mae'r ffurfiau hyn yn nodweddiadol o lestri Rhufeinig safonol, gan gefnogi dehongliad dyddiad o oes Rhufeinig ar gyfer y deunydd a gasglwyd. **English:** The same pottery fragments shown in Figure 1, arranged on edge to highlight rim profiles and wall thicknesses. These forms are characteristic of standard Roman vessel types, supporting a Roman-period attribution for the recovered material.

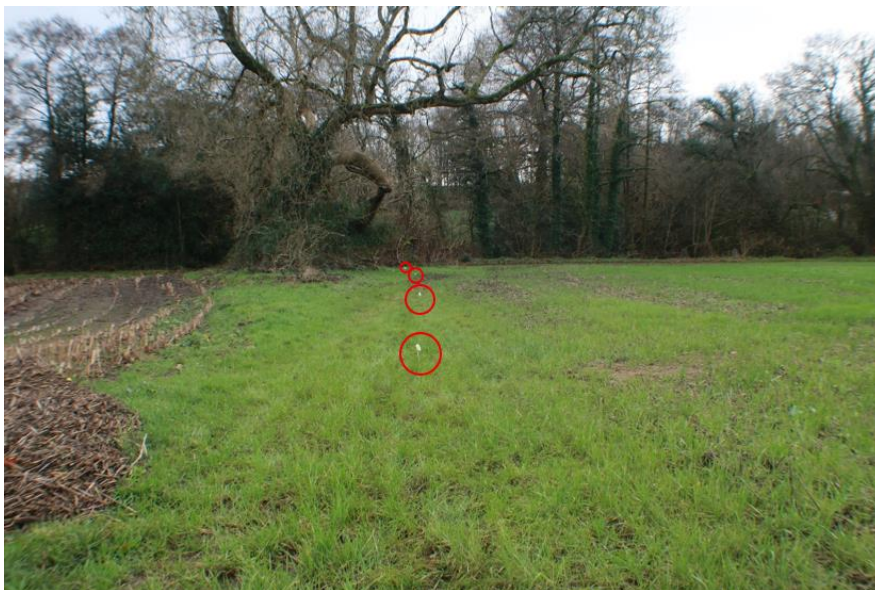
Ffigur 3 / Figure 3. Cymraeg: Golygfa gyffredinol o'r cae yn dangos cyfres o farcwyr wedi'u gosod i nodi safleoedd colofnau neu byst arfaethedig. Mae'r marcwyr yn ffurfio aliniad rheolaidd o chwe safle ar hyd echelin de-orllewin i ogledd-ddwyrain, gyda thair rhes draws-llledredol, gan awgrymu strwythur peirianyddol bwriadol, o bosibl ar gyfer ramp neu lwyfan llwytho cysylltiedig â'r afon. **English:** General view of the field showing a series of markers indicating proposed column or post locations. The markers form a regular alignment of six positions along a south-west to north-east axis, with three transverse rows, suggesting a deliberately engineered structure, possibly relating to a ramp or loading platform associated with the river.

- **Figure 3** shows marker alignment indicating six column positions on a longitudinal SW–NE axis, with three latitudinal rows, forming a grid of 18 column bases.
- **Figures 4 and 5** demonstrate the observed circumference of individual post holes, measuring approximately 2 m in diameter (1 m radius).

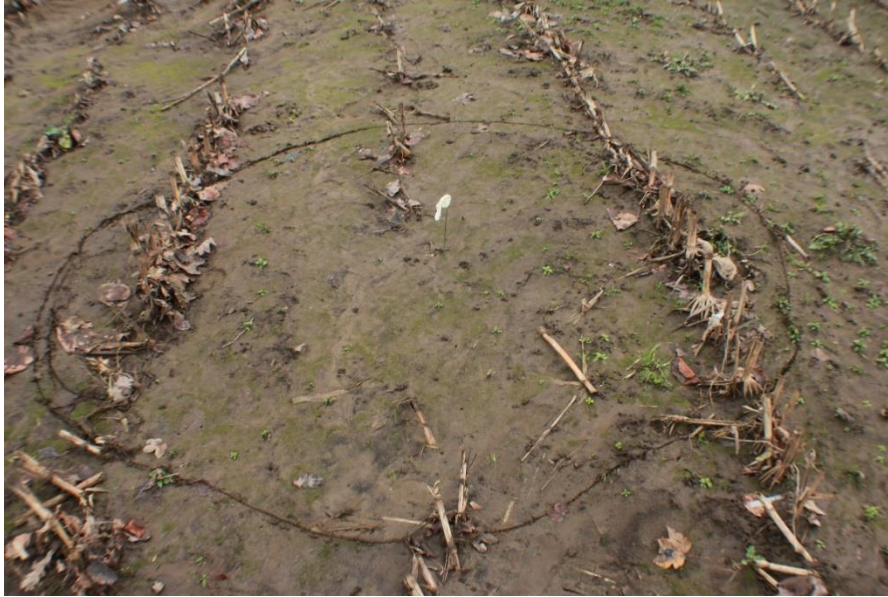
Ffigur 4 / Figure 4. Cymraeg: Manyllyn o un safle colofn arfaethedig, gyda'r amgylchedd wedi'i farcio i ddangos cylchedd tua 2 m mewn diamedr (radiws o oddeutu 1 m). Mae'r dimensiynau hyn yn gyson â sylfeini colfnau neu byst cynhaliol mawr. **English:** *Detail of an individual proposed column location, with markings indicating an approximate diameter of 2 m (c. 1 m radius). These dimensions are consistent with substantial column or post foundations intended to bear significant structural load.*

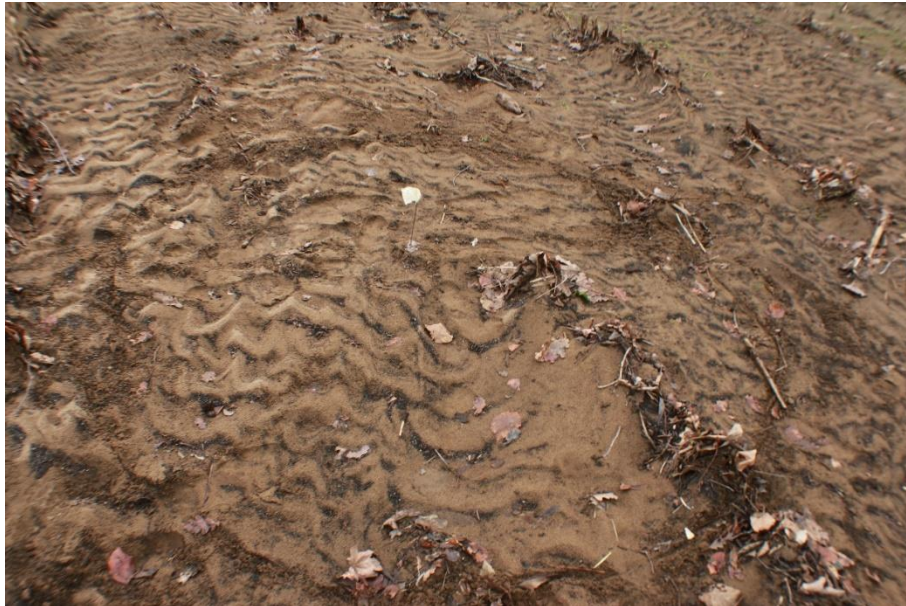
Ffigur 5 / Figure 5. Cymraeg: Enghraifft ychwanegol o gylchedd safle colofn arfaethedig, yn dangos cysondeb o ran maint a ffurf ar draws y safleoedd a nodwyd. Mae'r unffurfiaeth hwn yn cefnogi dehongliad o gynllun adeiladu safonol yn hytrach na nodweddion naturiol ar hap. **English:** *Further example of a proposed column footprint, showing consistency in size and form across the identified locations. This uniformity supports interpretation as a planned construction layout rather than random natural features.*

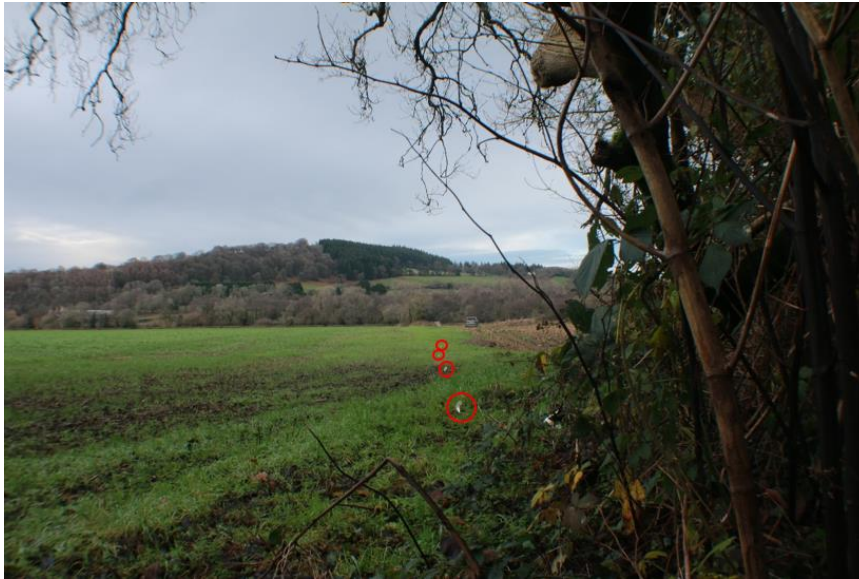
Ffigur 6 / Figure 6. Cymraeg: Golygfa o'r bumed safle colofn arfaethedig wrth edrych tuag at wal amddiffynnol yr afon ar yr ochr ogleddol-ddwyreiniol. Mae'r aliniad gweledol rhwng y safle hwn a'r terfyn afonol yn awgrymu cysylltiad uniongyrchol rhwng y strwythur arfaethedig a seilwaith rheoli neu fynediad i'r afon. **English:** View from the fifth proposed column position looking towards the river defence wall on the north-eastern side. The visual alignment between this point and the river boundary suggests a direct relationship between the proposed structure and river management or access infrastructure.

- **Figure 6** shows the approach toward the river wall from the fifth column position, aligning toward a north-east terminal point.
- **Figure 7** records a large foundation block near the river edge, constructed with mortar consistent in composition with the known river defence wall, though notably denser in fabric.
- **Figure 8** provides a close-up of this foundation block.
- **Figures 9 and 10** show the foundation block in situ and detail the surviving mortar matrix.

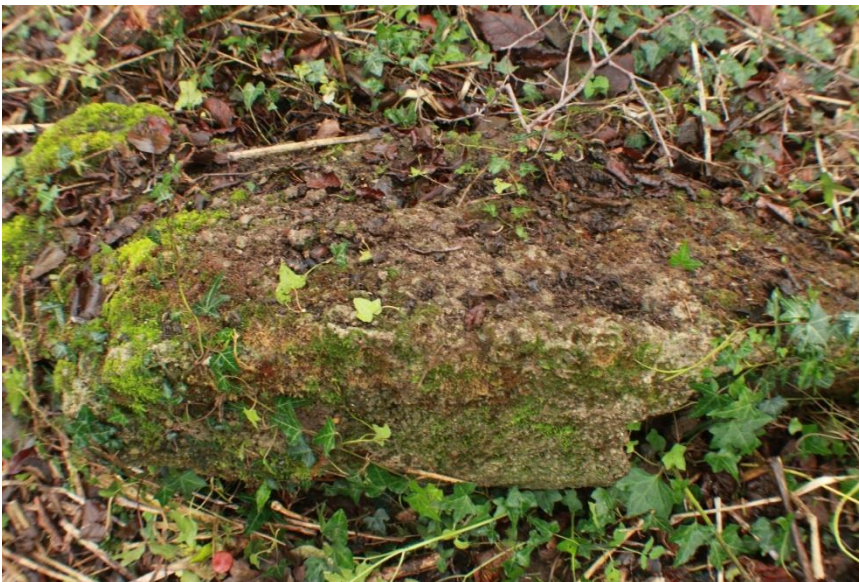
Ffigur 7 / Figure 7. Cymraeg: Bloc sylfaen carreg sylweddol wedi'i leoli ger lan yr afon, gyda mortar tebyg ei gyfansoddiad i'r mortar a welir yn wal amddiffynnol yr afon, ond gyda gwead mwy trwchus a chryno. Gellid dehongli'r bloc hwn fel rhan o sylfaen colofn neu strwythur cynhaliol, wedi'i leoli tua 80 m i'r de-orllewin o wal yr afon. **English:** Substantial stone foundation block located close to the riverbank, bonded with mortar similar in composition to that observed in the river defence wall, though denser in texture. This block may represent part of a column base or supporting structure, situated approximately 80 m south-west of the river wall.

The distance from the river wall to the terminal column position measures approximately 80 m, while the adjacent roadway appears to be approximately 18 m wide, suggesting a substantial engineered access route rather than a minor trackway.

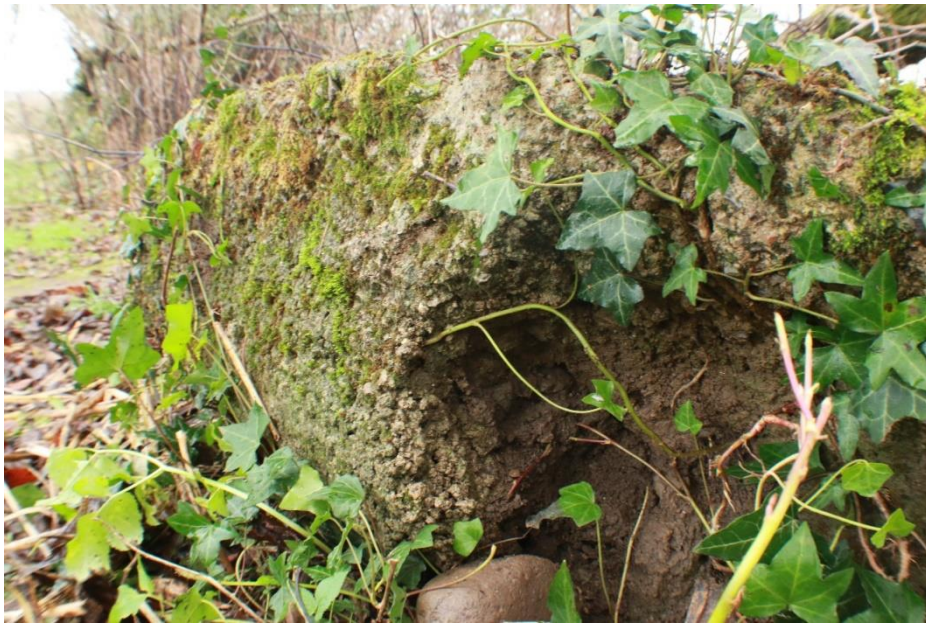
Ffigur 8 / Figure 8. *Cymraeg:* Golygfa agos o'r bloc sylfaen a ddangosir yn Ffigur 7, yn dangos gwead y mortar a'r agregau. *English:* Close-up view of the foundation block shown in Figure 7, illustrating mortar texture and aggregate composition.

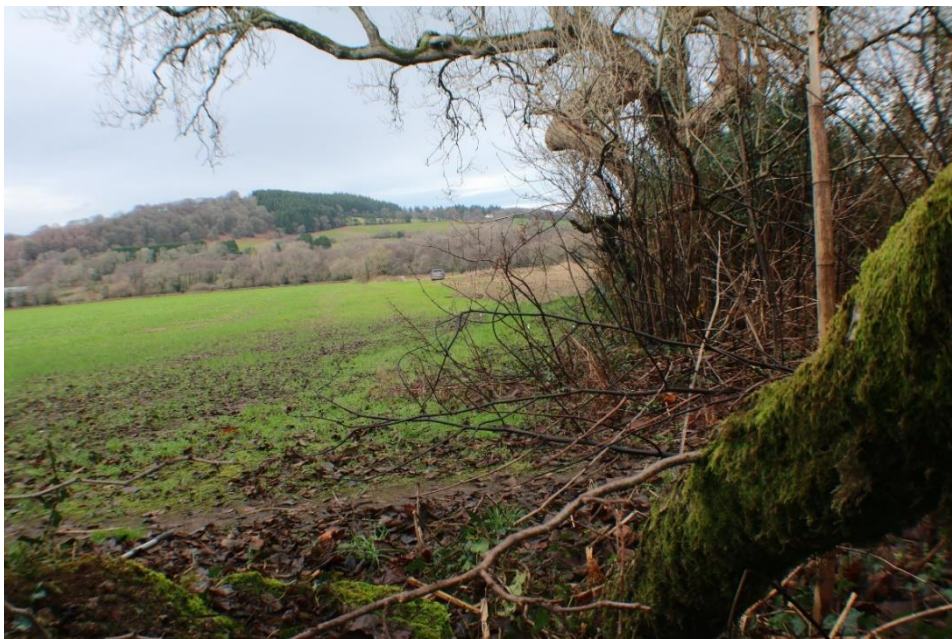
Ffigur 9 / Figure 9. *Cymraeg:* Golygfa o safle'r bloc sylfaen o ochr gyferbyn yr afon, gan roi cyd-destun gofodol o fewn y tirwedd afonol. *English:* View of the foundation block location from the opposite side of the river, providing spatial context within the fluvial landscape.

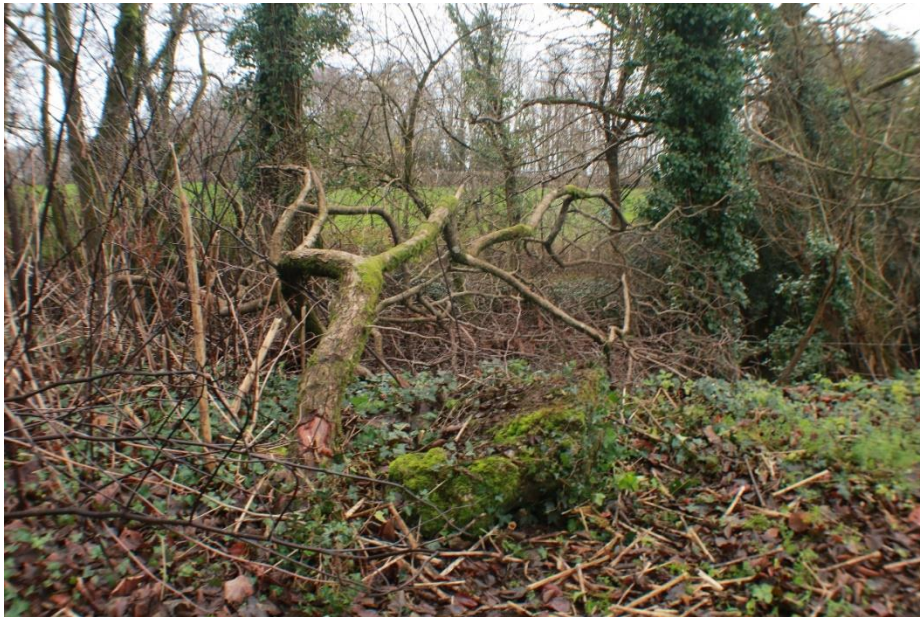
Ffigur 10 / Figure 10. **Cymraeg:** Morter yn ei le (in situ) o fewn strwythur y sylfaen, yn dangos cyflwr a chyfansoddiad. **English:** Mortar in situ within the foundation structure, showing condition and composition.

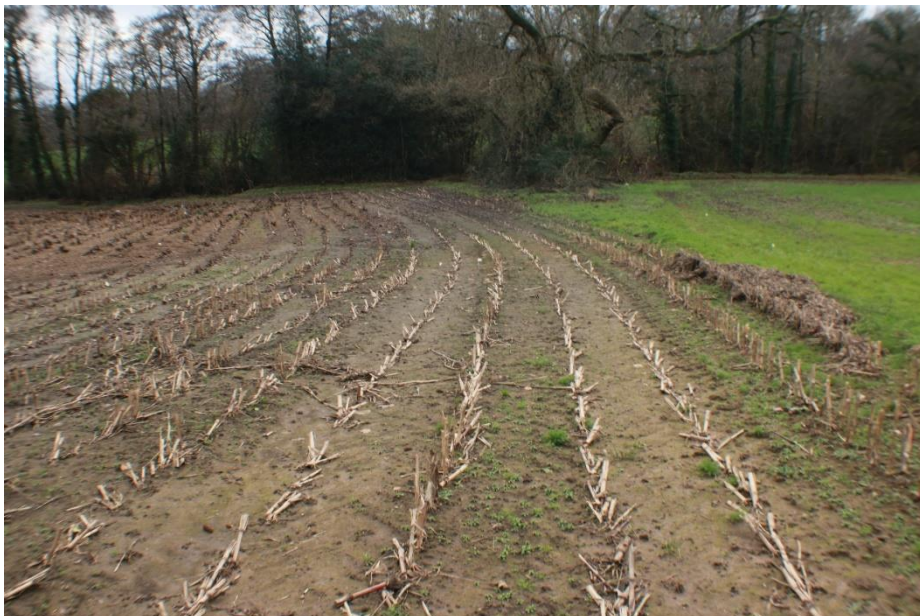
Ffigur 11 / Figure 11. **Cymraeg:** Nifer o farcwrwyr wedi'u gosod ar gyfnodau o tua 9m, yn nodi safleoedd tyllau post arfaethedig ar gyfer strwythur dwyn pwysau. **English:** Multiple markers spaced at approximately 9m intervals, indicating proposed post-hole locations for a load-bearing structure.

- **Figures 11 and 12** further illustrate the regular spacing of these features at approximately 9 m centre-to-centre, a measurement consistent with Roman engineering standards for heavy infrastructure.

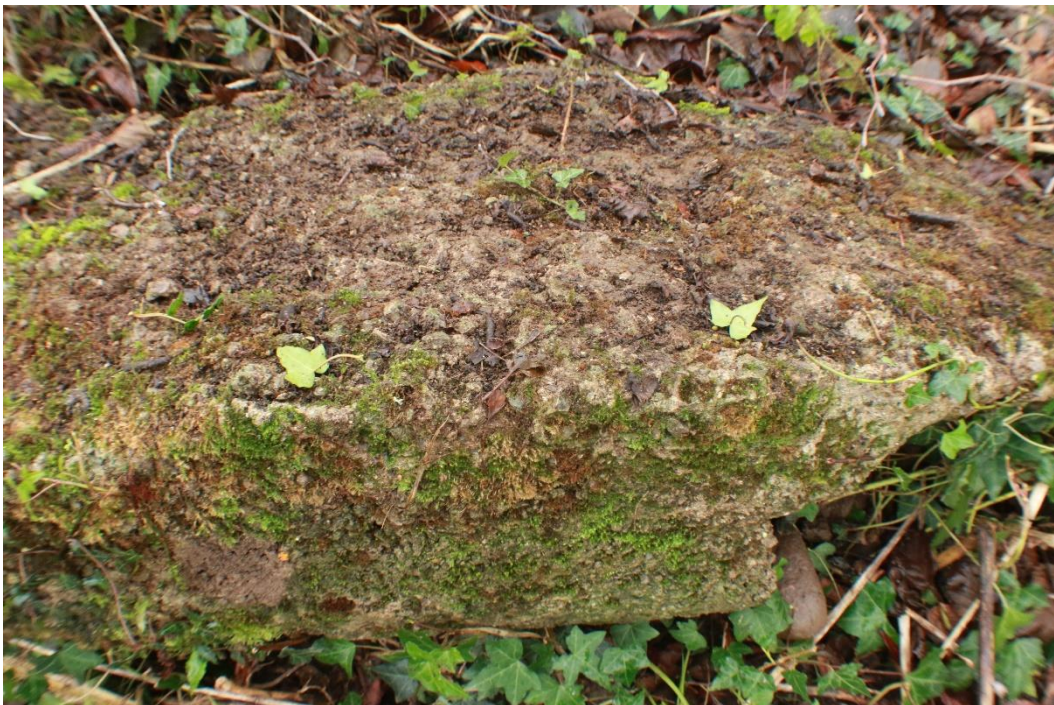
Ffigur 13 / Figure 13. Cymraeg: Sylfaen garreg ychwanegol ar hyd yr aliniad hydredol SW–NE arfaethedig ar gyfer rhediad y ramp. **English:** *Additional foundation stone along the proposed SW–NE longitudinal alignment of the ramp.*

- **Figures 13, 14, 15 and 16** document additional foundation material positioned along this axis.
- *These remains are embedded, substantial, and consistent in composition, supporting the interpretation of a continuous engineered structure rather than isolated rubble.*

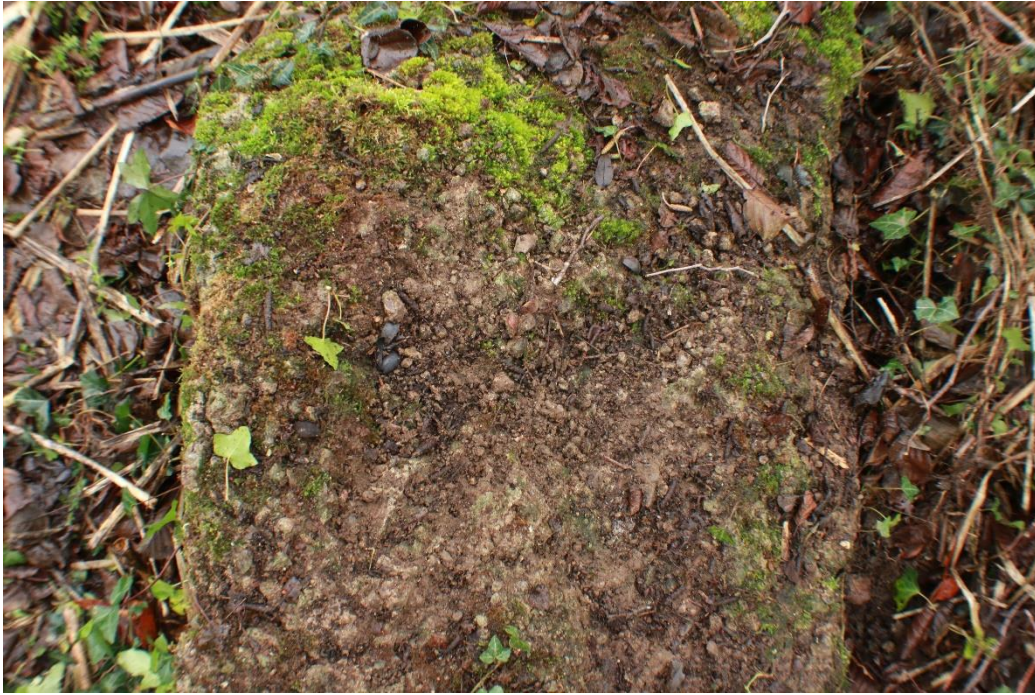
Figur 14 / Figure 14. Cymraeg: Golygfa arall o garreg sylfaen ar hyd rhediad arfaethedig y ramp, yn dangos cysondeb deunydd a lleoliad. **English:** Further view of foundation stone along the proposed ramp alignment, showing consistency of material and positioning.

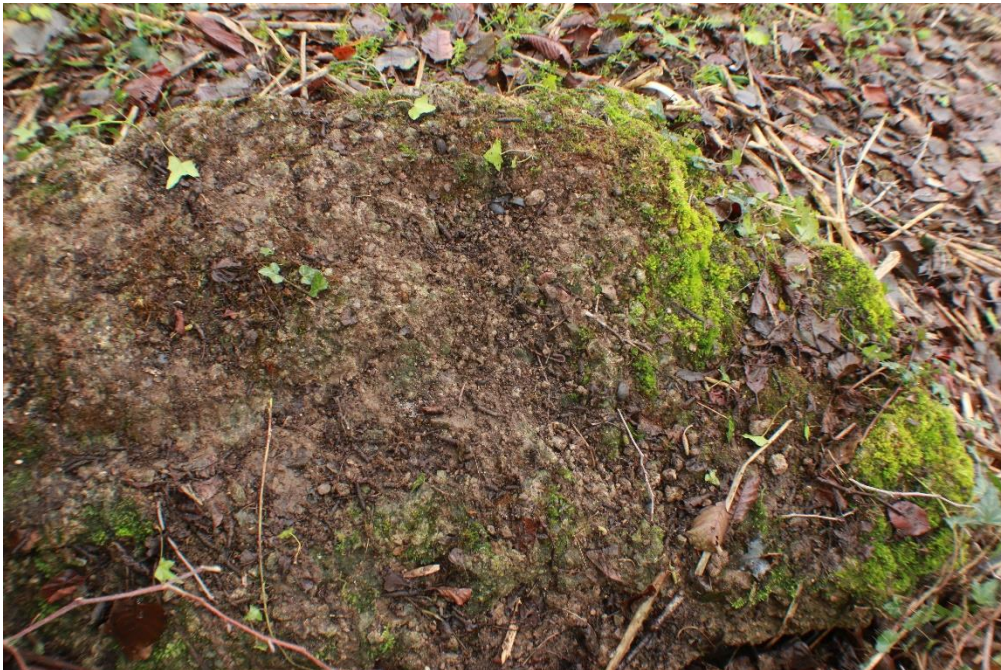
Figur 15 / Figure 15. Cymraeg: Golwg ar linell y ramp arfaethedig yn rhedeg o'r lan dde-orllewinol tuag at wal reoli'r afon ar yr ochr ogleddol-ddwyreiniol, gan ddangos parhad yr aliniad strwythurol. **English:** View of the proposed ramp alignment running from the south-western bank toward the river control wall on the north-eastern side, showing continuity of the structural alignment.

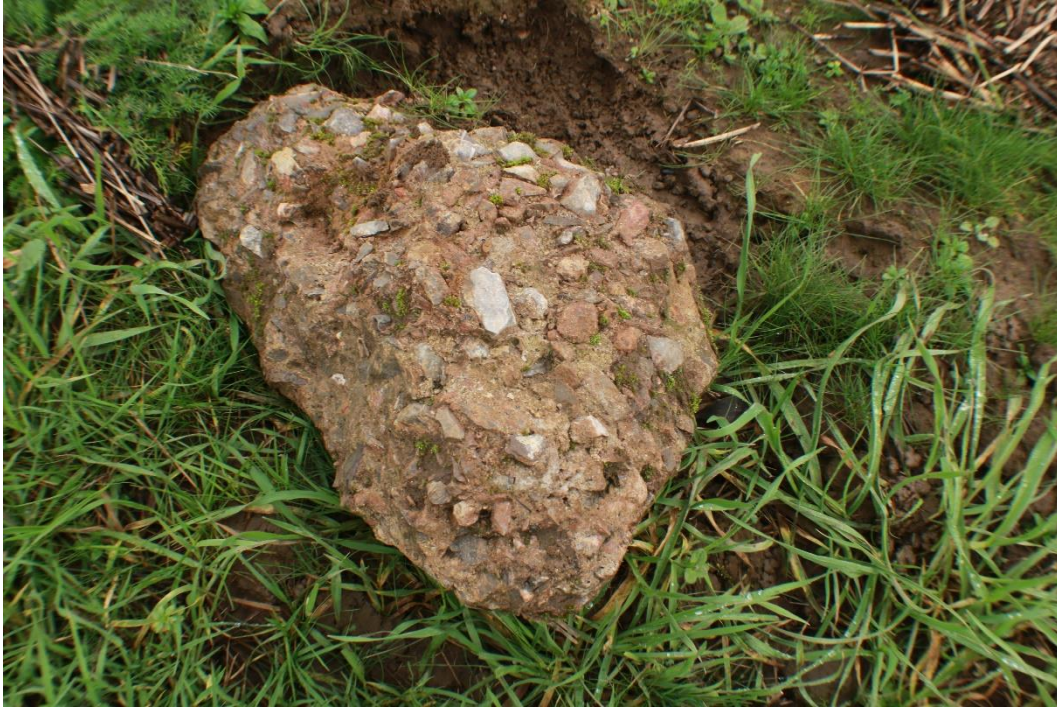
Ffigur 16 / Figure 16. Cymraeg: Deunydd carreg a morter ychwanegol wedi'i nodi ar hyd rhediad y ramp arfaethedig, yn awgrymu sylfeini strwythurol trwm. **English:** Additional stone and mortar material identified along the proposed ramp run, suggesting heavy structural foundations.

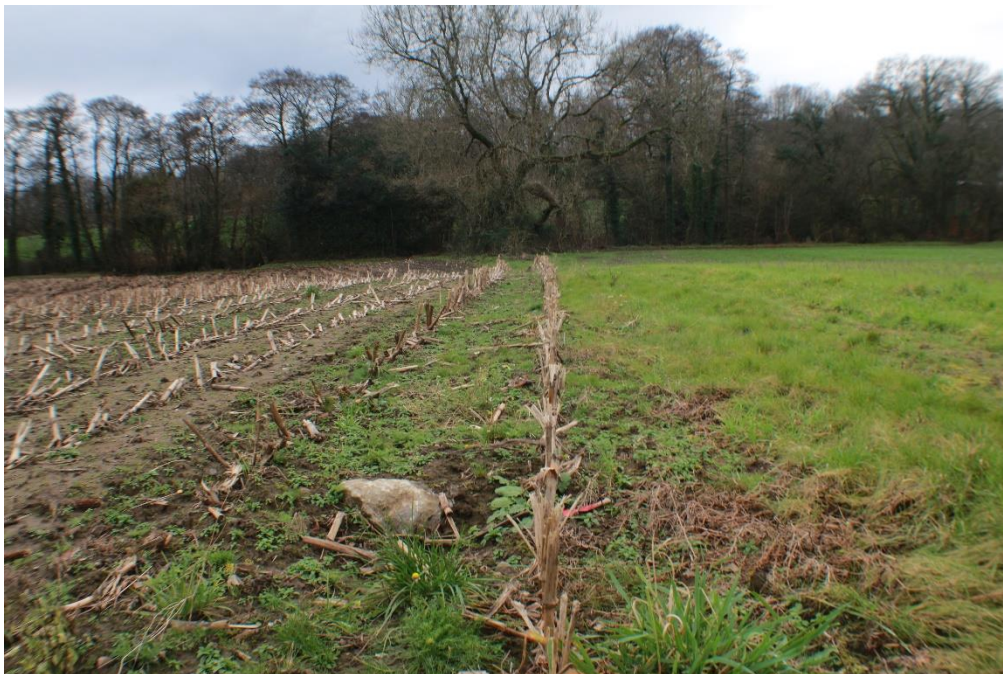
Ffigur 17 / Figure 17. Cymraeg: Aliniad gweledol rhwng wal reoli'r afon ar yr ochr ogleddol-ddwyreiniol a rhediad arfaethedig y ramp tuag at y lan dde-orllewinol. **English:** Visual alignment between the river control wall on the north-eastern side and the proposed ramp run toward the south-western bank.

- **Figures 17 and 18** show alignment from the north-east river wall toward the south-west bank and anticipated ramp run, reinforcing the interpretation of a managed river approach rather than a bridge crossing.

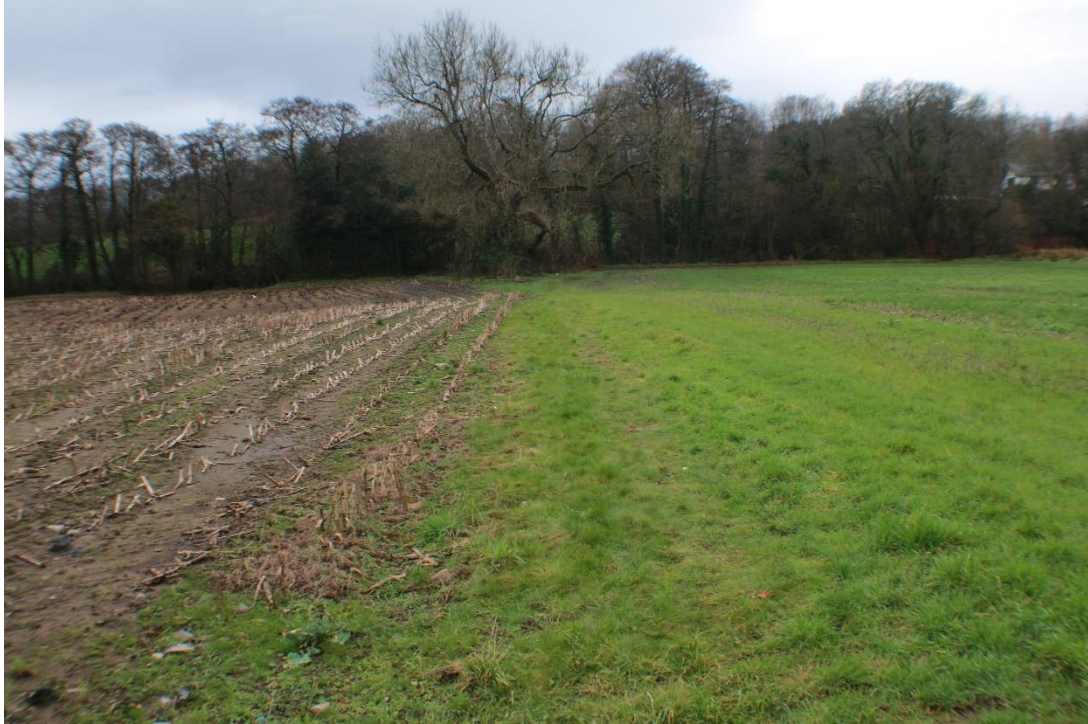
Figur 18 / Figure 18. Cymraeg: Golwg gyffredinol o’r dull arfaethedig at y ramp a’r parth llwytho ar hyd glan ogleddol-ddwyreiniol yr afon. **English:** General view of the proposed approach to the ramp and loading zone along the north-eastern riverbank.
